<u>AIR DEPARTMENT</u> <u>CIVIL AVIATION ADMINISTRATION</u> <u>APPLICATION FOR APPROVAL OF MAJOR MODIFICATION/REPAIR</u>	CA-150
	MOD/REPAIR NO. AWD/11.
	CLASSIFICATION MANDATORY.
TO BE EFFECTED NOT LATER THAN DURING MANUFACTURE

AIRCRAFT OR ENGINE TYPE Jodel D.11.	Component Affected AILERON PULLEY INSTN.
---	---

General Description of Mod/Repair and reason for introduction :-
 POSITIVE ATTACHMENT OF AILERON PULLEY MOUNTING BRACKET.
 TO PREVENT REPETITION OF FAILURE EXPERIENCED BY D-11 AIRCRAFT IN CANADA.

ACCIDENT REPORT

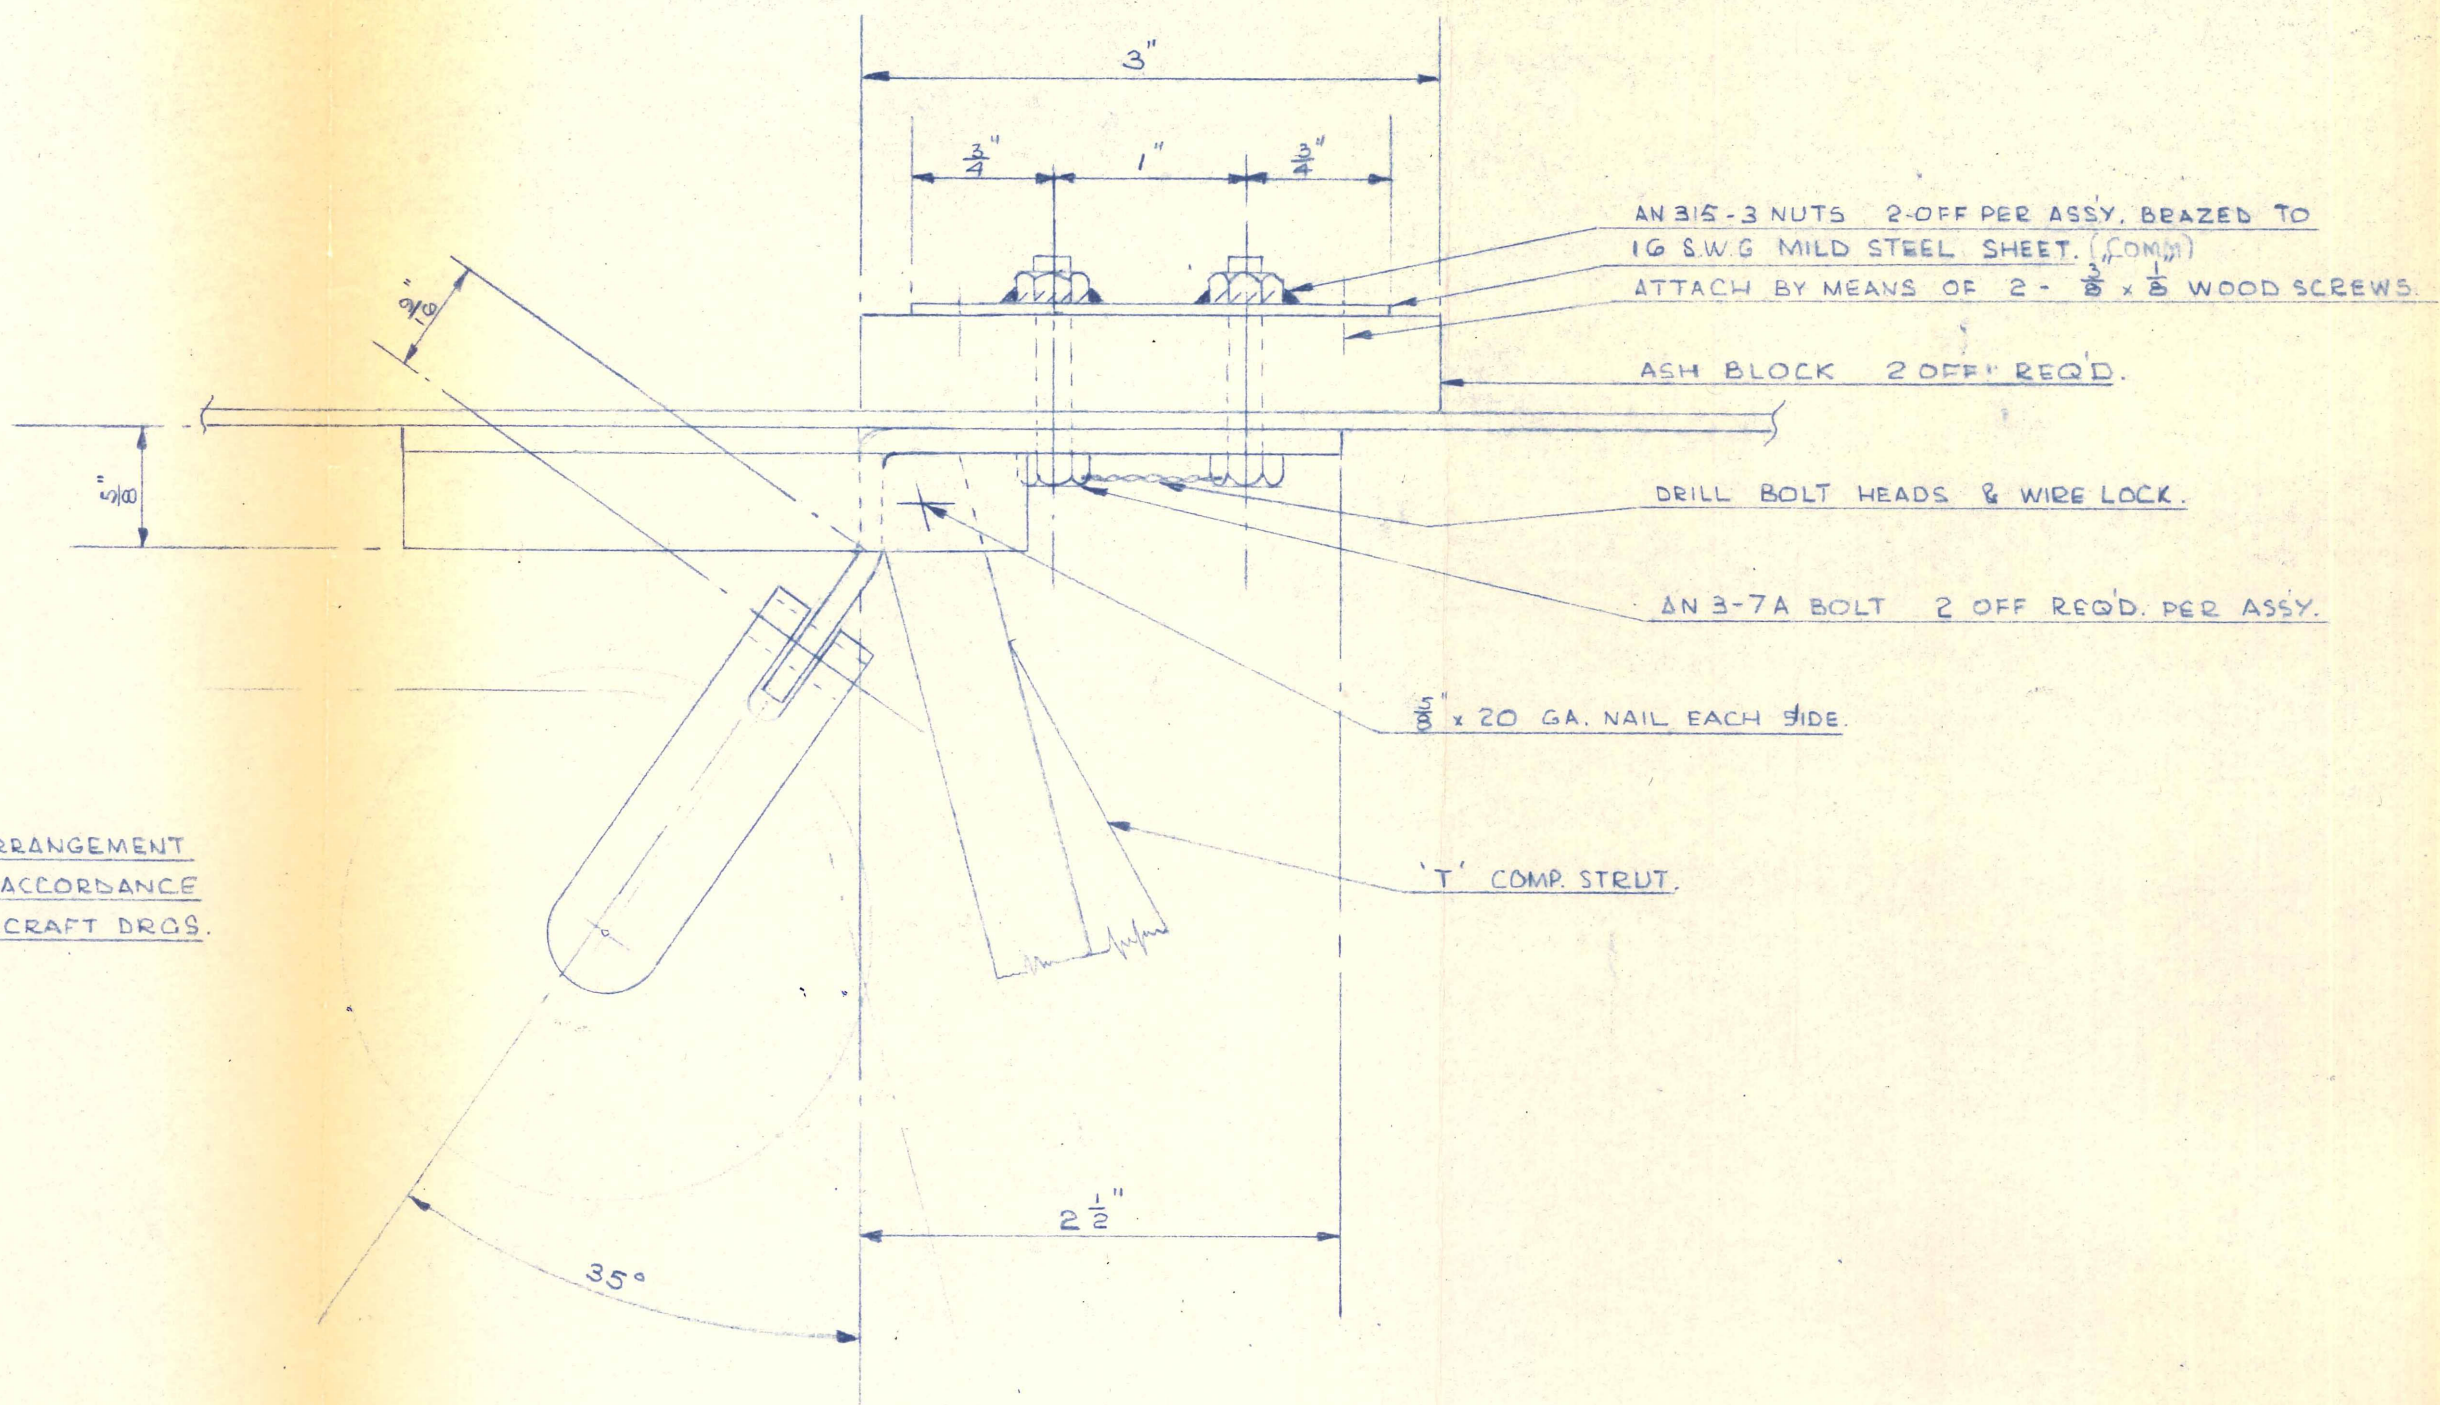
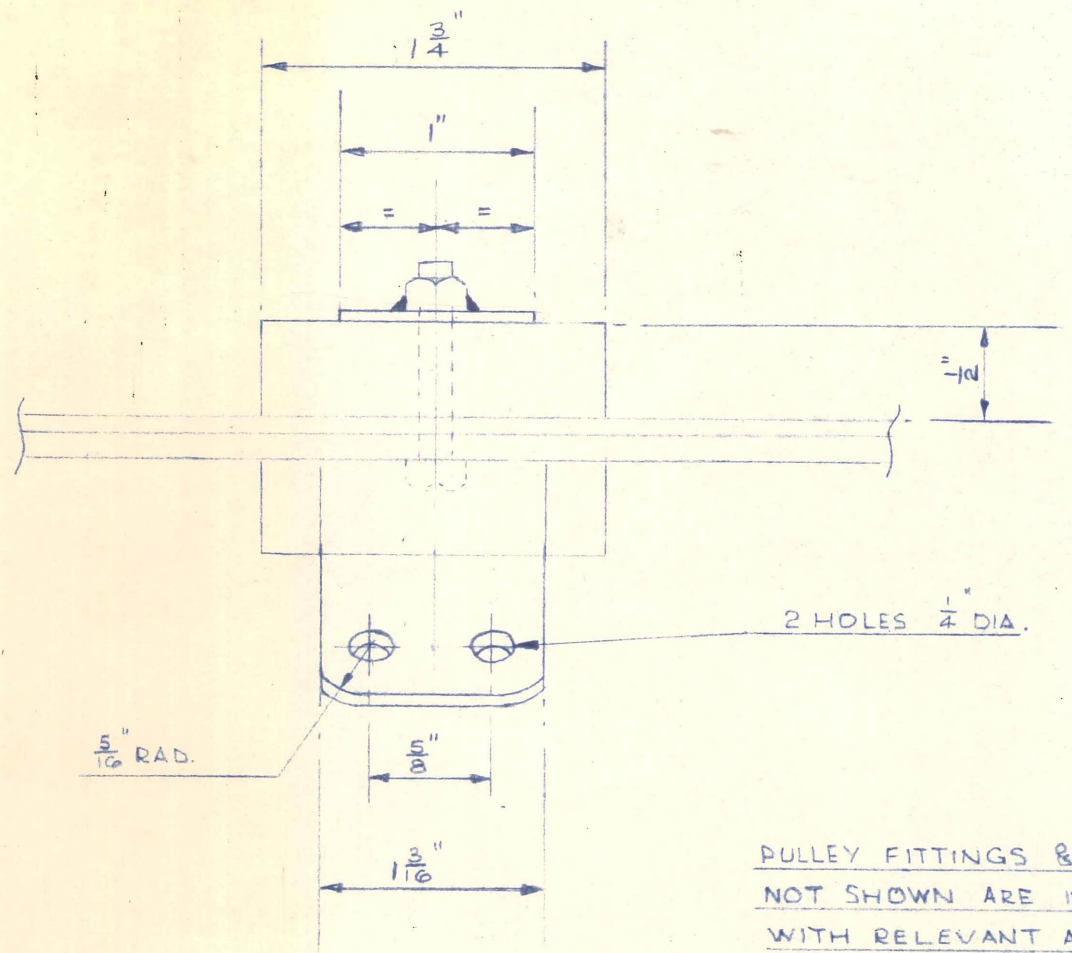
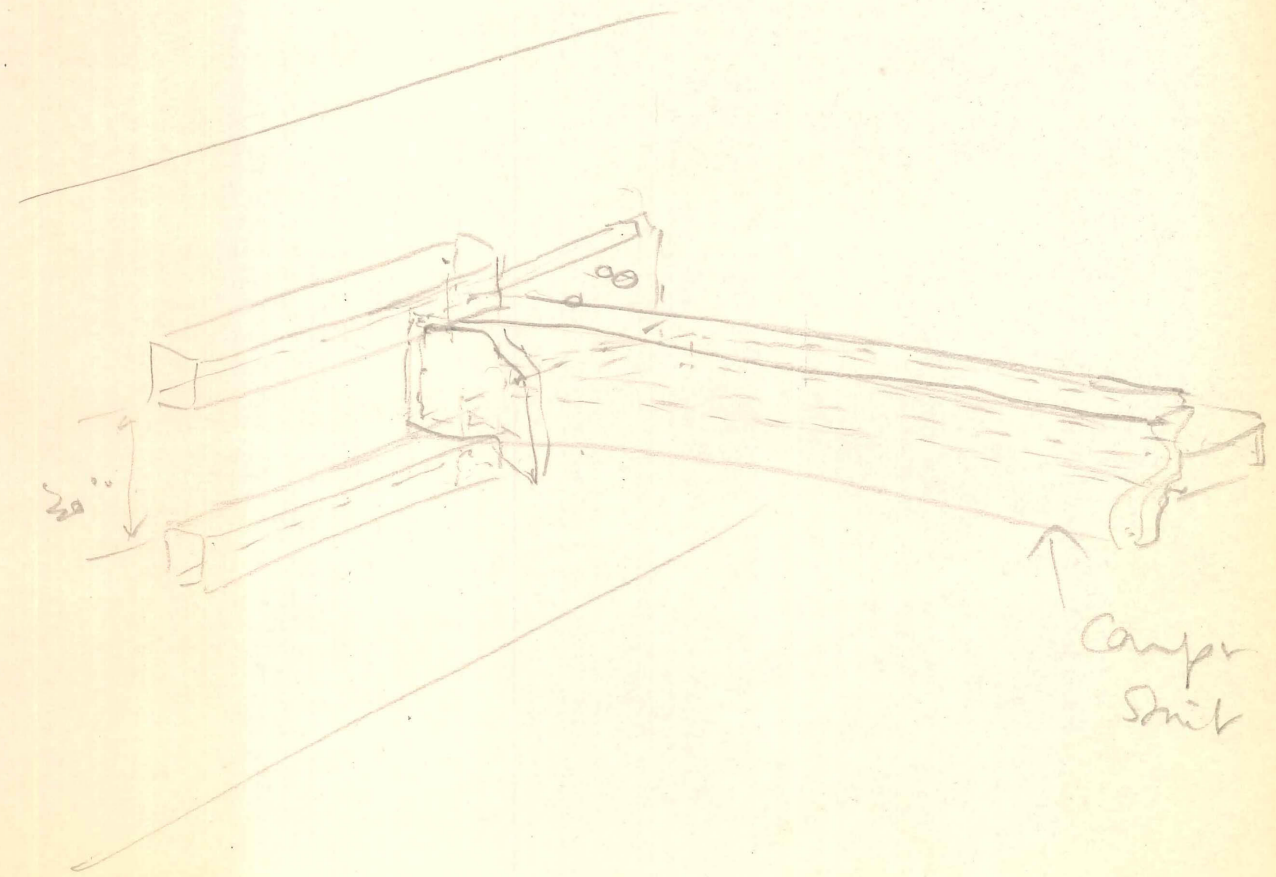
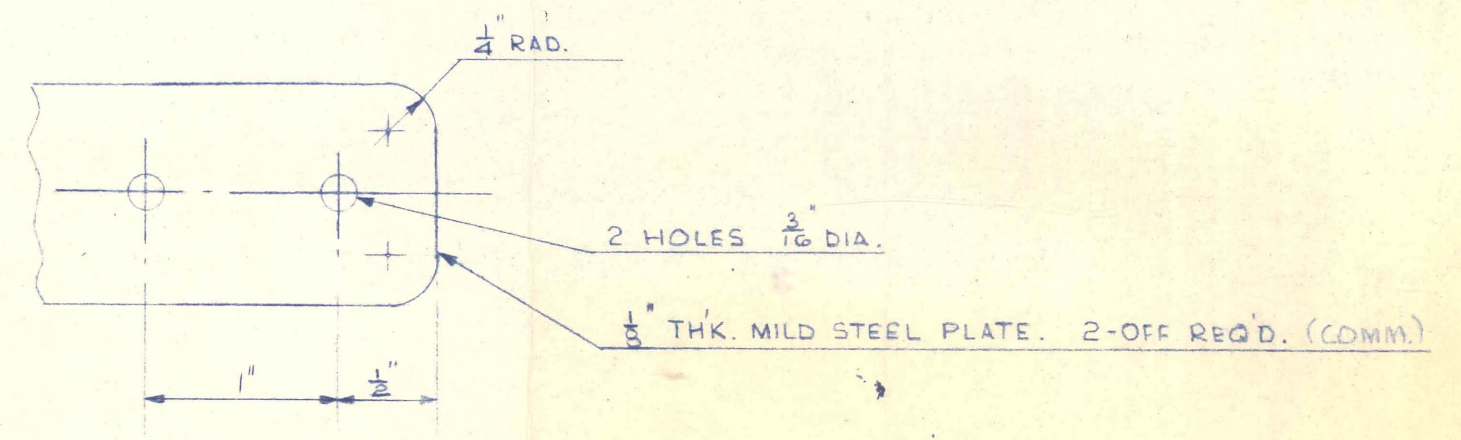
AIRWORTHINESS DIVISION C. A. A.		MODIFICATION AWD/11 AILERON PULLEY INSTALLATION	
DRAWN	M J BAKER	USED ON	JODEL D.II.
CHECKED	A. O. Ewart 2/3/66	SCALE	FULL-SIZE
A.W.D. 177

Investigation determined that effective aileron control was lost when the left wing aileron pulley bracket separated from its anchorage at the rear face of the box spar. This pulley bracket is not secured by bolts or screws, but is hooked over the front end of a compression strut. Aileron cable forces on the assembly tend to pull inboard but movement of the strut and bracket is stopped by a block attached to the rear face of the spar. In this aircraft the block was made of 5/32 inch plywood which proved inadequate to restrain the forward end of the strut and bracket which moved inboard and became detached.

The following Drawings and Data, together with proposed Amendments to Maintenance and Overhaul Schedules, are introduced :-
 DRAWING NO AWD 177 INTRODUCED.
