Continuing Airworthiness Notice 05-016

AS 350 Cargo Hook Swing Frame P/N 114-10000 – Eyebolt Retention

1 November 2023

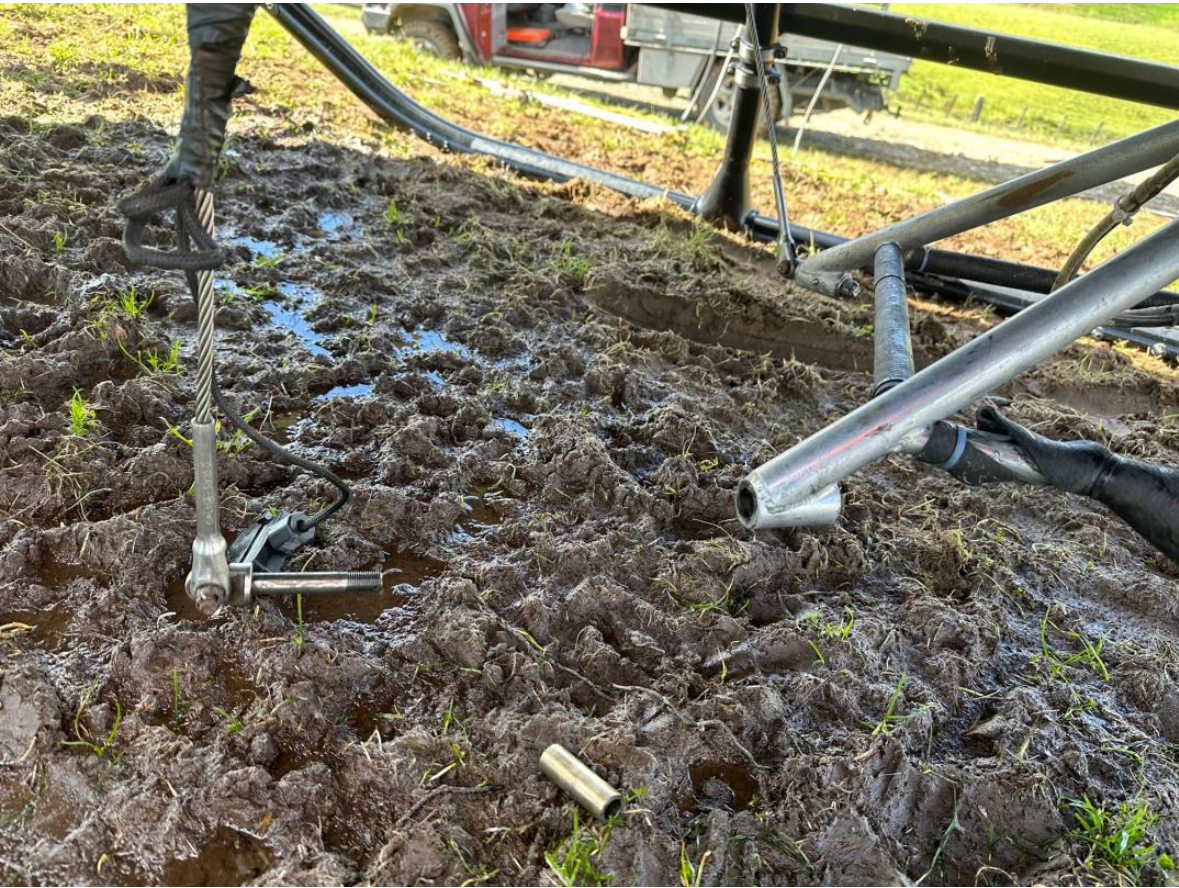
The front left hook frame attachment eyebolt was found separated from the swing frame and the retaining nut (and split pin) were missing. The swing frame was bent, and the airframe had suffered minor puncture damage.

An initial investigation by Oceania Aviation Limited has identified the potential for the eyebolt retaining nut split-pin to fail, allowing the retaining nut to undo.

Figure 1 Hook Swing Frame attachment failed in flight

Oceania Aviation has released Service Information Letter (SIL) OAL-SIL-005 in response to the possibility for the eyebolt retaining nut split-pin to fail.

Operators of the affected cargo hook swing frame are advised to review and follow the recommendations in the OEM SIL.

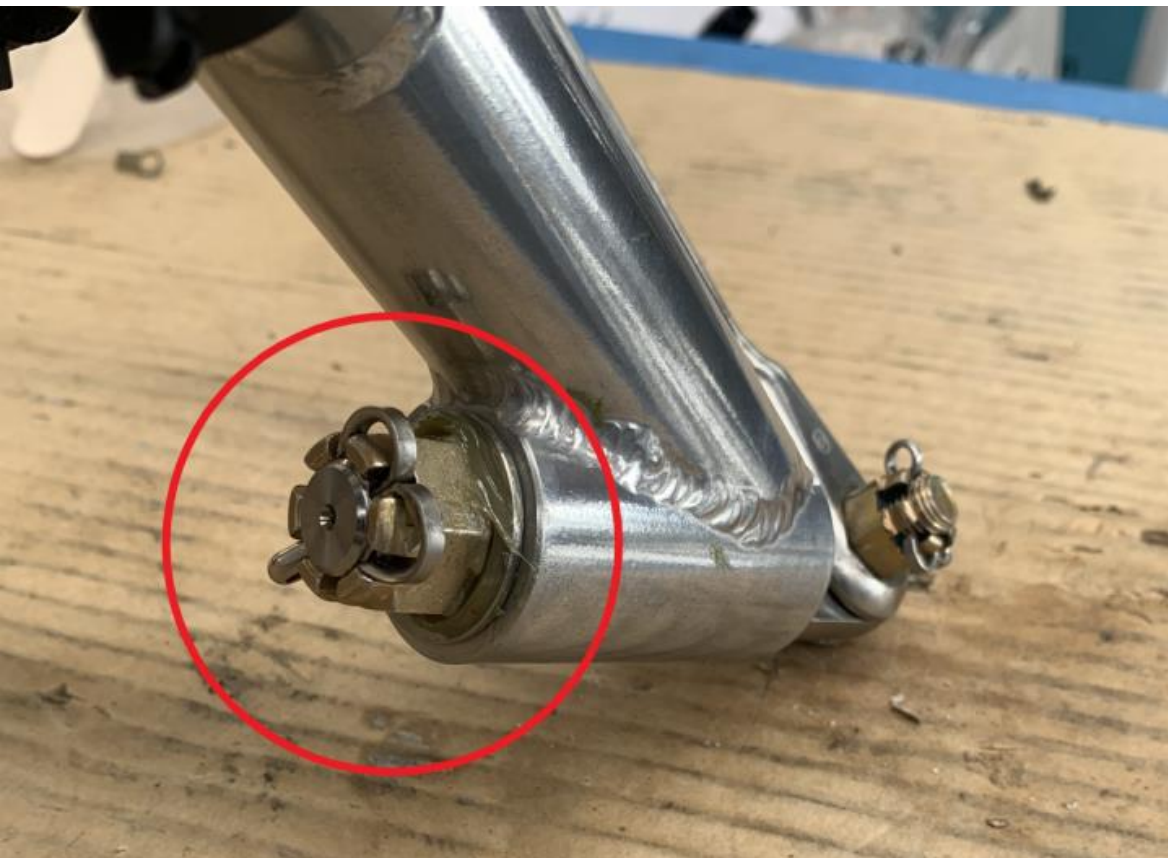
Figure 2 Hook Swing Frame attachment point correctly assembled (OAL-SIL-005)
