Guimbal Cabri G2 Helicopters - Main Rotor Flight Control Pitch Link Cracks

27 January 2023

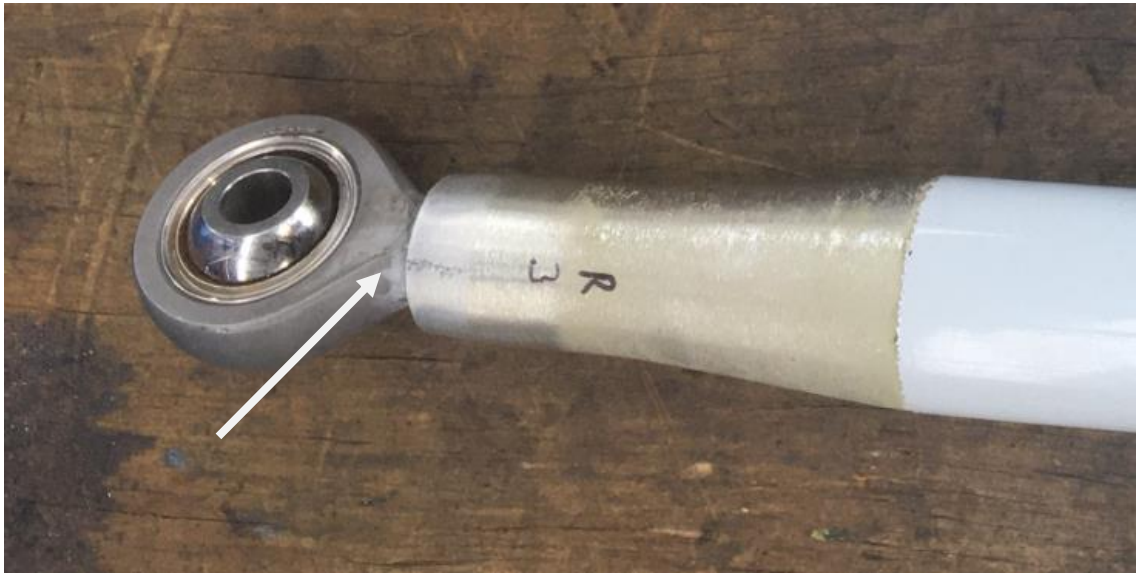
The CAA recently received a report from a New Zealand operator of a Guimbal Cabri G2 of finding cracks in all three main rotor pitch link assemblies (IPC Ref 4.1-02 #24 P/N G41-01-100). The cracks were found in the swaged end of each pitch link, running lengthwise to the rod. Refer to the photo below for further details.

1. When carrying out pre-flight inspections pay extra attention to the lower (swaged) end of the pitch link assemblies for any indication of corrosion, paint cracking, or surface anomalies. If any indications of cracks are identified, then a maintenance engineer should inspect the pitch link assemblies. If engineers identify any crack-like indications after referral, or during scheduled maintenance, they should further inspect the rods to determine if a crack is present.
2. Operators are advised to review the instructions in Guimbal SB 21-006B, which provides inspections and preventative maintenance actions related to main rotor pitch link assemblies.
