Continuing Airworthiness Notice 27-024

Guimbal Cabri G2 Helicopters – Cracked Tail Rotor Control Pedal

19 July 2023

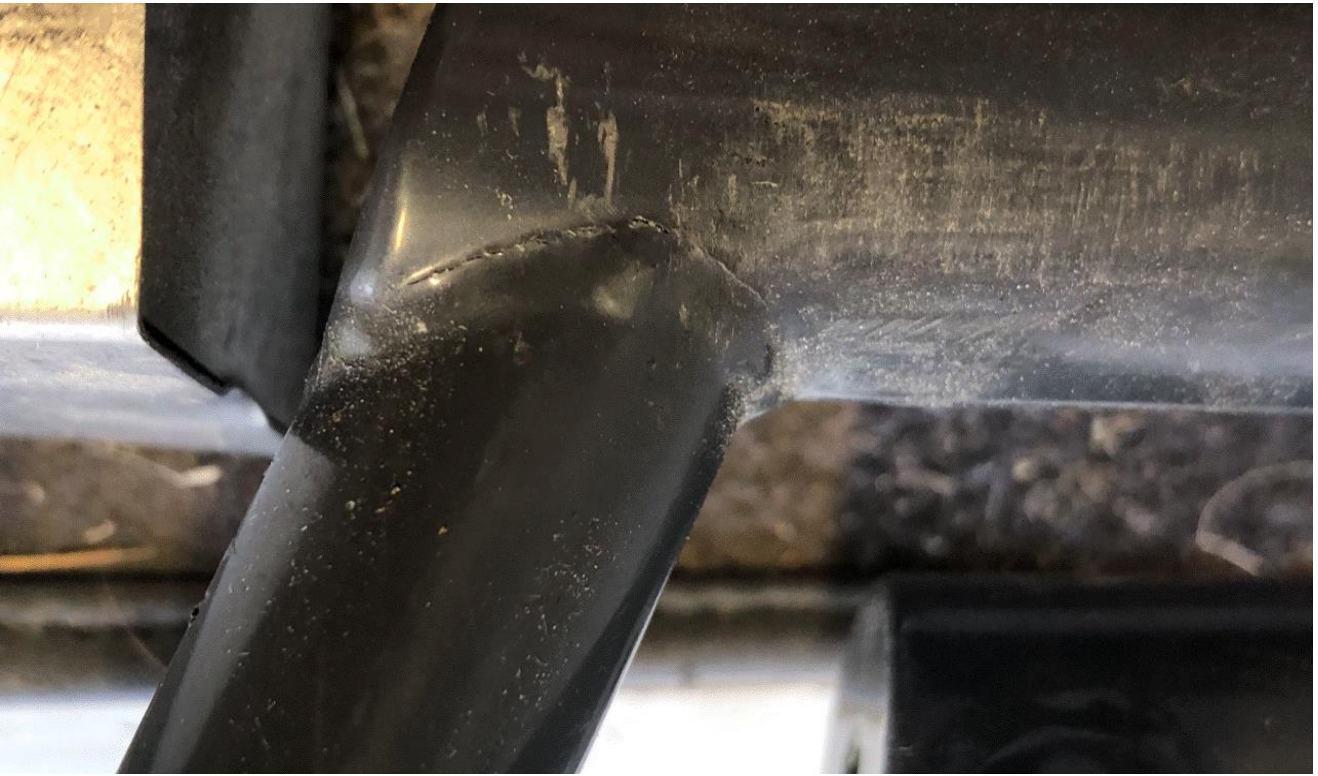
During a scheduled 500-hour inspection of the aircraft, the engineer found paint cracking on the tail rotor pedal assembly located on the RH side of the helicopter. The paint was removed, and the pedal inspected using a 10x magnifying glass. A distinct line and indications of rust were noted. The pedal was sent for NDT inspection where the indication of a crack was confirmed.

Figure 1. Pedal as initially inspected.

This incident highlights the need for diligence when carrying out routine inspections, and of the importance of further investigation when an indication of a defect (especially a crack) is identified.

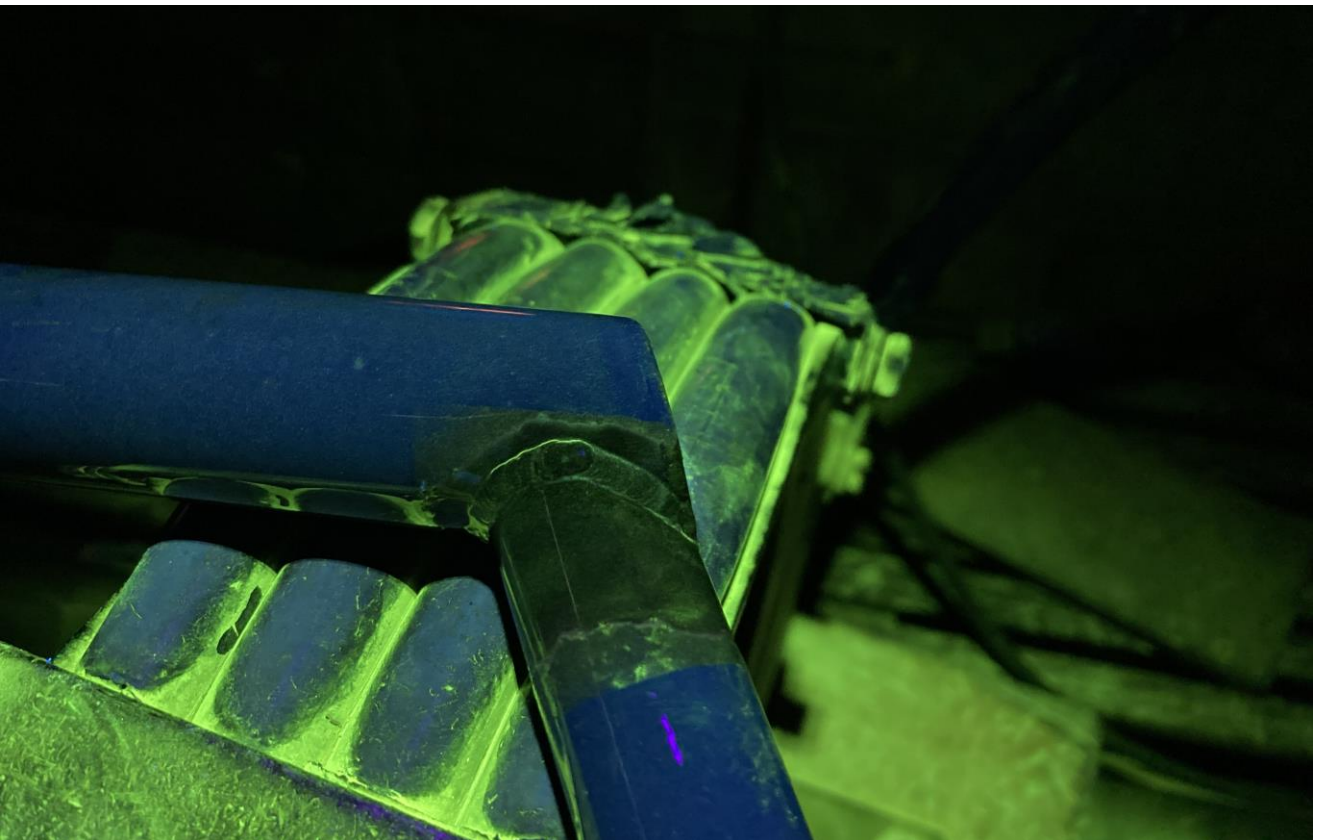
Figure 1. NDT inspection image (with paint removed).
