Airworthiness Directive Schedule

Helicopters

Airbus Helicopters AS 355 Series

31 August 2023

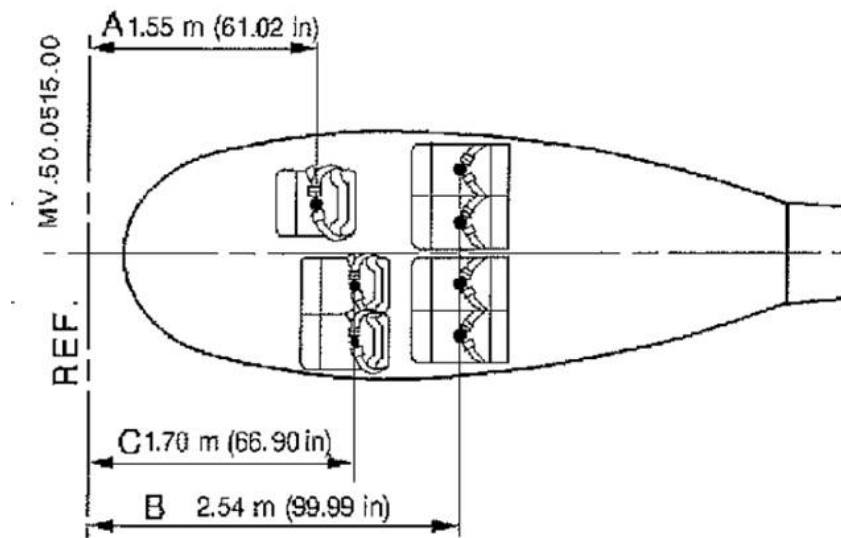
Requirement: To prevent a reduction of flight safety from that provided by the manufacturer, accomplish the following:

Figure: Airbus Helicopters recommended CG position of forward two-place seat.

1. Determine the longitudinal moment arm of the forward two-place seat using the center of the seat pan cushion as a measurement reference point.
Complete and issue a new form CAA 2173 Weight and Balance Data.
The weight of the seat components must be included in the CG calculations. If a seat adaptor plate is fitted the moment (position and weight) of the plate must also be considered for the CG calculation.
The lateral CG arm of the helicopter must not be assumed to be zero. The lateral CG must be recorded and be within the limits specified in the AFM.
Annotate the CAA2173 to include the value of the longitudinal moment arm of the forward two-place seat used.
2. Remove CAA Limitations Section, (1 page), dated 14 December 2015 and insert 1 page dated 30 June 2016.
