Feedback

Canadian Aviation Service Difficulty Reports

The following content was published between 1 January 2022 and 31 March 2022. The full accessible version of each article is available on the Feedback [website](#).

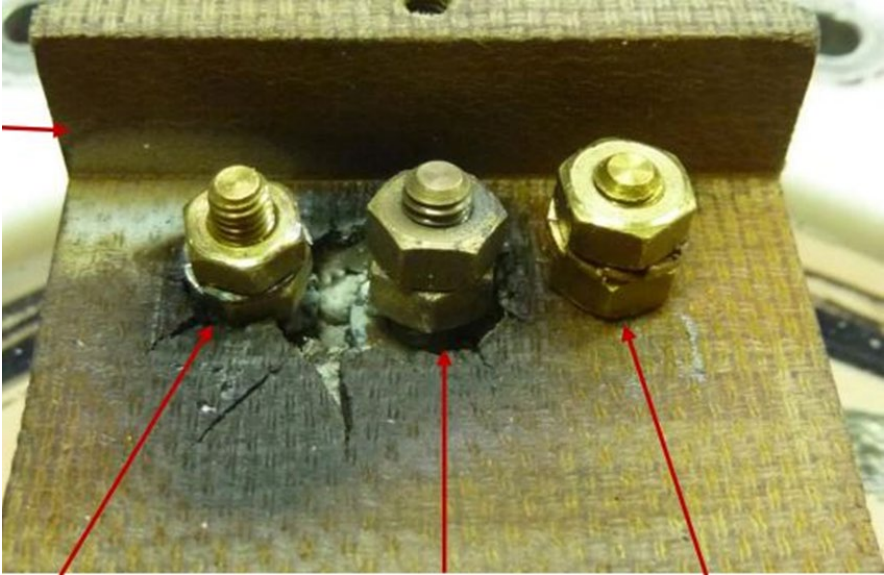
The side window anti-ice activated at approximately 4000 feet (ft). By approximately 2500 ft, the pilots could smell electrical smoke, followed by dark grey smoke emitting from the first officer’s side window. At this point, the aircraft was clear of the cloud. The side window anti-ice was de-activated, and Air Traffic Control (ATC) was notified that the aircraft was on final approach with smoke in the cockpit. Upon landing, the side window and the electrical connection for the side window heat began to burn and melt. The aircraft taxied off the runway, with small flames becoming visible. The aircraft was shut down and the handheld fire extinguisher was discharged on the burning portion of the window and the associated electrical connection. The initial investigation points to the fire starting at the positive stud on the electrical connection. There is no evidence of arcing of the positive wiring to the airframe, and it appears to have started internally in the phenolic housing.

The origin of the arcing was located at the electrical connections between the aircraft power supply and the connector of the side window (fastener with three screws and nuts).

The technical investigation shows that a mechanical clearance between the aircraft crimp ring and the connector screws may cause an increase in the contact resistance and a local overheating/arcing at the level of the crimp rings (terminal lugs) and fasteners.

Picture 1 – Burnt window de-ice terminal lugs

The technical investigation determined the most appropriate torque to be applied and added an additional nut to the terminals.

Issue 1. This AOM guides certain aircraft operators to Vendor Service Bulletin (VSB) 56-12-00-SPSATR42 and provides other operators with information on using the new torque values.

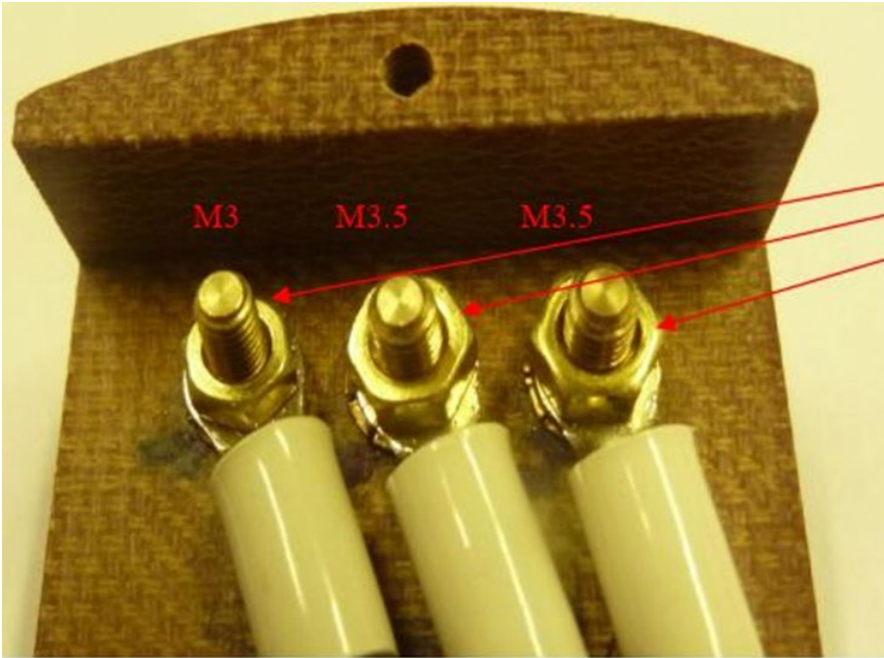
Picture 2 – Side window de-ice terminal - old installation

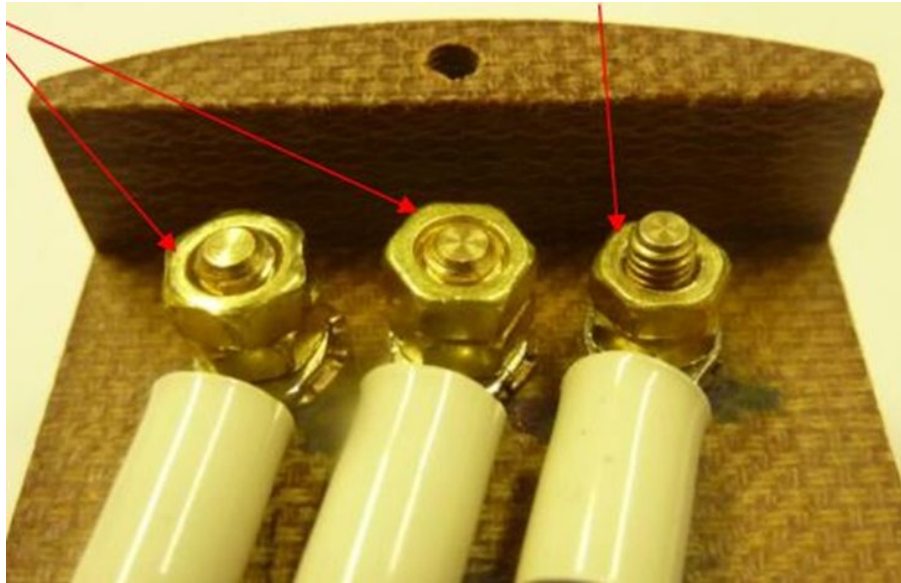
Picture 3 – Side window de-ice terminal – new installation

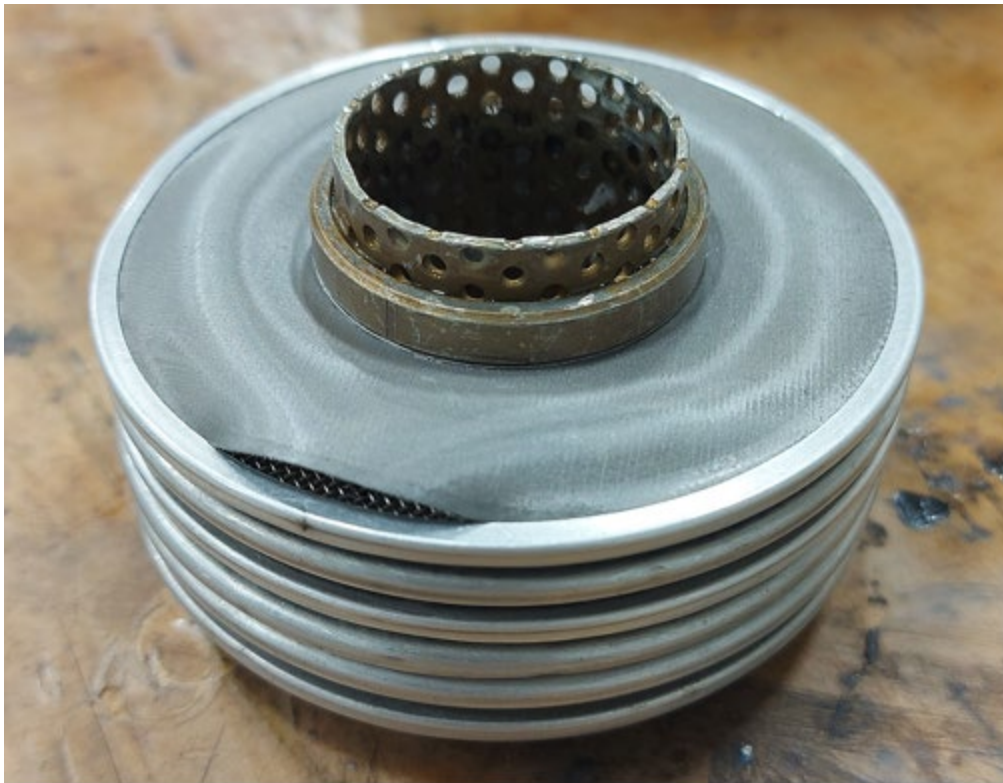
During flight, the L FUEL PRES LO annunciator came on, so the pilot turned on the standby pump, but the light did not extinguish. The airframe fuel filters were inspected, and the red (bypass) indication poppers were not popped though both filters were full of ice. The left-hand (LH) filter discs were severely deformed and bulged.

Further investigation determined that the incorrect part number airframe filter assembly was installed on the LH side of the aircraft. A right-hand (RH) filter assembly was installed on the LH side prior to the aircraft joining our fleet.

The maintenance error went unnoticed until ice buildup in the fuel filter assembly installed on the LH side significantly reduced the fuel pressure, resulting in a warning annunciation. Fuel bypass would not be possible as the direction of flow (IN/OUT) was the opposite than intended. The fuel filtering function would also flow in the opposite direction than designed; outwards versus inwards of each disc.

Figure 1 – Bulged filter disc due to the fuel flowing in the opposite direction than designed

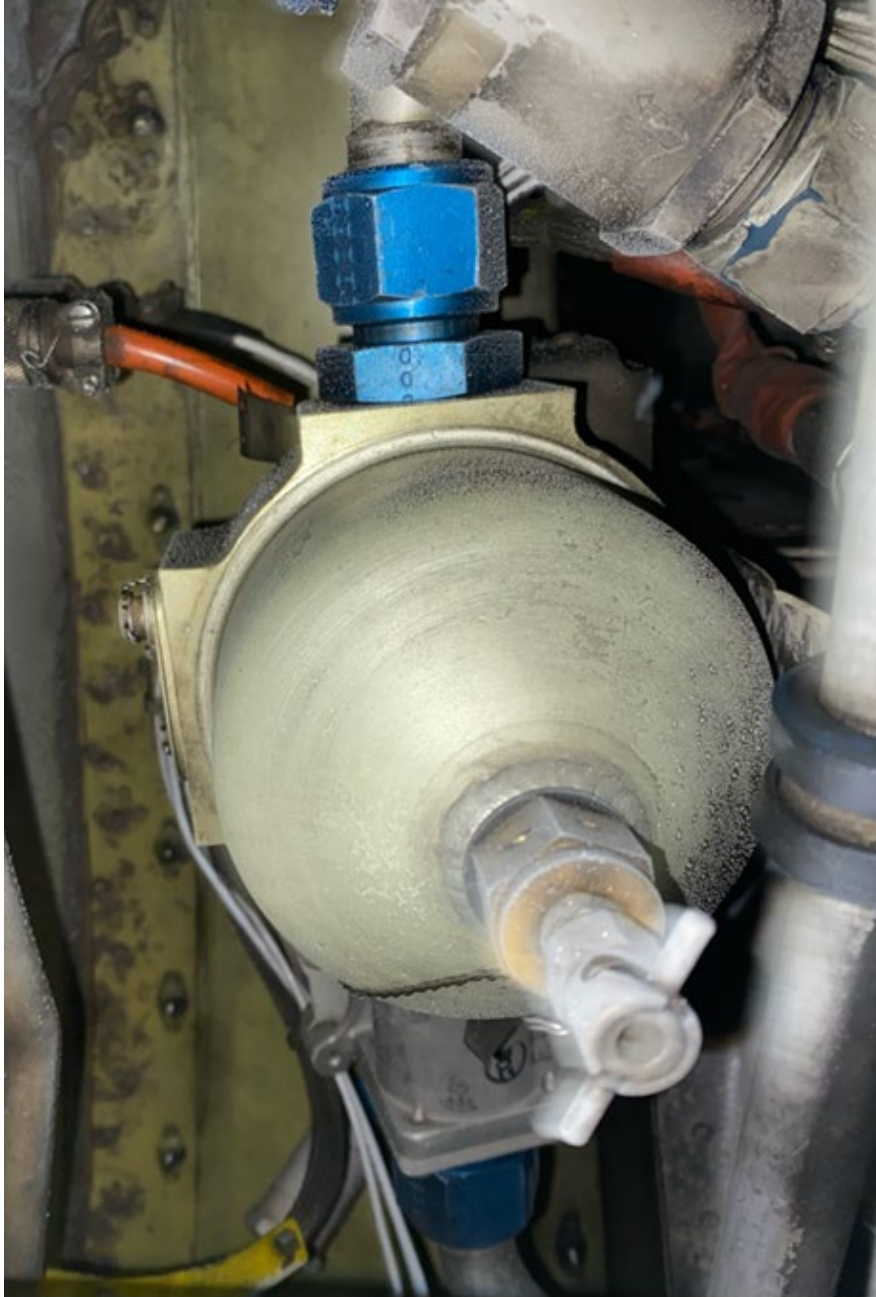
Please note that the IN/OUT markings on the fuel filter assembly casting are not visible when viewing through the under-wing filter access door as they are located on the top side of the casting inlet and outlet ports. The upper access panel on the top of the wing may need to be removed to see the markings on the casting.

Figure 2 – View through under-wing filter access door

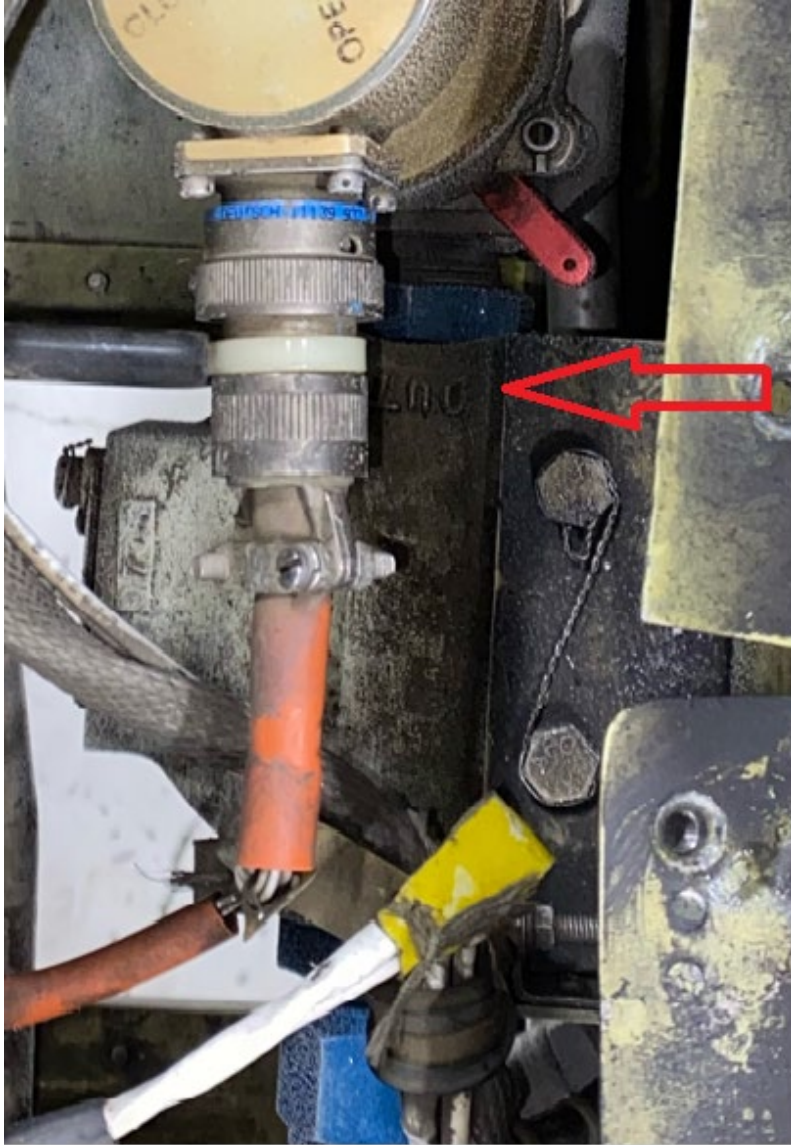
Figure 3 – View from upper access panel with OUT marking evident

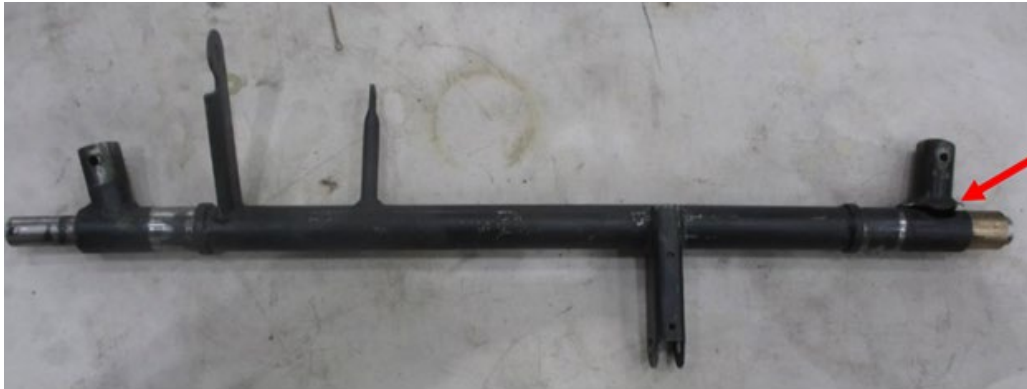
On the co-pilot's side, the right rudder pedal failed when fully depressed. Maintenance found the right rudder bar weld assembly broken at the pedal arm attachment location, on the tube. The rudder bar was replaced.

Figure 1 – Rudder pedal bar failure location

The rudder pedal torque tube design is similar across 100 and 200 series Textron Aviation Inc. (Cessna) models. Transport Canada Civil Aviation (TCCA) suggests that owners, operators, and maintainers of all series 100 and 200 models review SID 27-20-01, pay special attention to this area, and incorporate its contents into the aircraft's maintenance program.

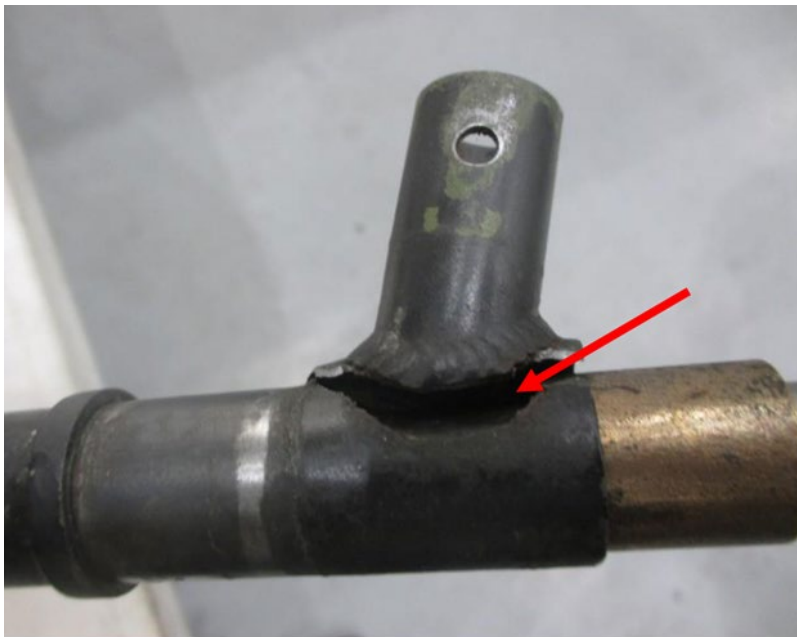
Cessna 150 aircraft Supplemental Inspection Document (SID) 27-20-01 describes the recommended inspection to verify the integrity of the rudder pedal torque tube assembly. As the SID states, typical failures occur at or close to welds.

Figure 2 – Failure at weld

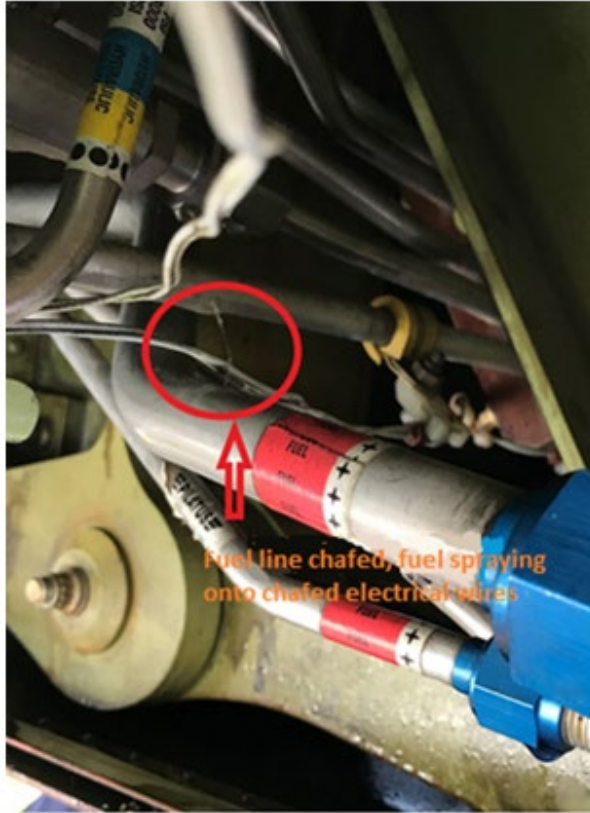
The pilot discovered significant fuel leakage from the belly of the aircraft, inboard of the left-hand (L/H) wheel well area, while the aircraft was shut down on the ramp after a call. Upon investigation by maintenance, it was noted that a main fuel line had a small pinhole in it, causing a steady stream of fuel to jettison the aircraft. In the area of the puncture was a wire bundle that appeared to be chafed. It appeared that the wire chafed a hole in the fuel line, and the fuel was spraying onto the chafed electrical wires. The fuel spill was contained on the ramp, and the leaking fuel line was contained using temporary means to prevent further fuel loss on the ramp.

Picture 1 – Fuel stream from the chafe on the fuel line

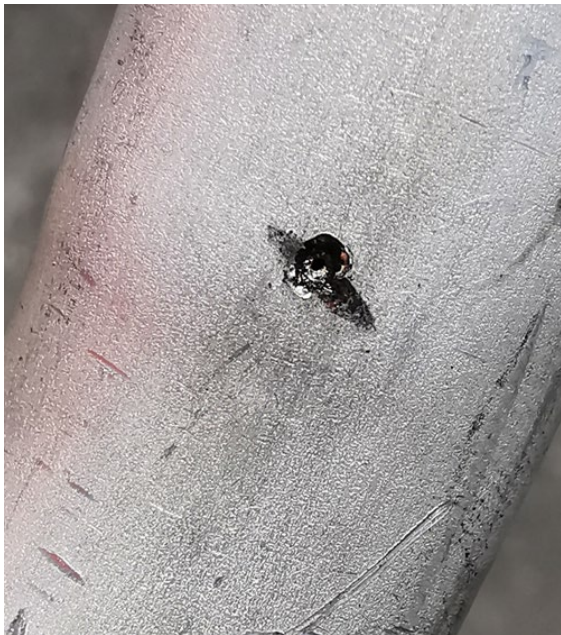
A hole was found in the L/H wing fuel line part number (P/N) 528.24.12.173A caused by a chafing wire from the belly beacon P/N L78B18/I79A18N, which chafed through the insulation, exposing the bare wire, and had arced on the fuel line, causing the leak. The wire was able to chafe due to a rotated Adel clamp and standoff, which held the two beacon wires.

Picture 2 – Chafe found on the fuel line

The aircraft was defuelled, the fuel line was removed, the wire was repaired with Raychem in accordance with standard practices, silicon fusion tape was applied to the hydraulic line, which the Adel clamp was attached to, and the Adel clamp was attached/reinstalled on the tape and positioned away from all lines. The Adel clamp cannot rotate due to friction from silicon tape. A new fuel line P/N 528.24.12.173B was then installed in accordance with standard practices.

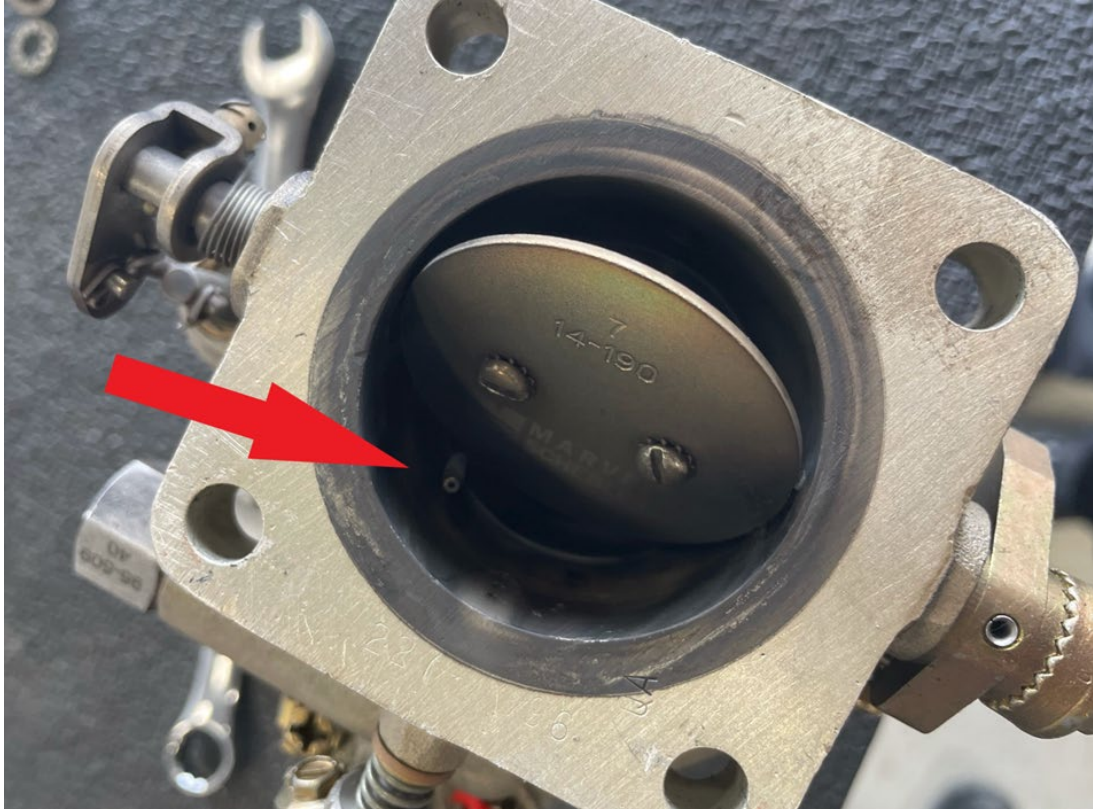
While landing, the student and flight instructor noticed that they were unable to reduce the engine speed to idle, revolutions per minute (RPM) could only be controlled between 2000-2200 RPM. They declared an emergency, shut down the engine in short final and landed safely. The company's maintenance technicians inspected the engine throttle control and noticed that it could not be pulled back. The carburetor was removed, and it was found that the accelerator pump discharge tube had detached and stuck in the butterfly.

Picture 1 – Discharge tube lodged beside throttle fly

Accelerator pump discharge tubes are bonded in place during assembly or overhaul and undergo a specified torque check to determine serviceability. Transport Canada Civil Aviation (TCCA) recommends that a detailed visual inspection of this area be performed whenever possible to detect a disbonded accelerator pump discharge tube and that such defects continue to be reported by submitting a Service Difficulty Report (SDR).

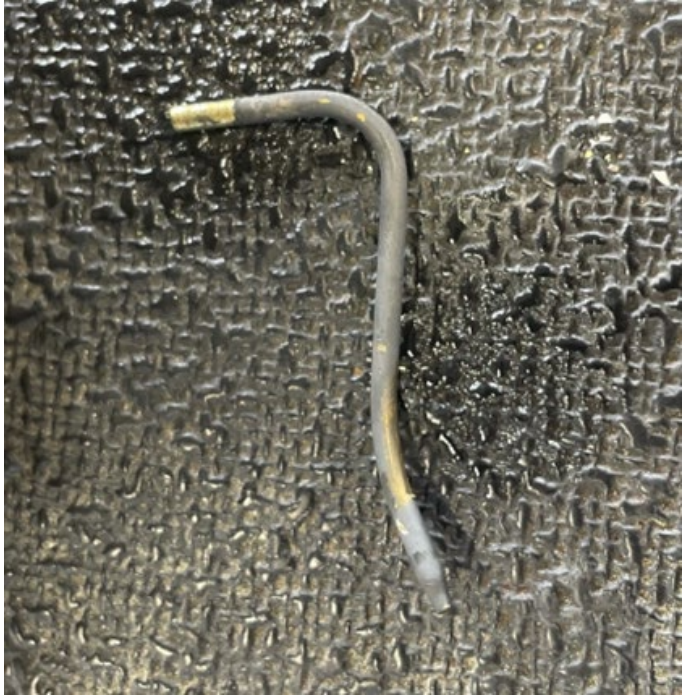
Picture 2 – Discharge tube

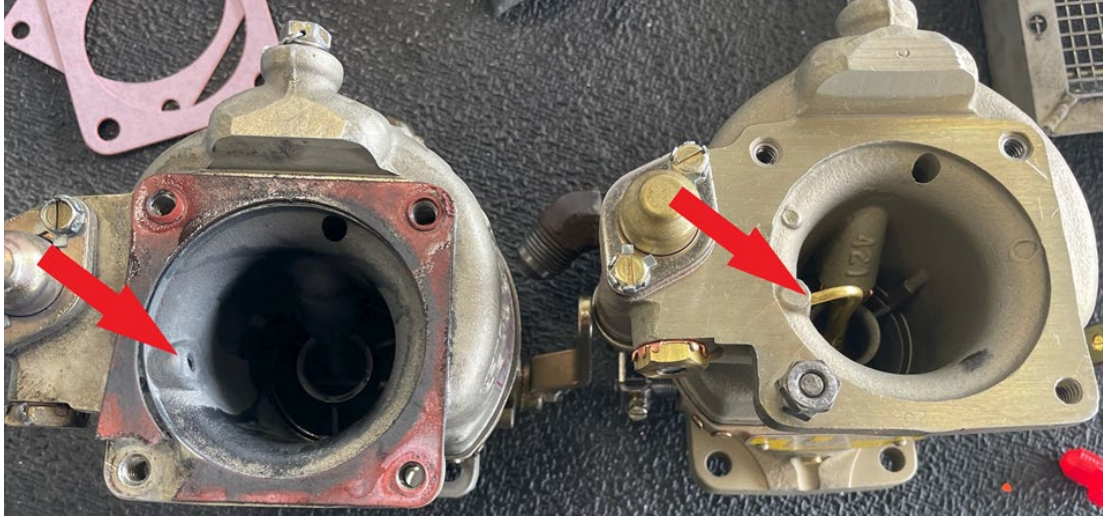
Picture 3 – Left-hand (L/H) unserviceable carburetor without discharge tube, right-hand (R/H) serviceable carburetor with discharge tube bonded in place

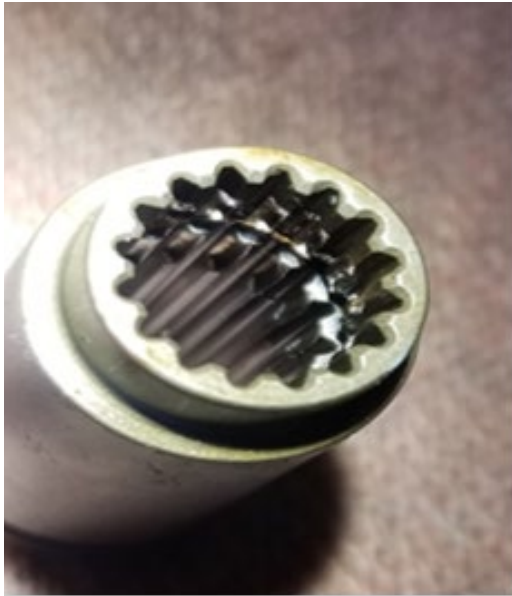
During the pre-flight checks after engine start, the pilots report the engine computer switch is to be set to manual mode, and a slight engine acceleration is noted. When the switch for the left engine was selected to the manual mode position, the engine had an uncontrolled acceleration. The pilots moved the engine computer switch back to auto mode and the engine returned to its normal operating condition, and the engine was then shut down. The Honeywell Maintenance Manual includes a caution for the fuel control unit (FCU) installation, stating that if the coupling between the FCU and fuel pump is not installed, the engine will overspeed rapidly in manual mode. The left engine FCU was removed to inspect the coupling between the FCU and the fuel pump, and the drive splines on the FCU. The inspection revealed that the output shaft from the fuel pump, the interconnect coupling and the FCU drive splines were stripped.

Photo 1 – Interconnect coupling

event, the manufacturer's Instructions for Continued Airworthiness (ICA) does bring attention to ensuring interconnect couplings are installed to prevent overspeed of the engine. However, maintainers are reminded to inspect the condition of the mating surfaces and to pay attention when installing components to ensure proper engagement.

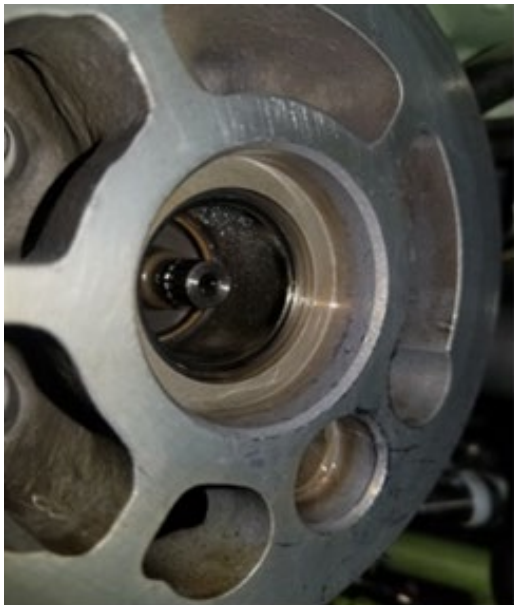
The root cause of these stripped splines has yet to be determined, but improper alignment during installation and material defects are possibilities. As stated in this

Photo 2 – Fuel pump drive spline

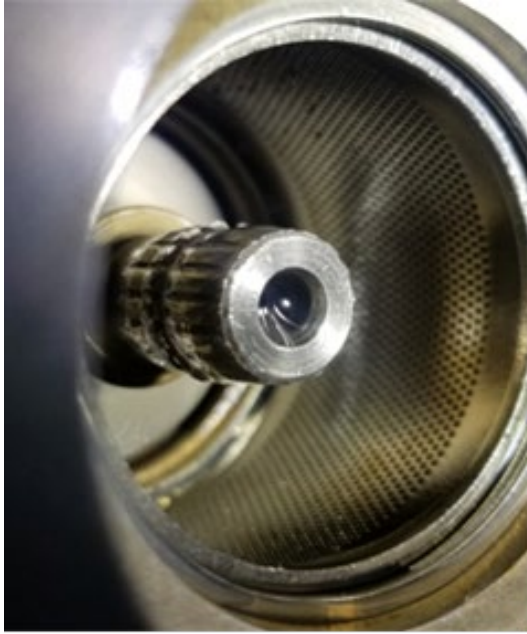
Photo 3 – Fuel pump drive spline close-up view

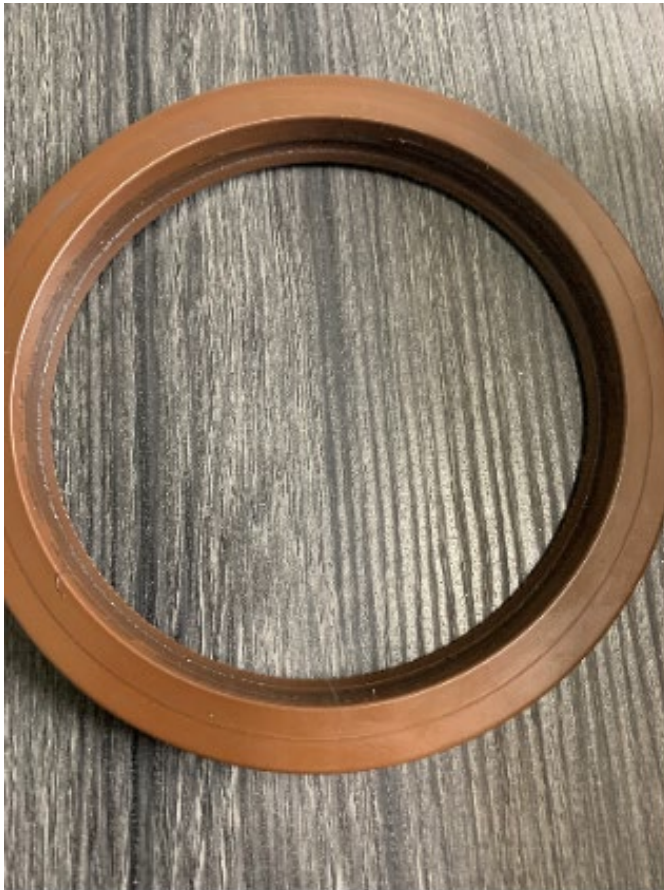
On July 11, 2020 the propeller shaft seal was replaced due to leaking, and an engine ground run and leak check were completed. On July 13, 2020 the aircraft took off from the airport and completed a turnback due to oil on the windscreen and the engine cowling. Maintenance replaced the faulty propeller shaft seal on July 15, 2020. During the replacement of the faulty shaft seal, a buildup of seal material on the mating surface of the seal was noted and grooves on the aft side of the seal mating surface had worn off.

Picture 1 – Propeller shaft seal

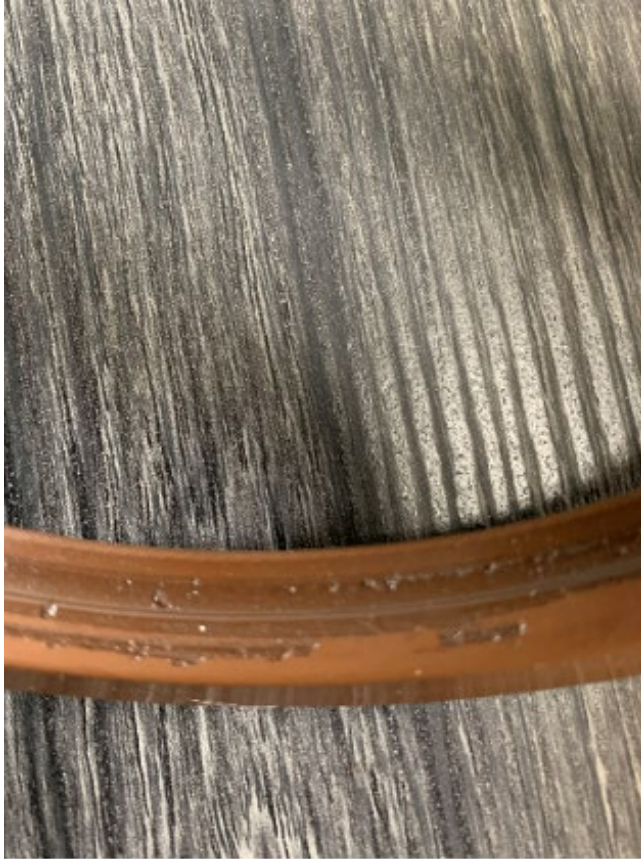
In this event, an oil leak was found, and a seal replacement was carried out by maintenance personnel. Unfortunately, the seal failed on the next flight even though ground runs had been performed after its replacement. Further inspection found a buildup of seal material on the mating surface, which probably resulted in the sealing grooves being worn off and another oil leak.

An investigation into the root cause could not rule out the possibility of both seals being defective. However, it was determined that improper maintenance practices likely contributed to the failure of the second seal. It was found that the replacement seal was

Picture 2 – Buildup of material on seal

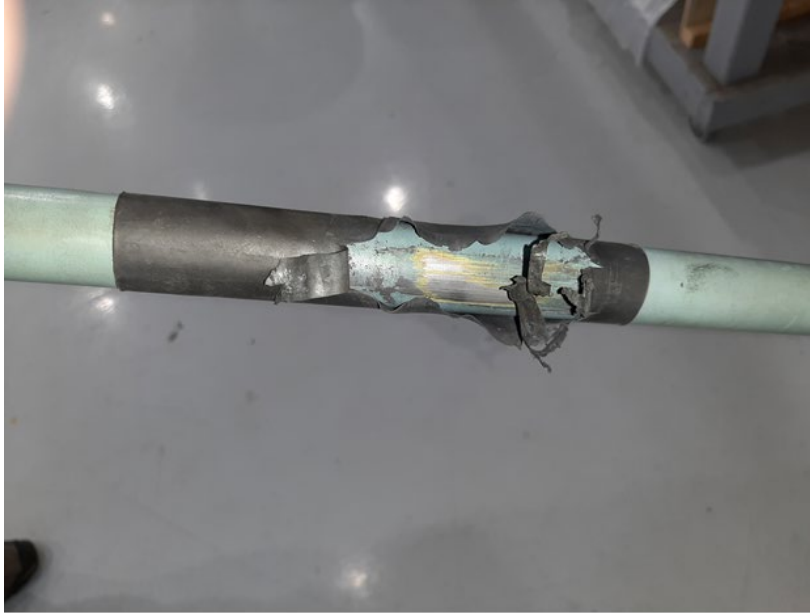
On a scheduled inspection, it was found that the protective sheathing was damaged and worn away to the point where the tail rotor control rod was damaged. The control rod guide had pressure on it as did some of the forward guides. It was found that the control rod was likely bent during a previous removal and installation. The maintenance manual describes the removal and installation, and if that process is followed, there is a risk of bending the control rod. To reduce this risk, the fin can be easily removed.

Damage found on the tail rotor control rod assembly after the rod was found bent during an inspection

The submitter of this Service Difficult Report has provided an excellent example of maintainers needing to remain vigilant during the performance of scheduled or unscheduled maintenance. As described by this submitter, the tail rotor control rod was only damaged because of the control rod being bent due to suspected improper maintenance during a previous installation or removal. Maintainers are reminded to always exercise good technical judgement and practices when performing any maintenance task to avoid inducing damage as described in this example.

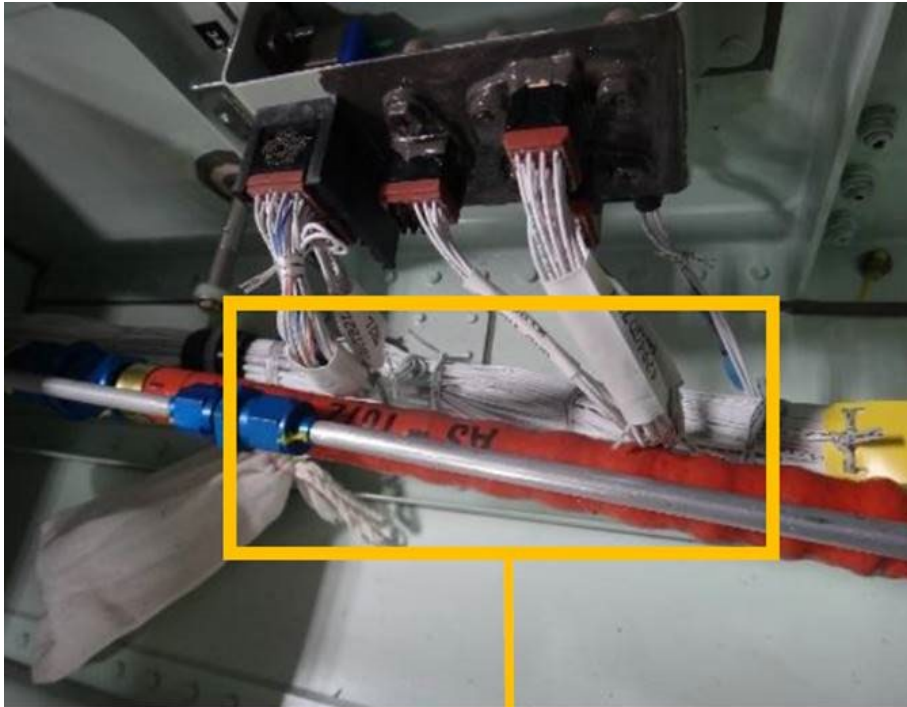
A potential fouling condition of an electrical harness was found at four locations between the air conditioner kit (505AC-101) and the cargo hook kit when installed. The aircraft was inspected but no visible chafing damages were present.

Bell investigated the possibility of some air conditioner system tubes chafing various locations of wire harnesses and cargo hook release cables on the model 505 helicopter. The investigation revealed that chafing could exist and if not corrected, could lead to damage of the wire harnesses and cargo hook release cables protective shielding. Following their investigation, Bell published alert service bulletin (ASB) 505-21-24 to provide instructions to inspect for damage due to chafing, and the installation of additional clamps when the air conditioning system kit is installed. Transport Canada

View of air conditioner tube and wire harnesses without the additional clamps

Civil Aviation recommends that owners and operators review ASB 505-21-24 and complete the Accomplishment Instructions of this ASB for the affected helicopters.
