Feedback

Canadian Aviation Service Difficulty Reports

The following content was published between July 1, 2021 and September 30, 2021. The full accessible version of each article is available on the Feedback [website](#).

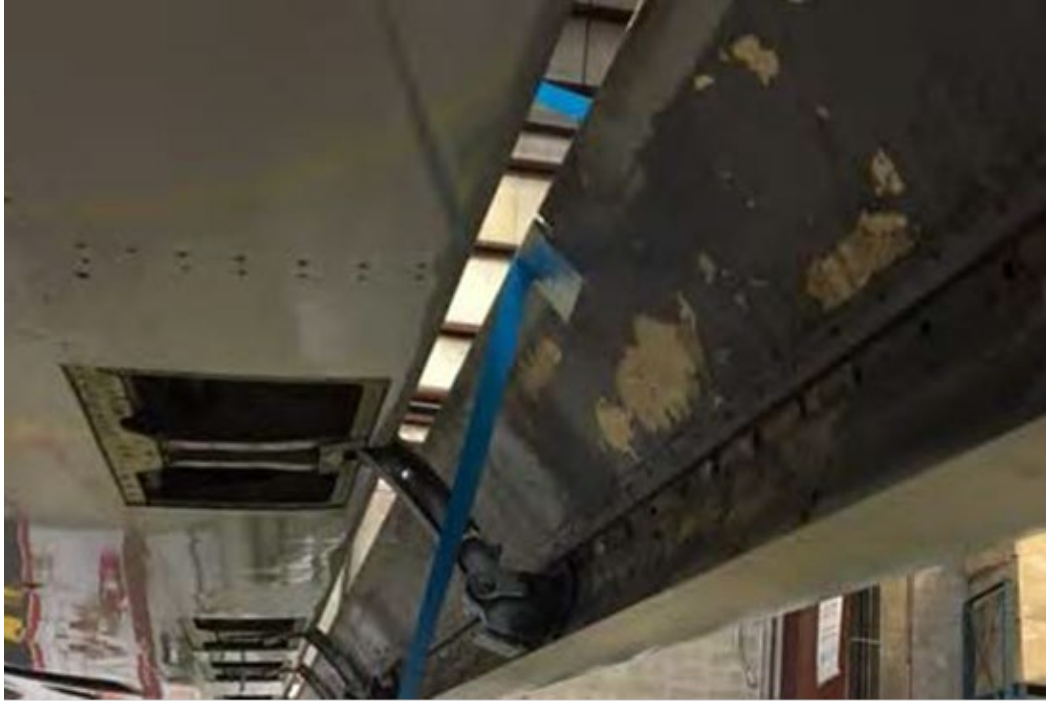
During unrelated scheduled maintenance, a deep gouge was observed in the upper portion of the left-hand #2 slat assembly. The damage was caused by a leading edge screw that had backed out and interfered with the trailing edge of the slat during retraction. A check of the maintenance records indicated that there have been several incidents resulting in similar damage to the slats on this aircraft type.

Figure 1: Slat showing location of damage in trailing edge

The screw that backed out and damaged the slat is located under the slat and is out of view when the slats are retracted. These screws thread into anchor nuts, so whenever they are removed and replaced, the condition of the anchor nut should be confirmed. Upon reinstallation, the proper torque should be applied to ensure these screws do not come loose.

More frequent and/or detailed inspections may be required to find these loose fasteners before they cause slat damage.

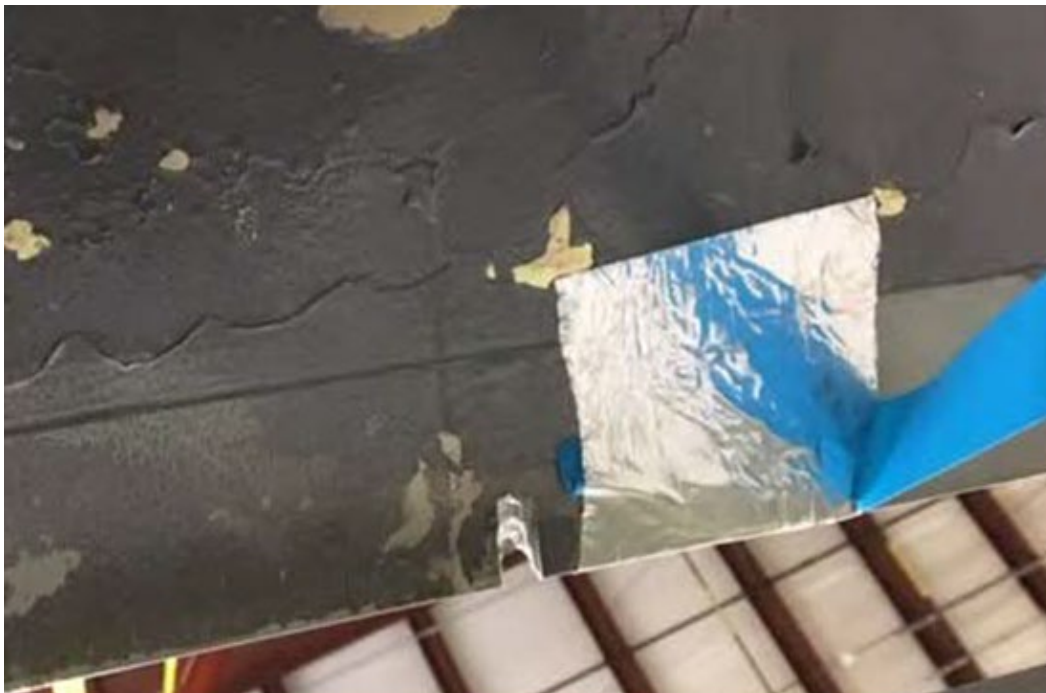
As seen by the damage to the screw head, the loose screw went through many slat up and down cycles before damaging the trailing edge. As the screw loosened, it would likely have marked the bottom of the slat before gouging the trailing edge.

Figure 2: Close-up of slat damage

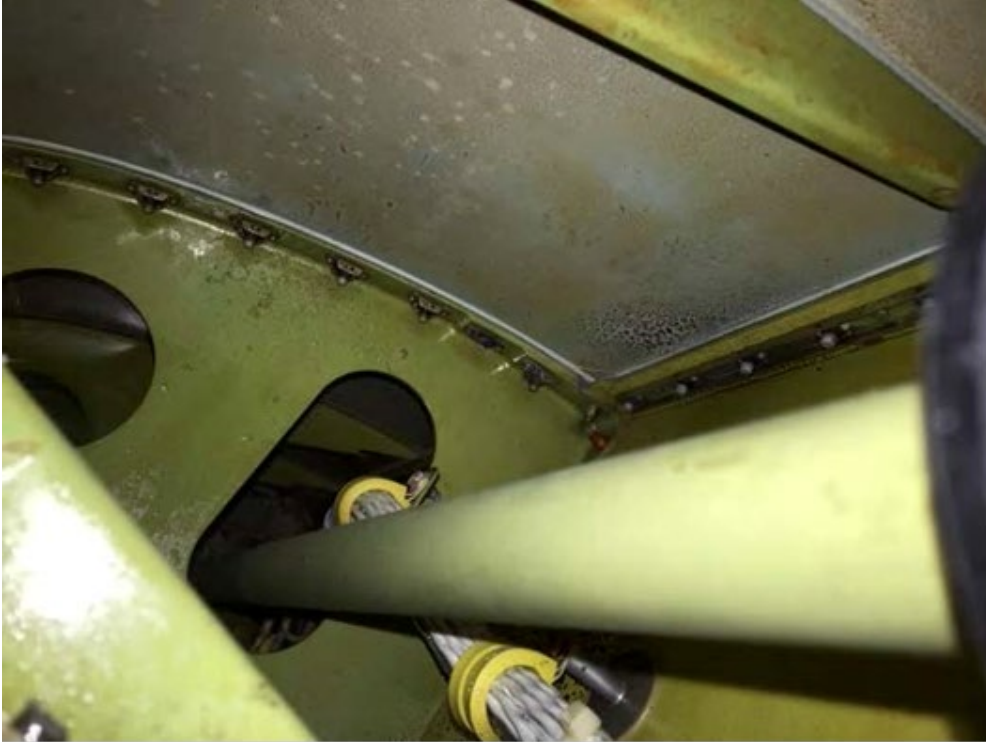
Figure 3: Underside showing anchor nuts

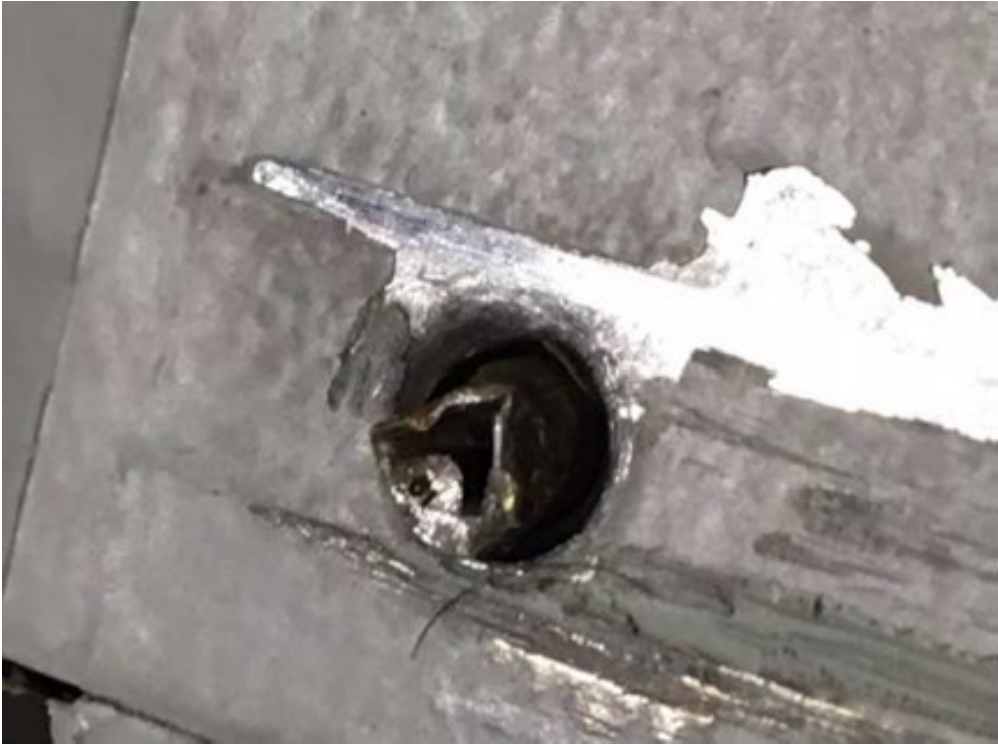
Figure 4: Damaged screw head missing

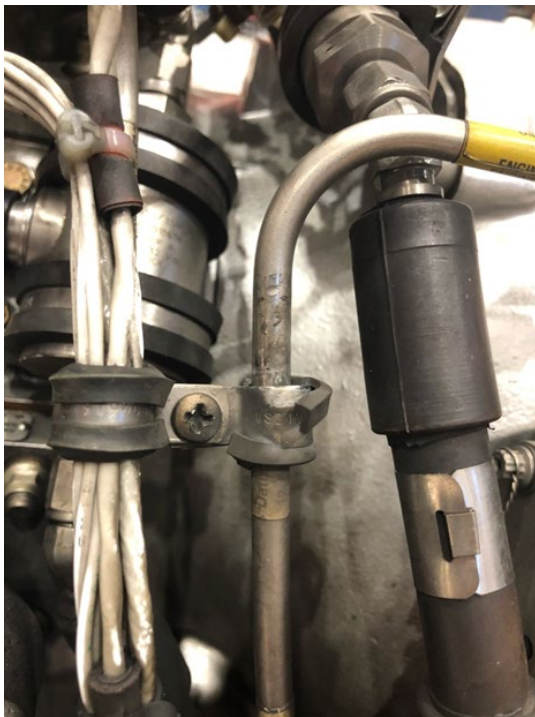
The issue was found during a function check of the stick pusher system. It was noticed that the torque transducer pipe assembly (oil line) Pilatus Illustrated Parts Catalogue (IPC) 12-B-77-10-00-010-941A-A item 15 pre-Service Bulletin SB-77-005 attaching upper Adel clamp rubber, appeared in poor condition but was still attached. It was pulled at the rubber portion slightly, and the rubber had worn through from the metal of the clamp and showed signs of chafing in the line. The clamp was removed to inspect further, and it was found chafed beyond limits. The oil line and both adjoining Adel clamps were replaced. The leak checks were completed. Note. If the line had failed, there would have been a potential for loss of propeller control.

Picture 1 – Damaged clamp attached to tube on the engine

This Service Difficulty Report (SDR) is an excellent example of reinforcing the importance of being vigilant while performing maintenance tasks and inspections. This maintainer was able to identify the deteriorated clamp and replace it along with the oil tube before a failure occurred.

Remember that clamps and similar hardware are on-condition. It may only take a few minutes to prevent a failure.

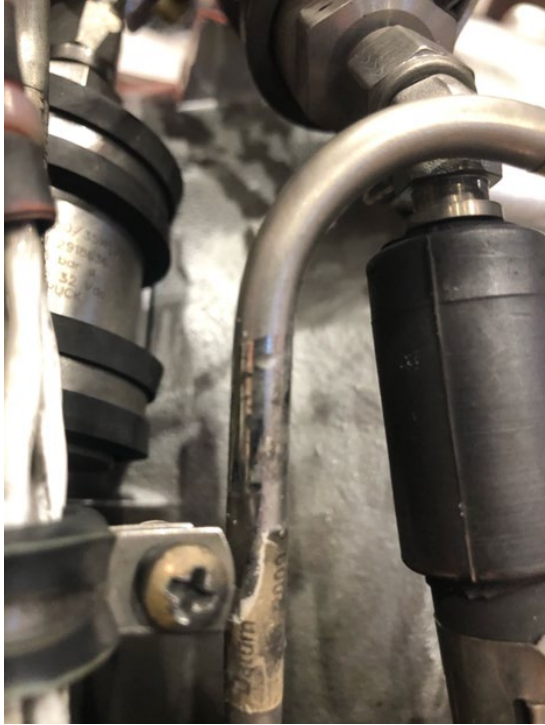
Picture 2 – Clear damage caused to oil tube by clamp

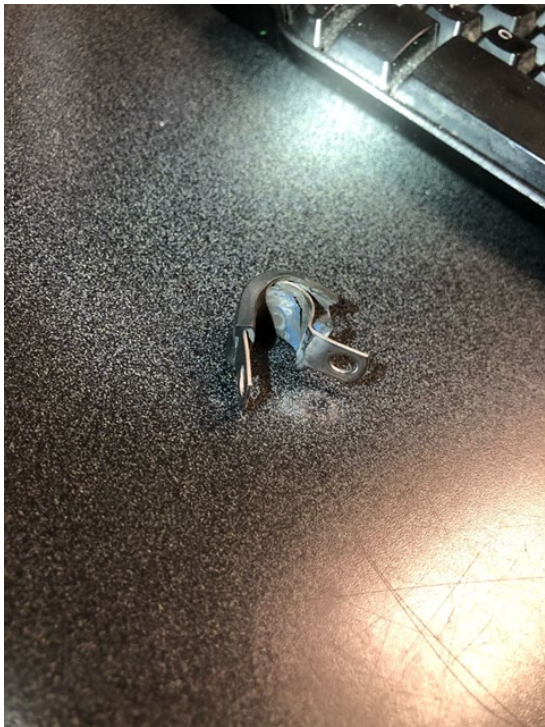
Picture 3 – Deteriorated clamp

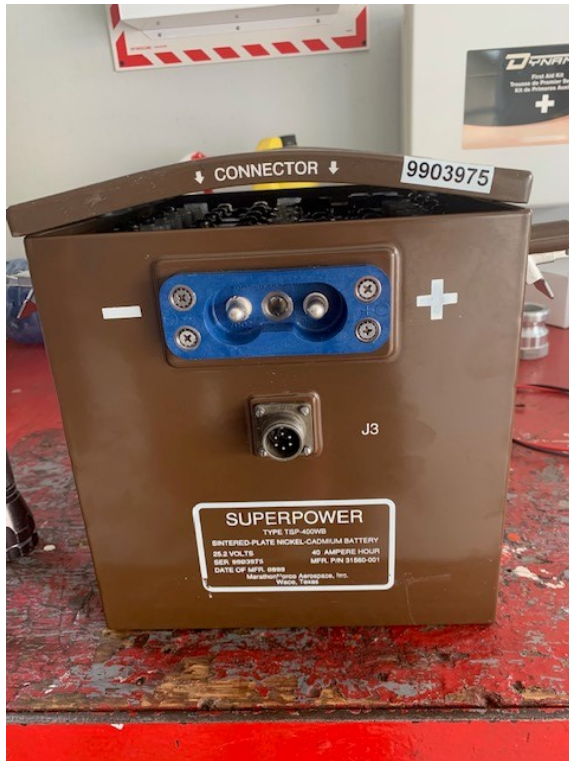
The Aircraft Maintenance Engineer (AME) attempted to troubleshoot the aircraft system, but upon selection of the #2 battery to the ON position, no power was observed on the aircraft. Subsequent troubleshooting of the #2 battery system revealed that the #2 battery case was distorted and the battery lid was bent. The battery was removed from the aircraft for further inspection.

There does not seem to be any evidence of the battery overheating, and the battery was cool when the defect was found. The battery voltage still read 24-25 volts. Removal of the battery lid revealed that the thermal switch was defective with an internal short or other failure. We can also see that one of the cells within the battery was cracked.

We have completed the initial inspection of the aircraft, and have found the pressure portion of the battery vent system plugged (insect). We have been in contact with the aircraft manufacturer (Viking) and have been trying to contact the battery manufacturer to address the cause of the distorted case. All other aircraft in the fleet have been inspected for battery case distortion, and no thermal switches with defects were found. The battery vent systems of the fleet have also been inspected and cleared of any obstructions.

Defective battery

This particular defect was found on the ground but could have been worse if it had been found during flight. Transport Canada Civil Aviation (TCCA) would like to remind operators, maintainers and ground service personnel of the importance of being vigilant for possible ingress of dirt, insects etc. in aircraft systems vent openings. The latter would include, without limitation, pitot-static openings, fuel system vents and, as in this case, battery venting openings. Obstructions of venting provisions on an aircraft can lead to more serious problems.

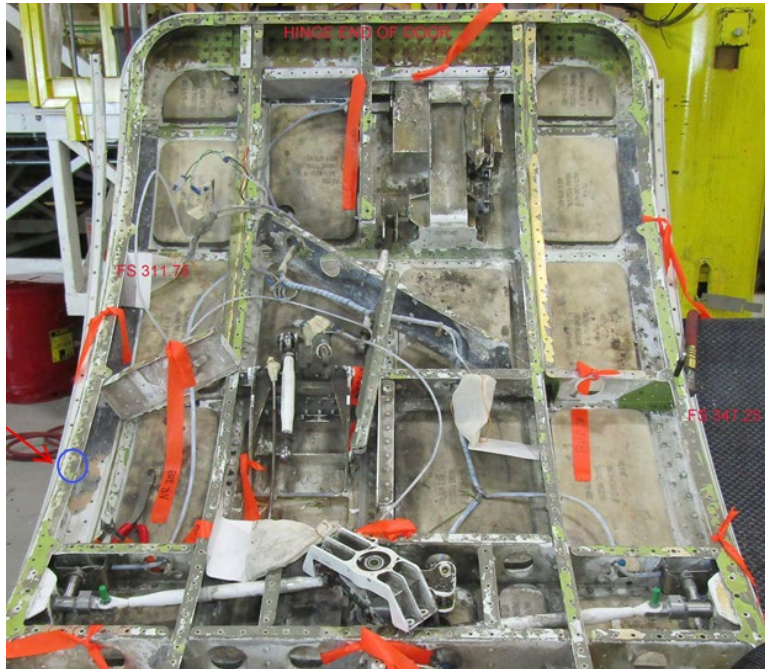
During scheduled maintenance, level 2 corrosion damage beyond allowable limits was observed on the forward former of the passenger door assembly at fuselage station (FS) 317. The damaged area was cut out and replaced with a new section of former, and the repair work was accomplished in accordance with approved repair engineering order (REO) 690-52-11-582.

Figure 1: Forward frame location with damaged area circled in blue

Transport Canada is not aware of the actual inspection interval frequency for this task for this operator. The service difficulty report did not indicate that a localized corrosive spill caused the corrosion, so this finding of level 2 corrosion suggests a more frequent inspection interval is likely needed and should be applied to this area.

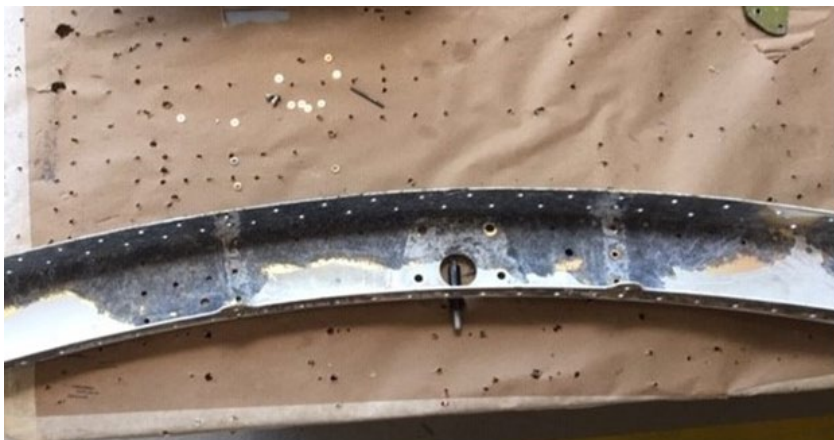
Figure 2: Frame showing corroded area

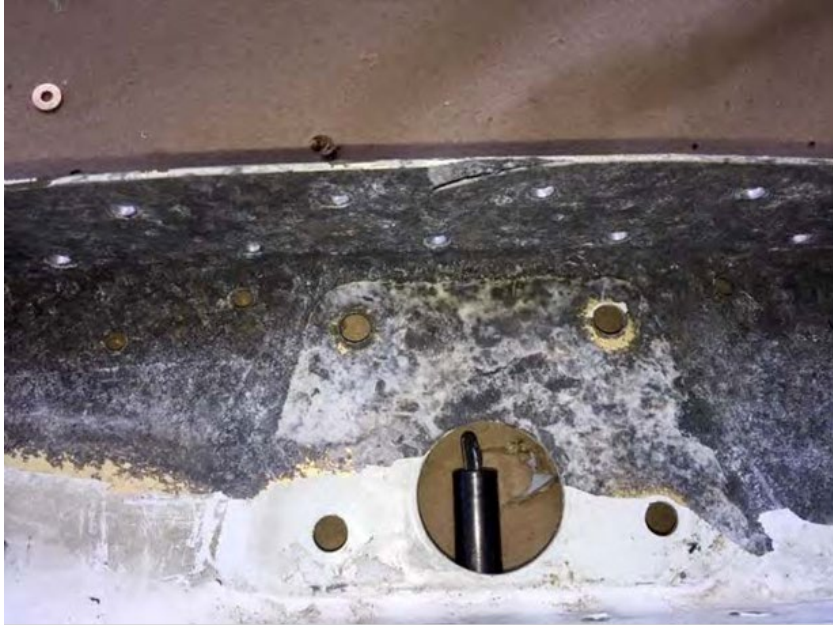
Figure 3: Close-up of corrosion

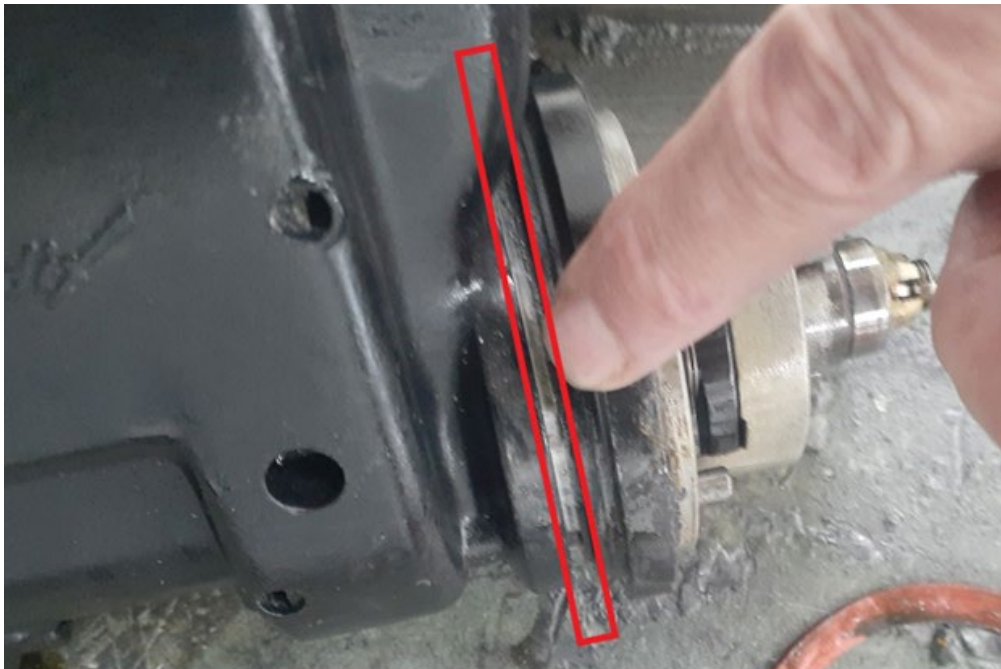
After flight, oil was observed to be leaking from the left engine. The Aircraft Maintenance Engineer who inspected the engine found the magneto to still be firmly fastened to the engine, but its case had split at a swaged joint, allowing oil to leak from the resultant gap.

It was confirmed that all 3 internal wrenching screws part number (P/N) 10-349652, which secure the flange to the body of the magneto, were found loose. S-1200 series magnetos, which include 4, 6 and 8 cylinder models all use this method of attaching the flange to the body of the magneto.

Flange to body – Split line gap highlighted

Multiple notes and warnings are included in the published service manual, stating to remove and discard the flange securing screws and washers, regardless of whether disassembly is for the purpose of inspection, parts replacement, or overhaul. Additionally, adherence to published fastener torque specifications is highlighted.

A daily pre-flight check may not specifically include checking for security of attachment of the magneto, although including such an item may be beneficial.

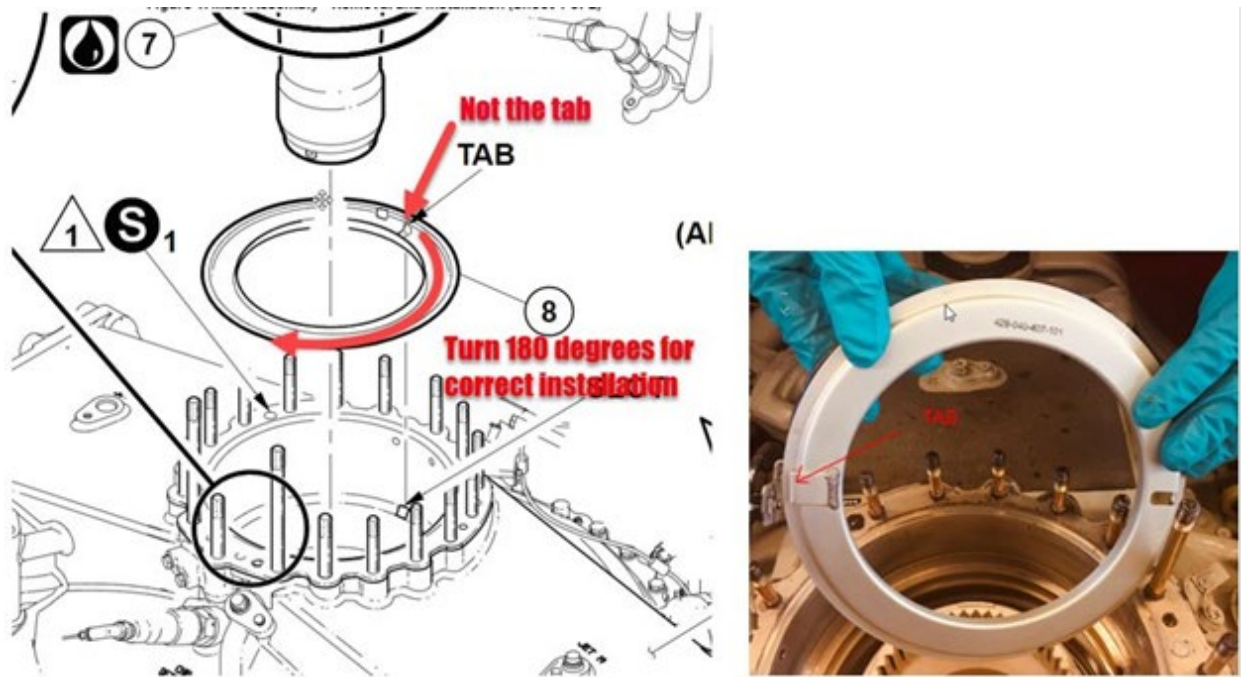
An operator found one debris pan incorrectly installed, which could prevent the mast chip detector from detecting metal contamination from the mast bearing. After Bell investigated, it was found that the maintenance procedure was clear and accurate, however the figure in support of the procedure could be misleading. Consequently, the maintenance manual figure will be updated to avoid repeating such an issue.

The debris pan has a tab and a cutout, an incorrect installation of the debris pan is when the tab of the pan is not properly aligned with the slot in the main rotor transmission. Following their investigation, Bell published Alert Service Bulletin (ASB) 429-21-54 to provide instructions for completing a one-time inspection, and a figure showing the correct installation of the oil debris pan. The ASB states that incorrect installation could result in the lubricating oil not being supplied to the mast chip detector and to the mast spline from the #13 oil jet. In addition to the ASB, Bell will be revising the potentially misleading figure currently published in the model 429 maintenance manual. Transport Canada, Civil Aviation (TCCA) encourages owners, operators and maintainers to review and accomplish ASB 429-21-54 to verify the correct installation of the debris pan.

An example of the current potentially misleading figure in the maintenance manual and the debris pan.
