CAA OCCURRENCE 19/6687
TECNAM P2002 SIERRA RG
ZK-SGO
COLLISION WITH TERRAIN
TARARUA RANGE, 8NM WEST OF EKETAHUNA
29 SEPTEMBER 2019

Foreword

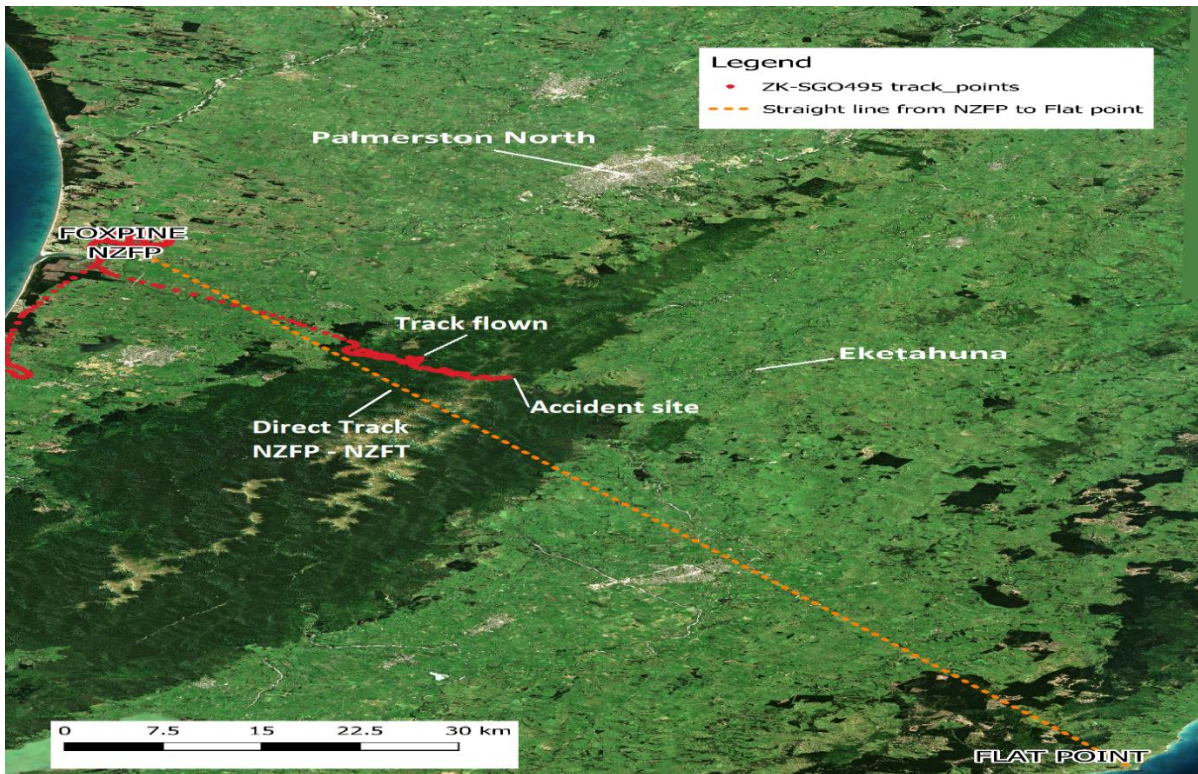
- 1.1.6 The aircraft later climbed to approximately 3100 feet near Levin while en route to NZFP, where it completed four circuits.
- 1.1.7 After departing NZFP the flight deviated from the known plan and tracked towards Flat Point aerodrome (NZFT). The direct track NZFP to NZFT was found loaded into the aircraft's GPS unit (refer Figure 1).

Figure 1. Direct track NZFP to NZFT as loaded in aircraft's GPS unit. Track flown in red. Garmin495™.

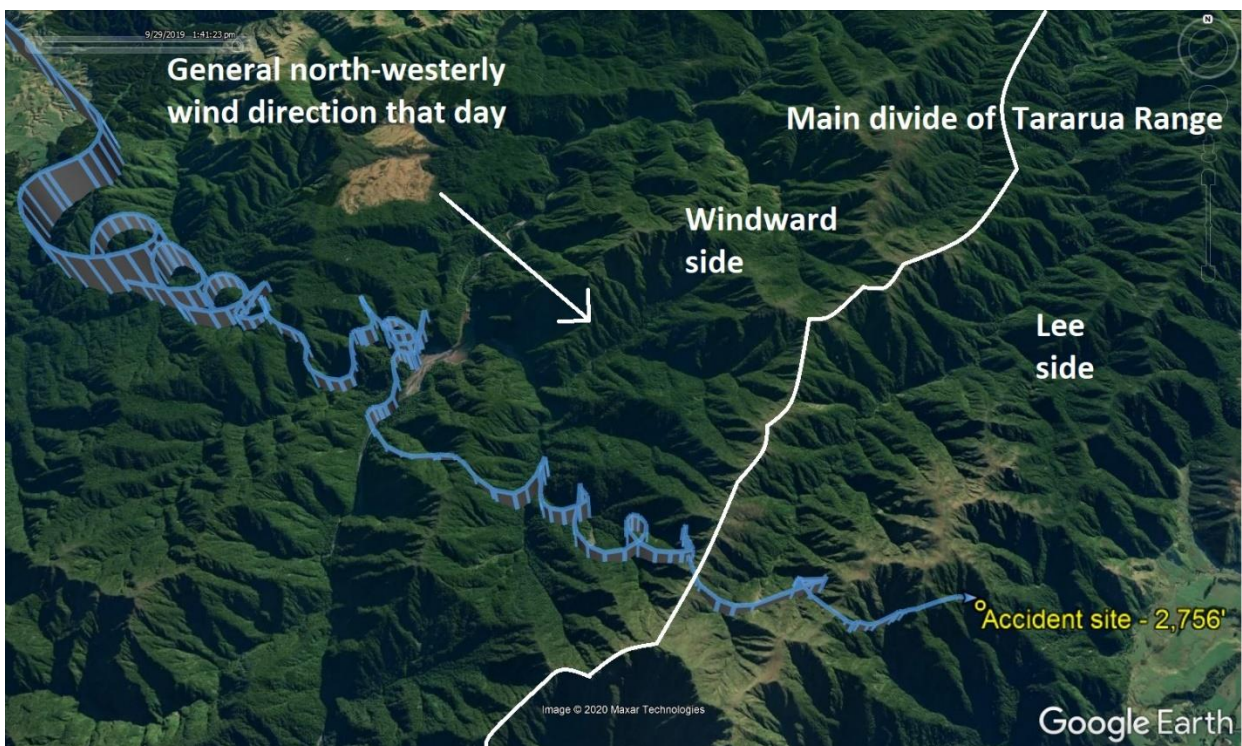
1.1.9 The aircraft collided with terrain approximately 90 seconds after crossing the main divide of the Tararua Range (refer Figure 2).

Figure 2. Track flown and accident site location, overlaid in Google Earth™.

- 2.11 The flight operated in the Tararua Range for approximately 12 minutes and carried out 13 turn manoeuvres as it continued eastwards (refer Figure 2). This suggests that flying conditions were suitable enough for the pilots because they did not turn back. There was plenty of opportunity to do so if conditions were not suitable.

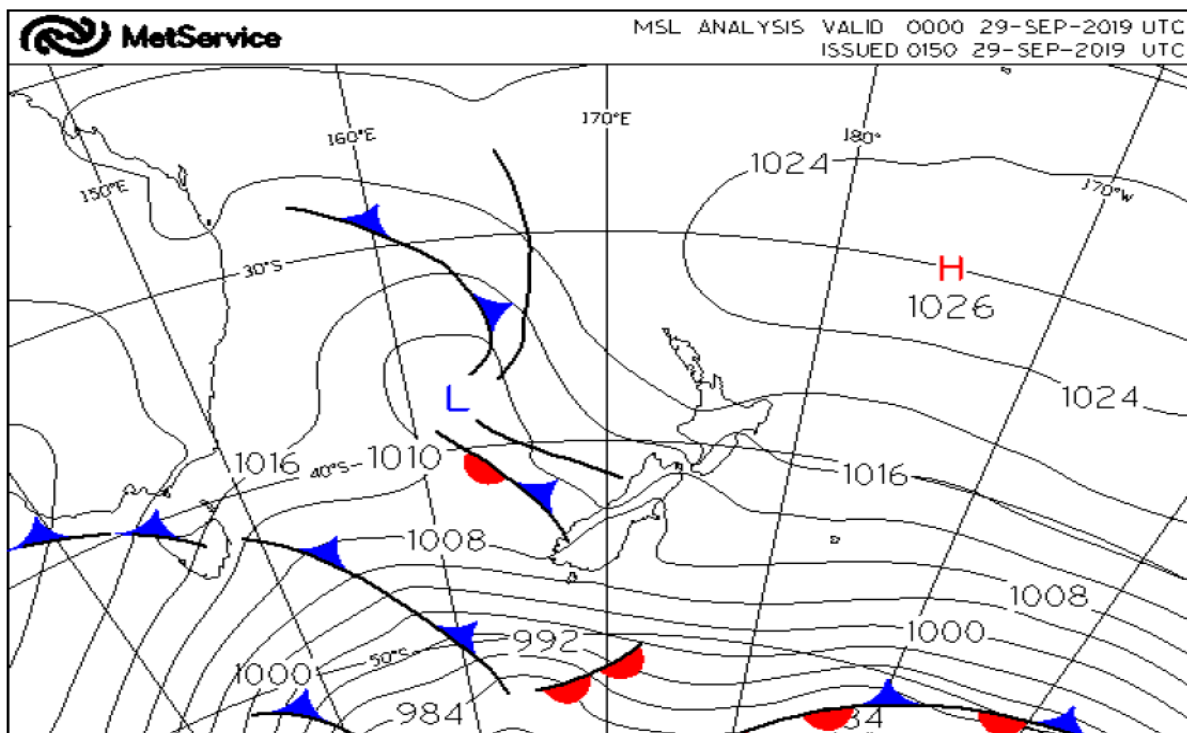
1.7.1 The New Zealand Meteorological Service (MetService) mean sea level analysis chart showed that a ridge of high pressure lay north of the country, while a trough lay over the mid Tasman Sea.

1.7.2 These two systems contributed to the development of a strong north-west airflow over central New Zealand (refer Figure 3).

Figure 3. Mean sea level analysis at 0000 UTC 29 Sep 2019 - Diagram from MetService.

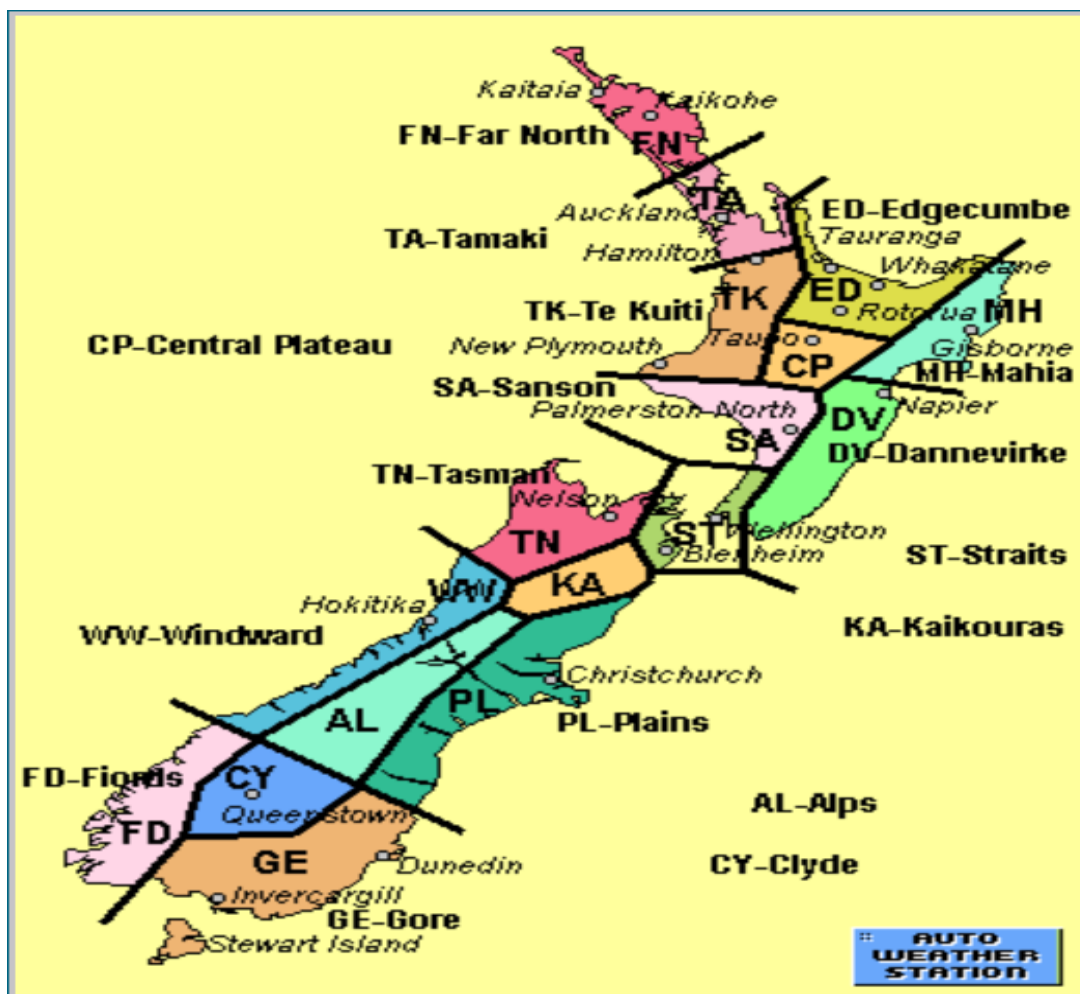
1.7.3 Both pilots logged on to the MetService General Aviation Weather Briefing service the morning of the flight but only requested the Straits Area Forecast (ST ARFOR) weather briefing (refer Figure 4).

Figure 4. New Zealand ARFOR areas. Only the ST ARFOR was requested (MetService[©]).

- 2.5 The Sanson (SA) and Dannevirke (DV) ARFORs were not obtained by the instructor. These also contained important information regarding high wind speeds from 25 to 30 knots between 1000 and 3000 feet in their respective areas.

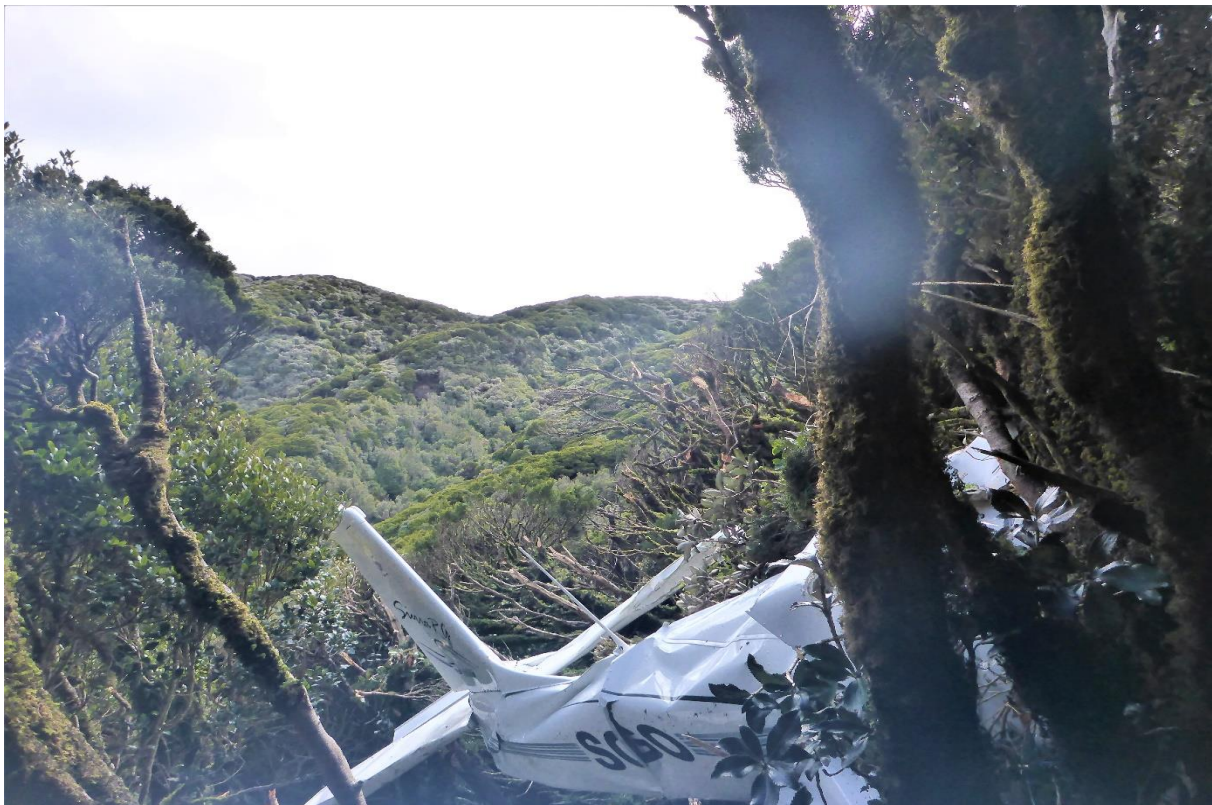
1.12.1 The aircraft cut a swathe through a tree-covered ridge and collided with the terrain at an altitude of approximately 2756 feet, on a heading of approximately 140° True. The general direction of the ridge was approximately 165° True.

1.12.2 Observations and bearings taken with reference to the damaged trees indicate the aircraft was banked approximately 35° to the right while in a 10° nose down attitude (refer Figure 5).

Figure 5. Accident site indicating aircraft entry angles and track cut through the bush canopy (CAA photo).

1.12.3 Aircraft wreckage and impact signatures were consistent with a high-speed collision with terrain.

1.12.4 Post-accident inspections established flight control integrity and found no evidence of any pre-existing defects or indications of an engine failure.

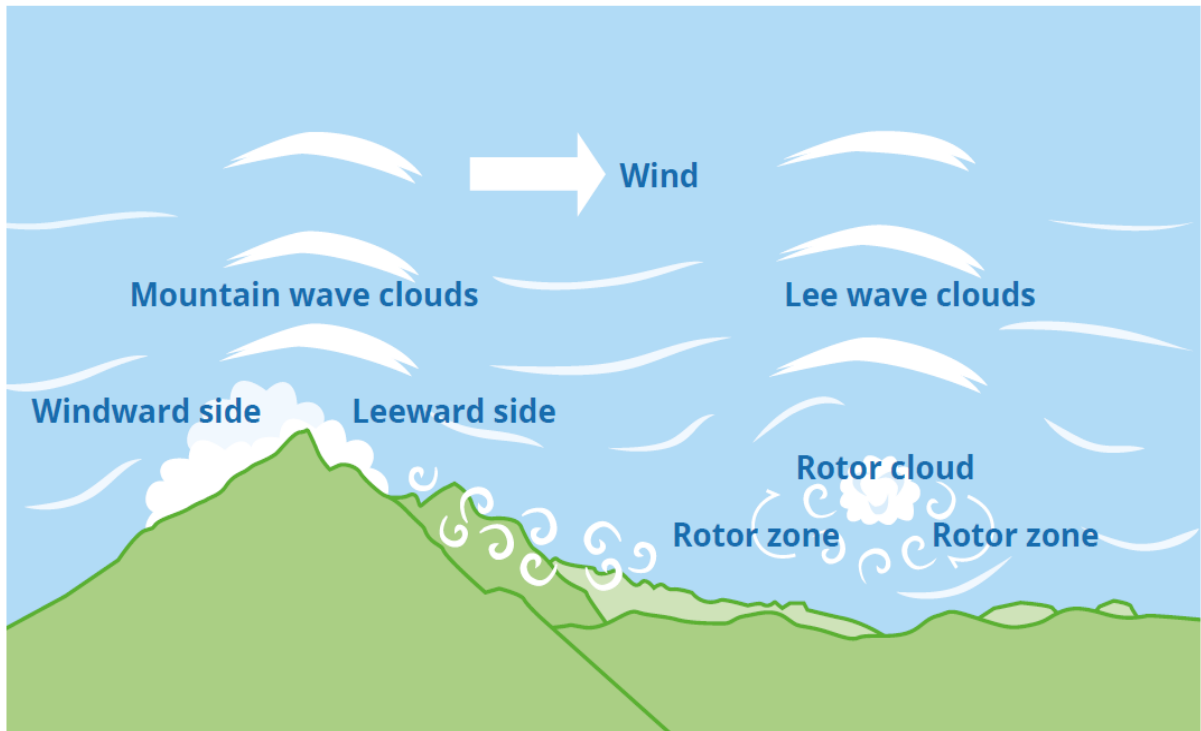
- 2.6 The diagram below illustrates the basic interaction of wind flow over a mountain range and includes some of the phenomena that can be associated with it. This diagram is copied from the GAP booklet *Mountain Flying* (refer Figure 6).

- 2.7 MetService analysis of the weather that day including a weather balloon sounding flight launched from NZPP that morning, identified a stable layer of air at approximately 7000 feet. Their analysis said the stable layer of air acted like a ceiling that effectively squeezed the wind between the ceiling and the terrain which in turn produced a strong accelerating wind, possibly in excess of 50 knots, to flow down the lee side of the Tararua Range.

Figure 6. Diagram illustrating the wind flow over a mountain range (CAA GAP Mountain Flying)

- 4.5 While there was no evidence to suggest the flight in the Tararua Range was a ‘pseudo’ mountain flying training flight, the CAA would recommend that microlight pilots obtain and read all the GAP booklets that relate to mountain flying. These publications collectively describe many of the potential hazards of flying in and around mountainous terrain. These can be obtained from a local flying club or aero club, downloaded directly from CAA at www.aviation.co.nz or requested as hardcopies by emailing publications@caa.govt.nz.

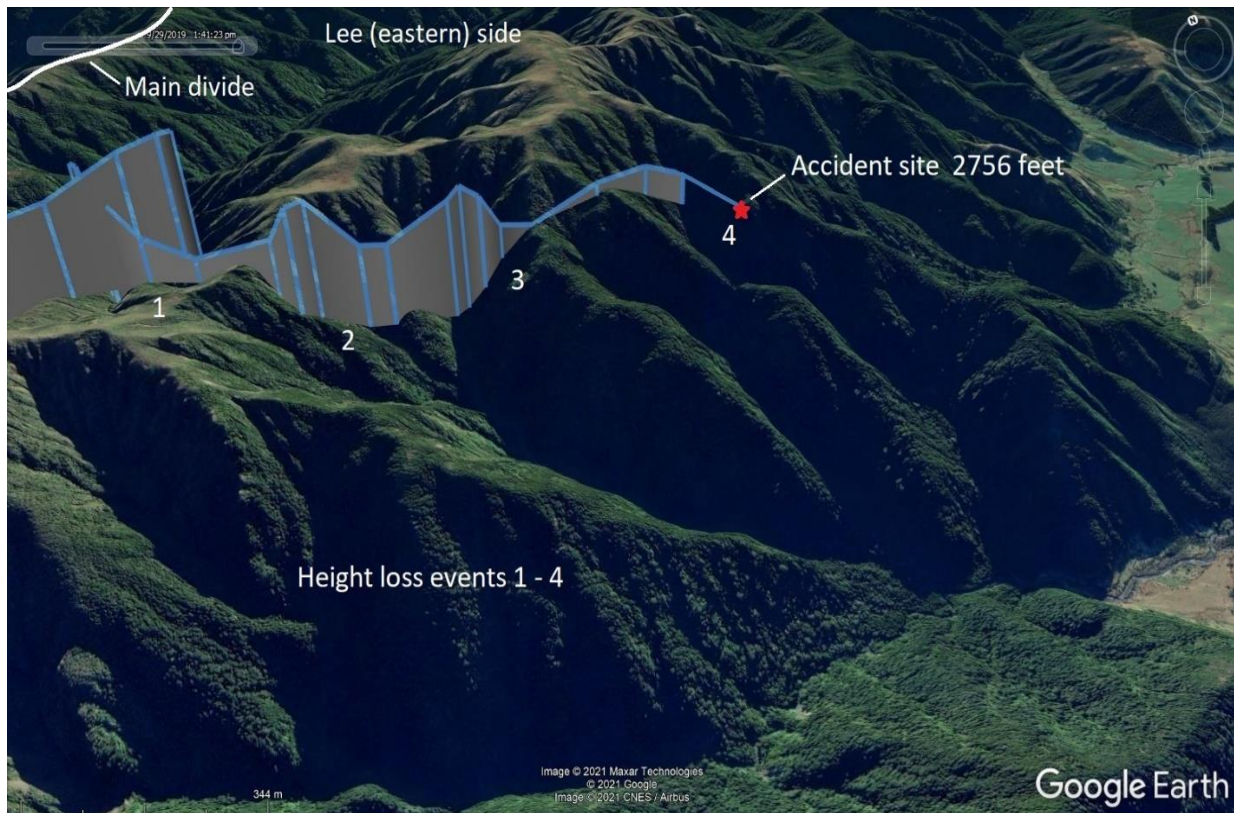
2.12 After the aircraft crossed the main divide to the lee (eastern) side, it experienced four rapid height loss events in approximately 90 seconds (refer Figure 7).

Figure 7. Last 90 seconds on lee side showing four rapid height loss events 1 - 4. Google Earth™

2.13 The estimated rates of descent for each height loss event (rounded down to nearest 100 feet) were calculated as follows.

- Height loss event 1: 5000 feet per minute
- Height loss event 2: 5600 feet per minute
- Height loss event 3: 3000 feet per minute
- Height loss event 4: 2300 feet per minute

The aircraft's published rate of climb is 1200 feet per minute.

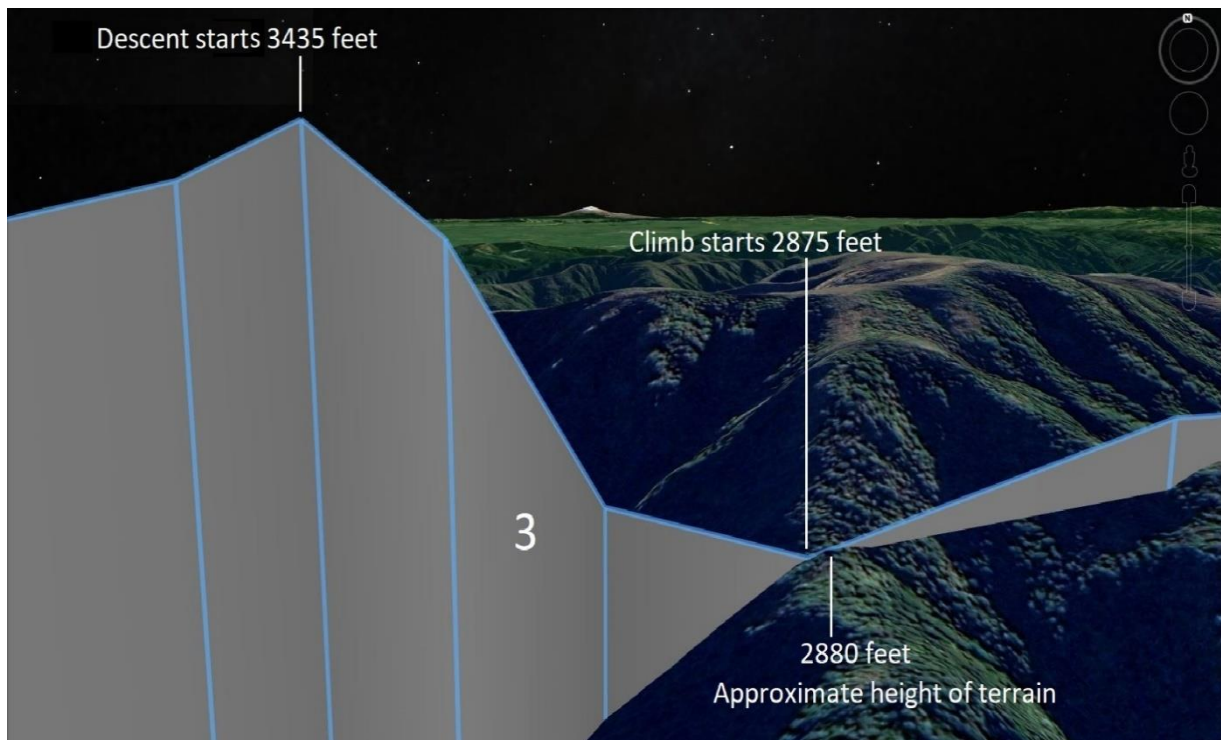
2.14 On the third event the aircraft appears to have narrowly avoided colliding with terrain during recovery from that height loss event (refer Figure 8).

Figure 8. Height loss event three showing approximate recovery altitude and terrain height. Google Earth™
