Safety Investigation Report

Fatal Paraglider Accident Mount Cheeseman, Canterbury, 14 January 2020

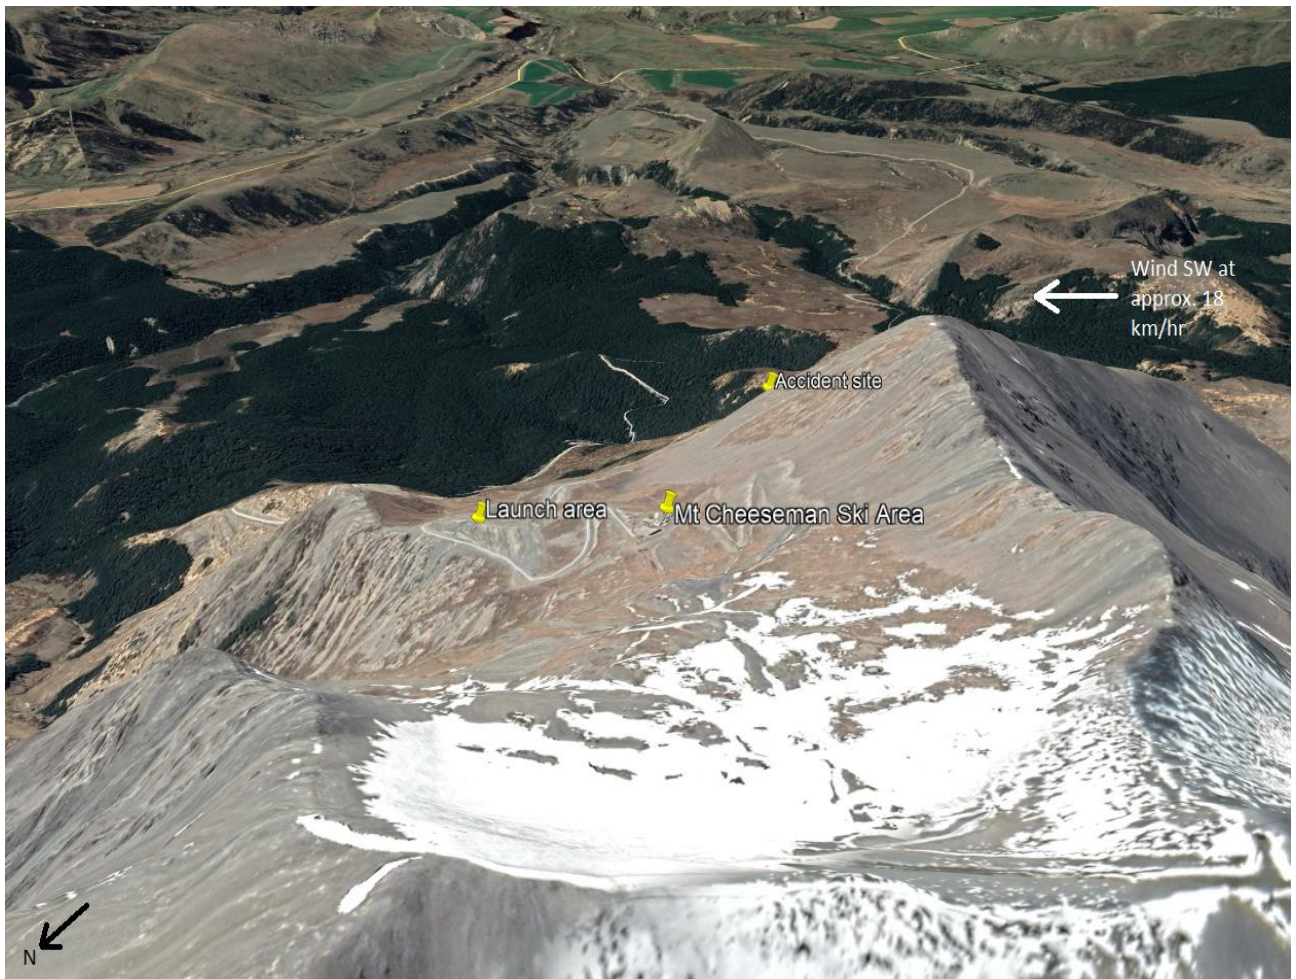
Attempts to contact the pilot by radio were not successful. Shortly after, witnesses found the pilot at the accident site (refer to Figure 2). The pilot was conscious for a time but subsequently died from impact injuries.

Figure 2: Accident location. Adapted Google™ Earth image.

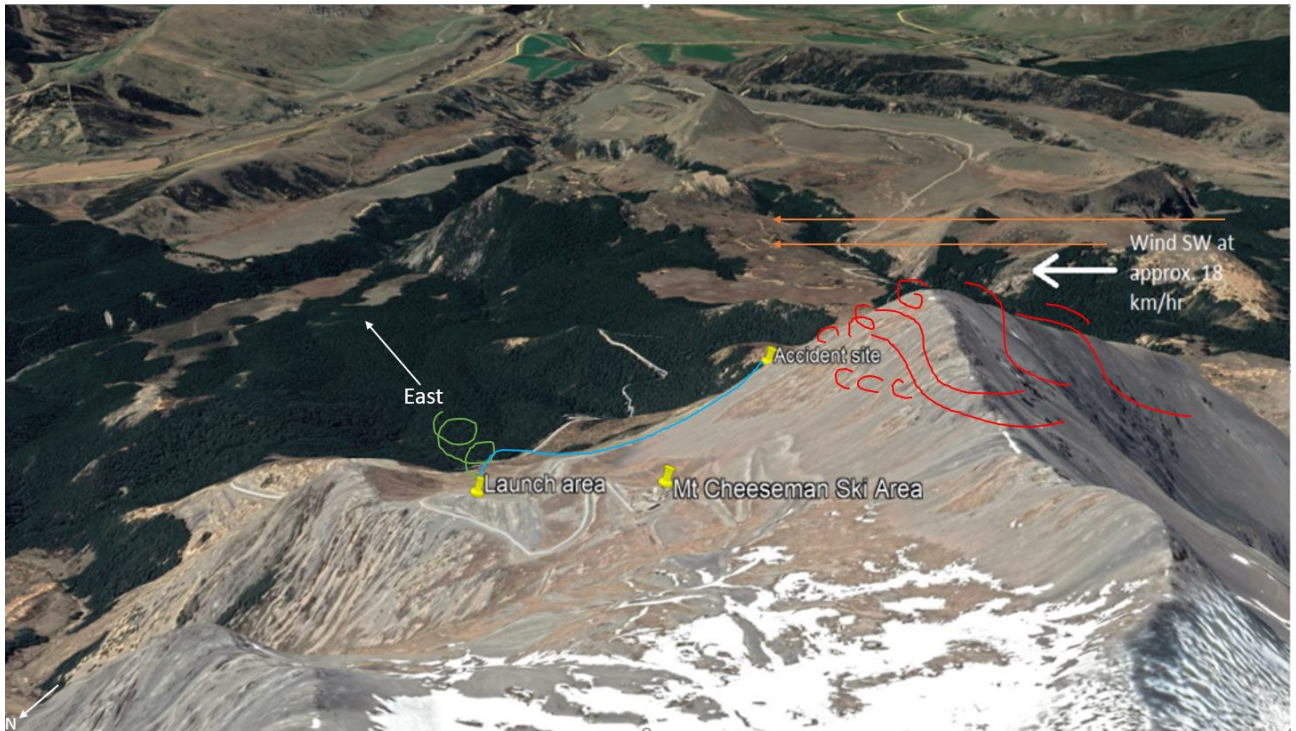
The accident occurred in south-west wind conditions. The location of the launch site in these conditions meant the flight path of the accident flight was also on the lee side of the slope. Any light thermal rising from the valley floor from the east would quickly be dominated by a stronger prevailing south-west wind. As the pilot tracked around the ridgeline on the lee side of the slope, she would have encountered a lot of turbulence (refer to Figure 3).

This lee side turbulence is the most probable cause of the initial frontal collapse and the subsequent asymmetric collapse.

Figure 3: Depiction of flight path and likely areas of turbulence (diagram for illustration purposes). Adapted Google™ Earth image.

During the investigation process, the NZHGPA advised they had updated the Canterbury Sites Guide with additional information to alert pilots to the challenging conditions that can be experienced at Cheeseman Skifield. This includes a warning not to fly at the site in strong south-west, west, or north-west conditions, and additional comment that the dangers of mountain flying apply at this site. Refer to Appendix 1 for full changes included in the Canterbury Sites Guide.
