AIRCRAFT ACCIDENT REPORT
CAA OCCURRENCE NUMBER 12/2242
HUGHES 369D
ZK-HXZ
CONTROLLED FLIGHT INTO LAKE
LAKE SUMNER
21 MAY 2012

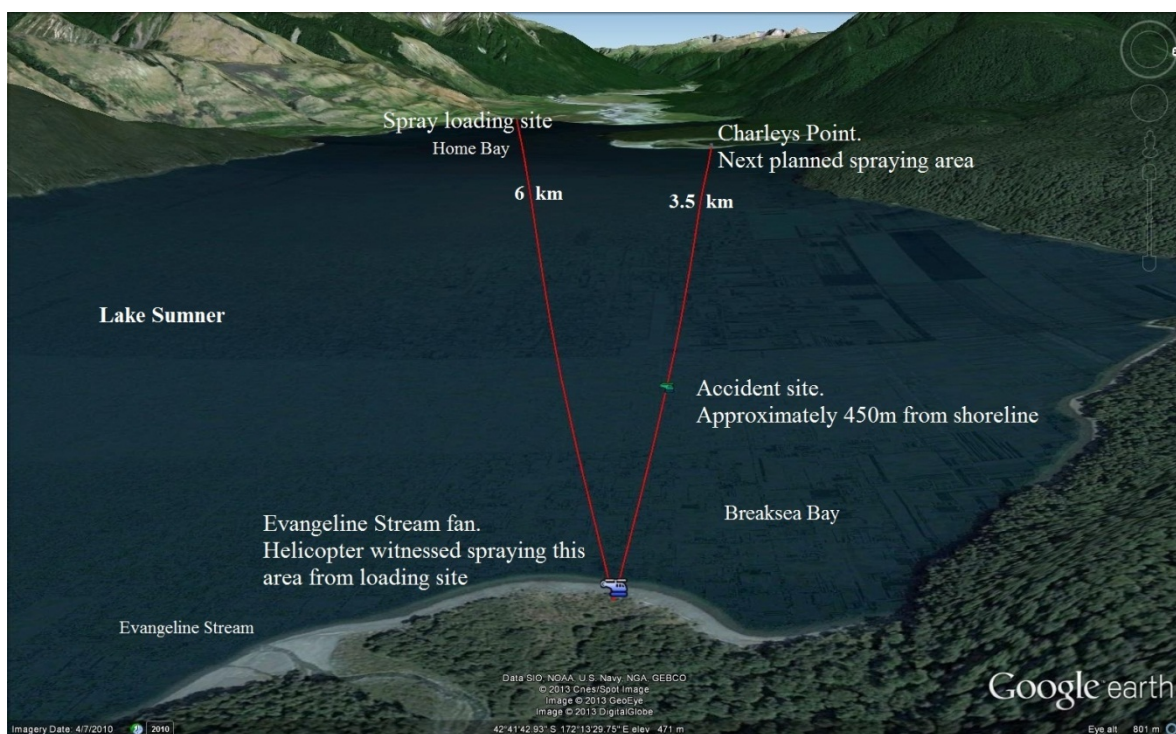
Figure 2.

- 1.1.5 When the DOC Ranger next heard the helicopter he observed it carrying out a spray run in the vicinity of the Evangeline Stream fan, 6 km away across the lake. He also saw that it was operating at low level and at a later stage appeared to be either hovering or flying towards him, before he looked away (refer Figure 2). The ground support crewman was busy preparing the next load of spray chemicals

Last spray area. View toward Charleys Point and loading area.

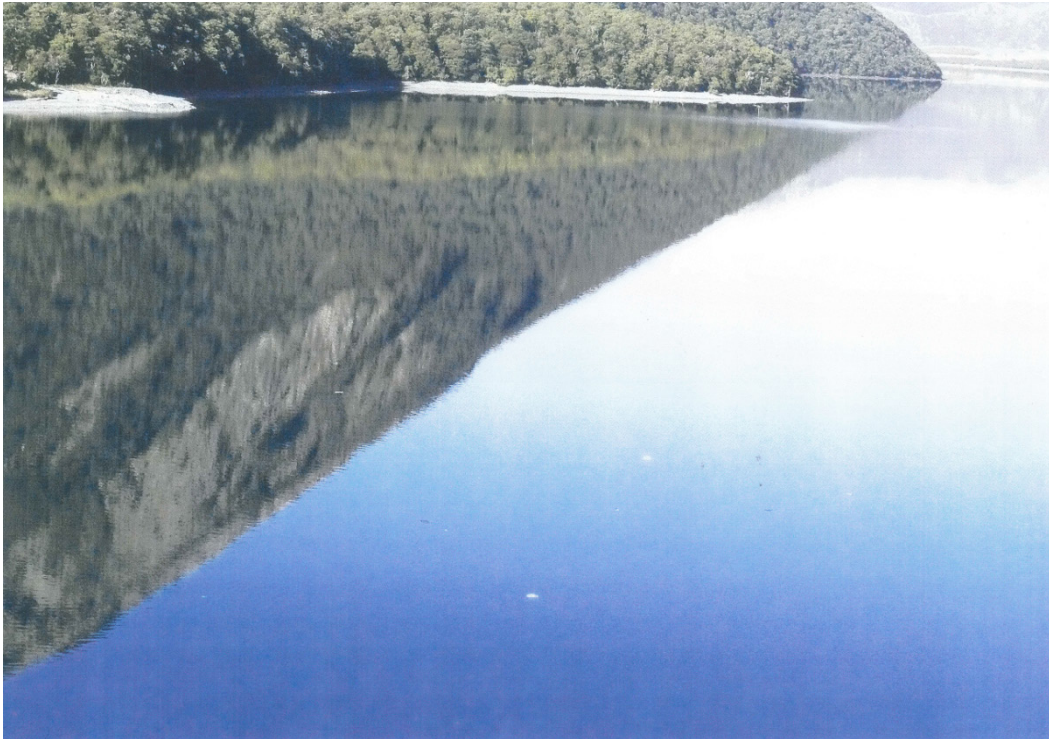
Figure 3.

- 1.6.1 Conditions at the time of the accident were described by the DOC Ranger and the helicopter ground support crewman as being very calm with clear skies. The DOC Ranger added that the lake surface was approximately 90% flat and calm with slight ripples in places (refer Figure 3).

Photo taken by search helicopter approximately two hours after accident.
White spots are helicopter debris floating on the surface.

- 2.6 Conditions on the lake were very calm and the lake surface was mostly still and mirror like. A lack of visual clues while accelerating over the surface may also have contributed to the pilot not recognising the height of the helicopter above the water.

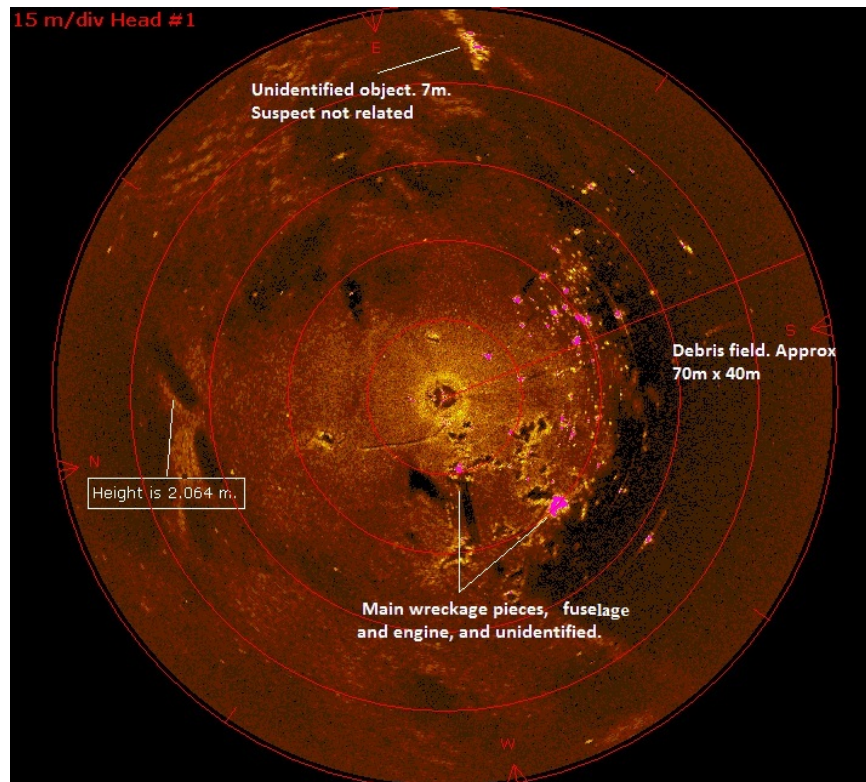
Figure 4.
Police sonar image of debris field (photo courtesy of NZ Police).

- 1.7.4 Colour video footage of the wreckage was provided to the CAA by the Police from the RNZN and the NIWA operated ROV's while sonar images were provided by the Police National Dive Squad.
- 1.7.5 The sonar images illustrate that the wreckage was spread over an area of approximately 70 metres by 40 metres, (refer Figure 4).

1.9.1 The degree of disruption to the helicopter airframe was characteristic of a high energy accident. The expansive debris field was also indicative of this fact.

- 2.2 Evidence found during the investigation, such as the large debris field and the degree of disruption to the cabin area of the helicopter, illustrate that the helicopter collided with the lake surface with considerable force and forward speed.

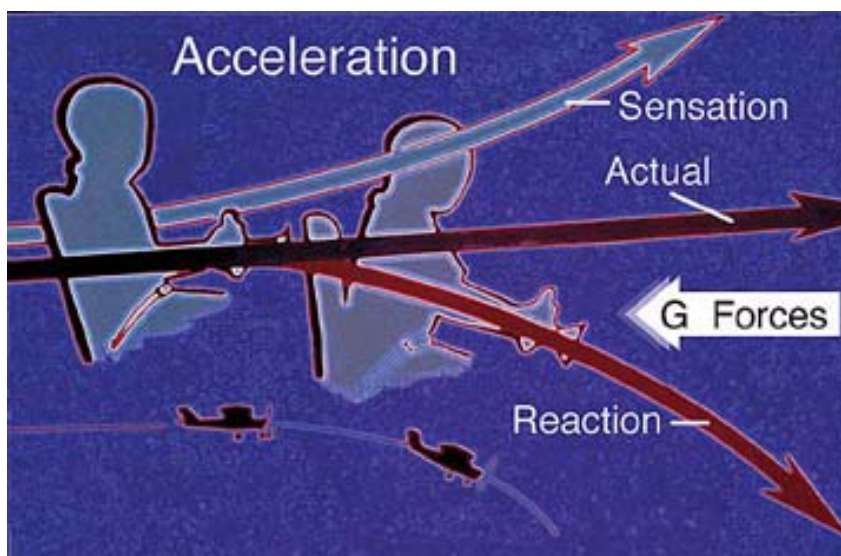
Figure 5.
Illustration of effects of Somatogravic Illusion - acceleration.

1.10.5 Somatogravic Illusion occurs as a result of acceleration forces which may cause a pilot's non-visual sensory systems to perceive that the aircraft is climbing. The natural reaction to counter this situation is for a pilot to lower the nose of the aircraft to arrest the perceived climb. The result of lowering the nose is that the aircraft will be placed into a descending attitude (refer Figure 5). The opposite effect can also occur during deceleration. If the aircraft is already operating at a low level then there is an increased risk of collision with terrain before the pilot can intervene.

- 2.7 The investigation found that it was most likely that the pilot probably experienced some form of spatial disorientation in respect to elements of somatogravic illusion and height perception illusion. This resulted in him inadvertently flying the helicopter along a shallow descending flight path.
- 2.8 These phenomenon have previously resulted in numerous cases worldwide of controlled flight into water and flat terrain, and it is conceivable that this occurred in this accident.
- 2.9 Due to the remote location of the lake and its depth the helicopter wreckage was not recovered.

- 4.1 It is proposed that the CAA Safety Promotion Unit consider updating previous articles on spatial disorientation to include special mention of the specific potential illusions that exist when pilots are required to operate an aircraft at low level over indistinct surfaces such as flat terrain or in this case a still lake surface.
