**CAA Safety Investigation Report**  
**Loss of directional control during approach to land**  
**Sabre Aircraft Company - Sabre 503 Trike ZK-JHE**  
**Kaitoke airstrip**  
**23 Nov 2020**

## Executive summary

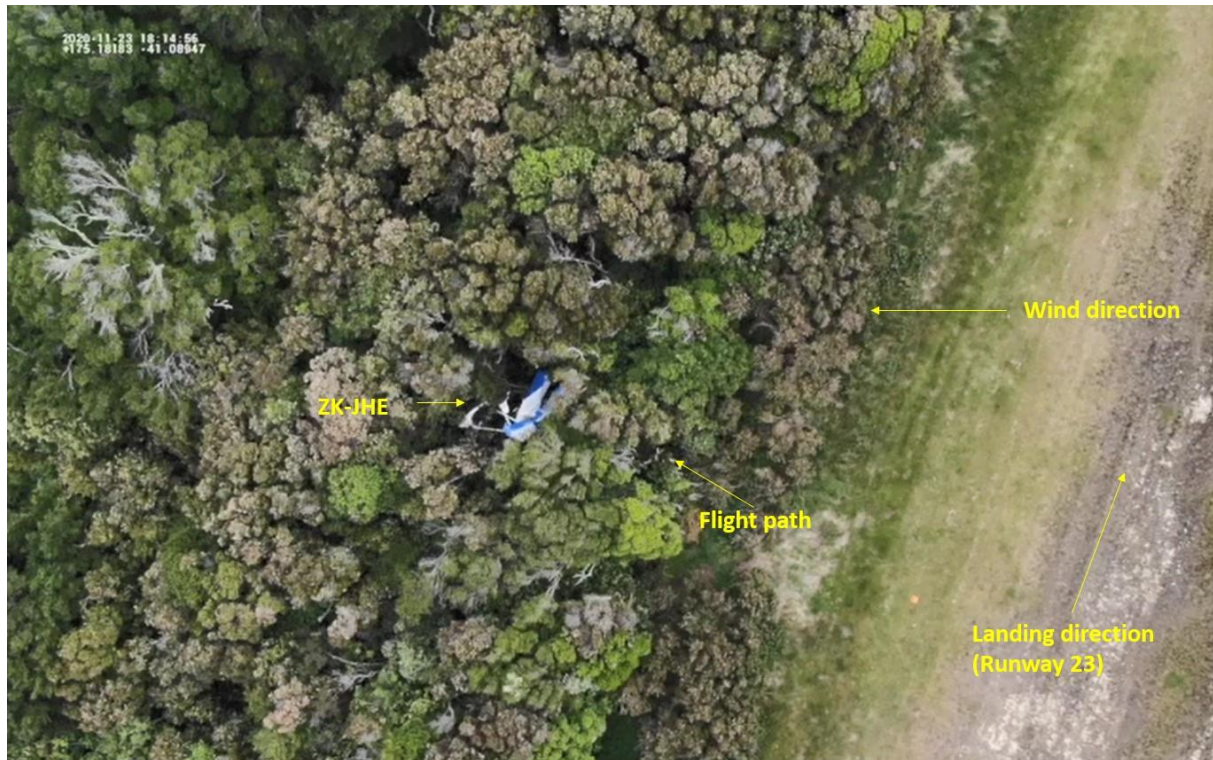
Examination of the accident site revealed that the aircraft had collided with scrub on the left side of the airstrip approximately two metres above the runway elevation. The aircraft penetrated 10 metres into the scrub and was found suspended two metres above the ground. Refer Figure 3.

Entry into the scrub resulted in major structural damage to the wing which had folded rearward. It was noted the wing control bar which the pilot holds to control the aircraft had been bent rearwards at the ends of the bar, forming a partial U-shape.

Impact damage was evident on the fuselage pod, along with the left-hand main landing gear being detached, as a result of striking some sizable tree branches in the scrub.

Damage to the three-blade composite propeller indicated that significant power was being produced by the engine when the aircraft entered the scrub.

Figure 3: Accident scene (Source: Still image taken from New Zealand Police file video)
