VECTOR

In-Flight Fin Failure

November / December 2002

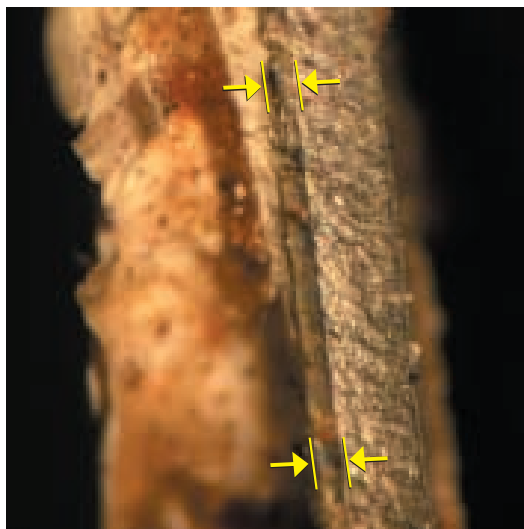
Examination of the fracture surfaces revealed the fatigue crack had initiated from a score mark in the 0.020-inch skin of the leading edge. The score mark appears to have been caused by the knife used to trim the anti-abrasion rubber strip that had been applied to the leading edge of the vertical fin (refer to the accompanying photographs).

The bottom of the fin fracture on the starboard side showing the cut mark, as indicated by the arrows (at x 35 magnification).

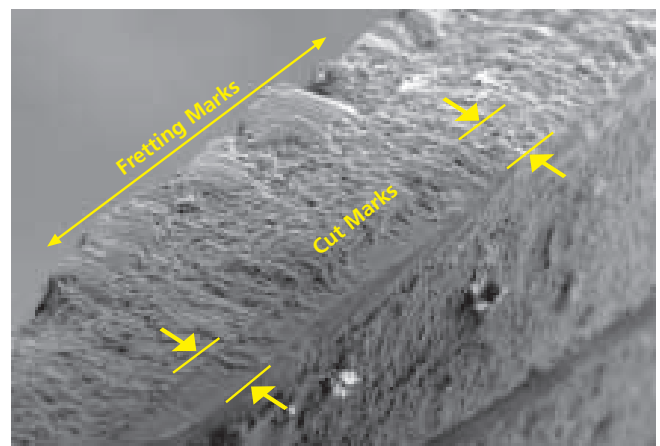
Investigation revealed that the fin failed due to a fatigue crack in the skin near the base of the leading edge. The crack progressed until the skin failed suddenly, immediately aft of the forward attachment fitting. Without the support of the forward fitting, the rear-mounted spar was unable to resist the aerodynamic loads and the fin departed over the left side of the aircraft.

The fin fracture surface showing the cut mark and fretting marks, as indicated by the arrows (at approximately x 60 magnification).

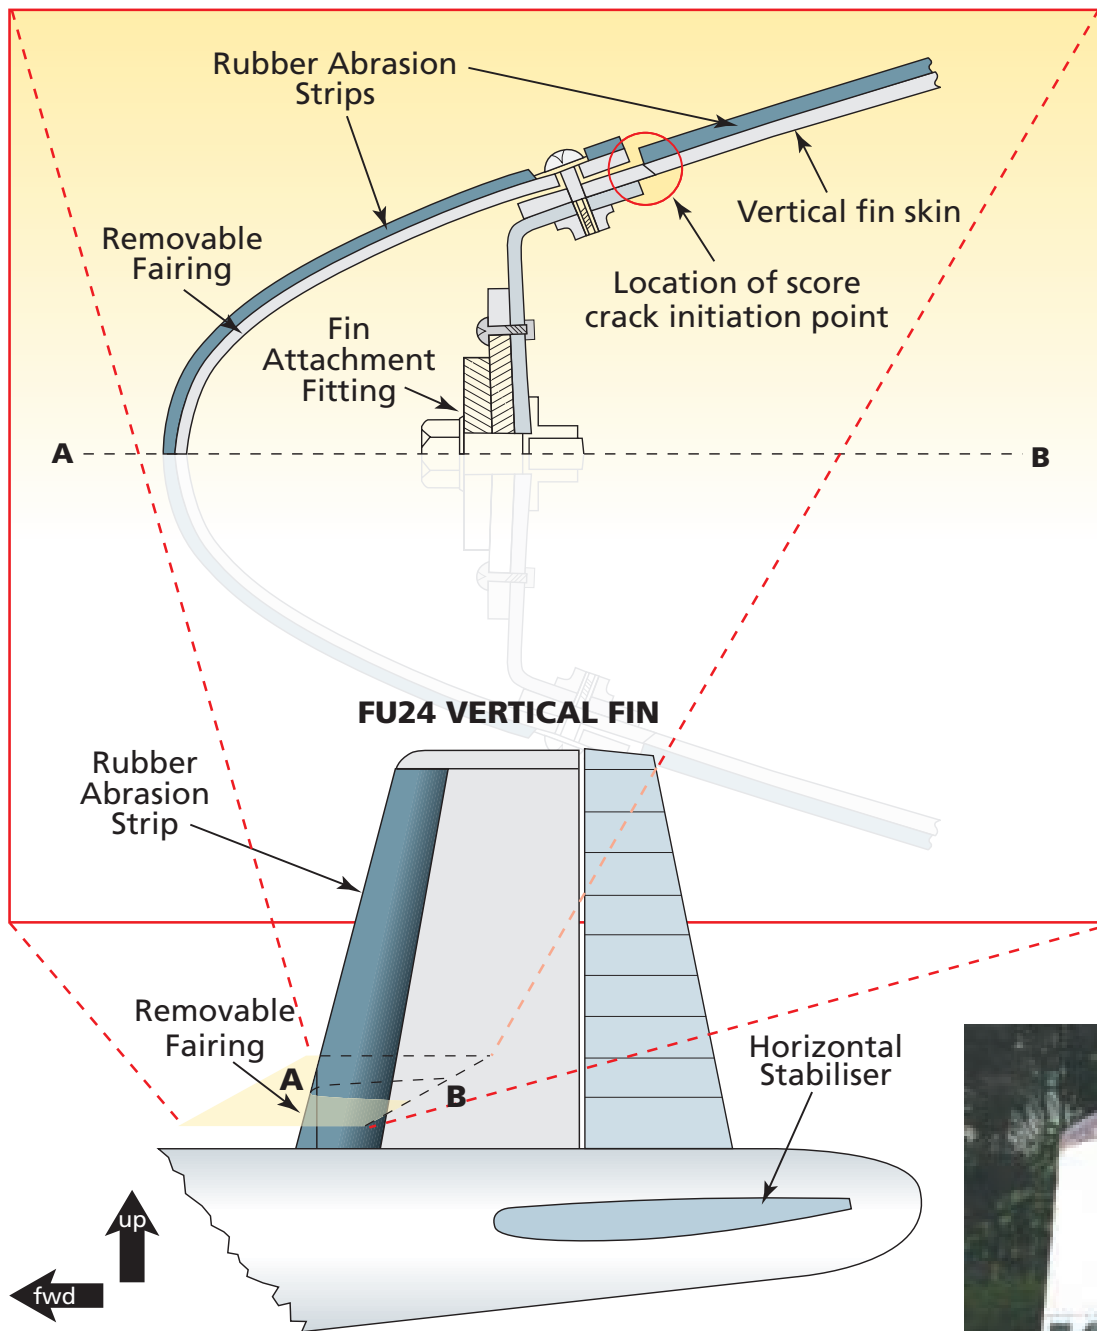
PLAN VIEW OF SECTION A – B

The forward fin fitting is known to be a critical area on the Fletcher, and Airworthiness Directive DCA/FU24/172 requires the root fairing to be removed every 12 months to enable the fin fitting to be inspected. To permit removal of the accident aircraft's fin fairing, it appears the rubber abrasion had been trimmed in situ, using the fairing, or similar, to provide a straight edge. Although this method certainly produced a neat job, the knife scored the skin beneath the rubber. The fairing was replaced and the joint carefully sealed with PRC, inadvertently hiding the score mark and the subsequent crack progression. (Refer to the diagram of the FU-24 vertical fin assembly for details).

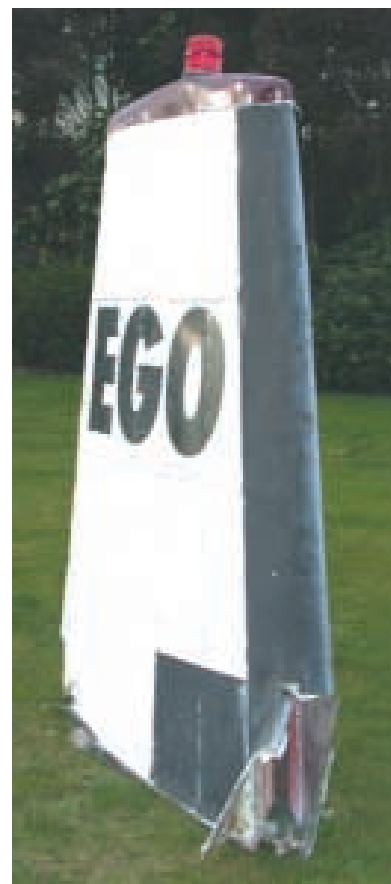
The failed tail fin.
