Continuing Airworthiness Notice – 25-001

Titan Aircraft Company T51 Mustang - Seat Belt Attachment

13 September 2017

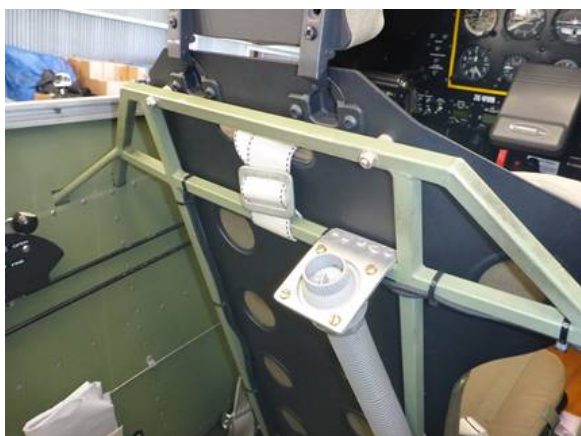
This CAN is prompted by a CAA safety investigation of an accident with a Titan T51 Mustang aircraft. The aircraft experienced an engine power loss on take-off at approximately 250 feet AGL. The aircraft landed heavily resulting in the pilot sustaining fatal injuries due to the high load applied to the shoulder harness and failure of the seatback frame.

The seatback frame on these aircraft has two horizontal bars, an upper and a lower bar. Examination of the pilot seat revealed that the shoulder harness was attached to the upper bar of the seatback frame.

Shoulder harness attachment – correct position.

According to Titan Aircraft Company the attachment of the shoulder harness to the upper bar of the seatback frame is not a factory recommended position. To reduce the leverage on the seatback frame the shoulder harness should be attached to the lower bar of the seatback frame.

The CAA recommends an inspection of the shoulder harnesses for both the front and rear seats to determine the attachment position of the shoulder harness. If a shoulder harness is found attached to the upper bar, then reposition and attach the harness to the lower bar of the seatback frame.
