# Defence Technology Agency Composites Research

FAA/CAANZ Composite Safety  
Meeting and Workshop

Wellington, NZ, 2-3 March 2016

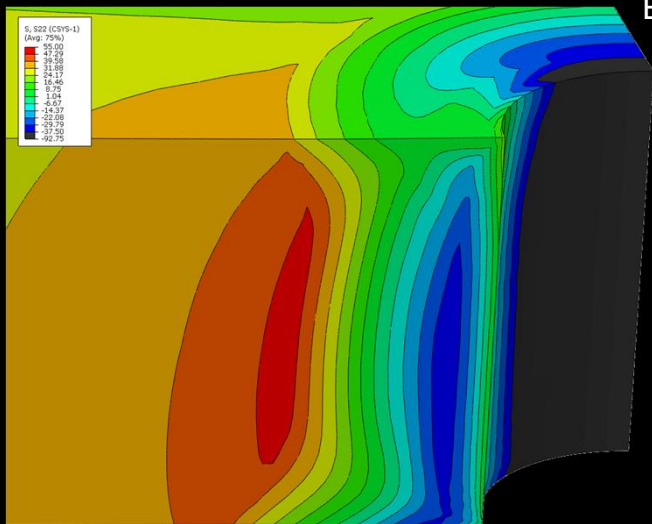
Entry face with low residual compressive field and crack initiation

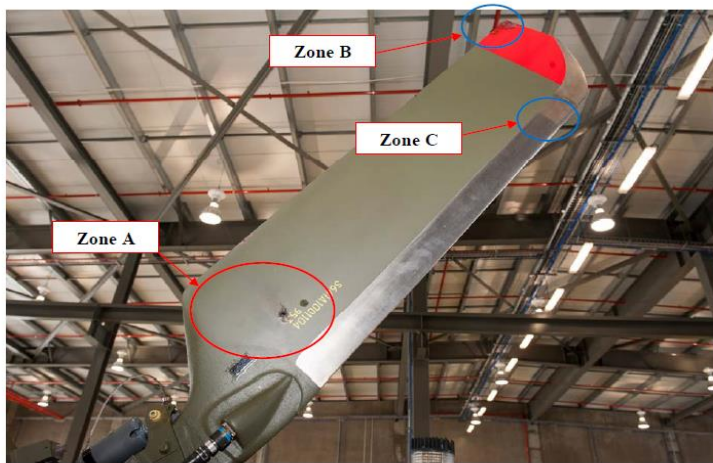
## TRB: Black Blade

- " Zone A . Burn markings (penetration)
- " Zone B . Rupture of trailing edge
- " Zone C . Arcing across leading edge strip

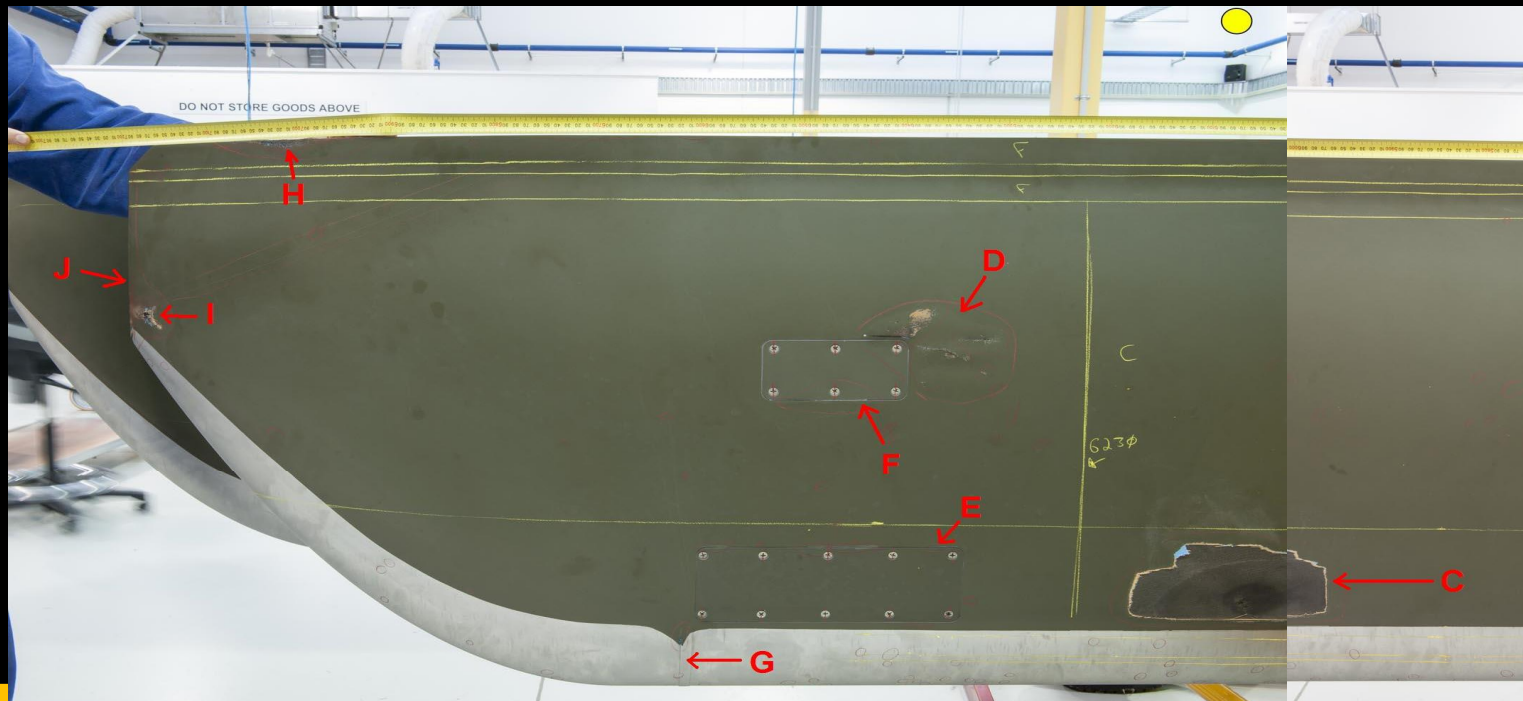
## MRB (yellow): Top Side

- " Area C . Large surface rupture with associated burn marking
- " Area D . Multiple blistering/delamination, concentration of heating effects
- " Area H . Rupture of trailing edge
- " Area I . Localised heating effects, penetration.

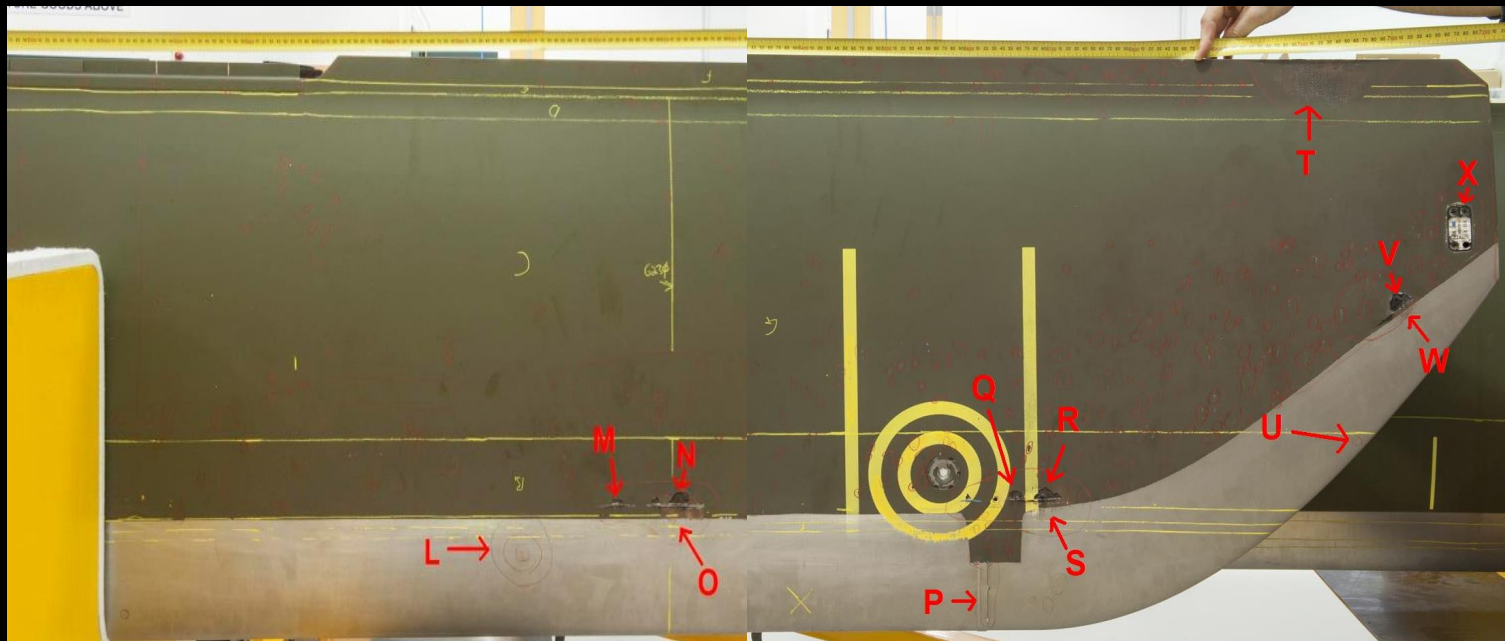
- “ MRB (yellow): Lower Side
  - “ Areas M/N/O - Localised blistering, burning, delamination
  - “ Areas Q/R/S . Localised heating effects, penetration
  - “ Area T . Melting/erosion to expose composite weave
  - “ Area X . Tip light rupture
- “ Some route damage on other MRB§
