# Ag Work

## A Recent Accident

# and the R22

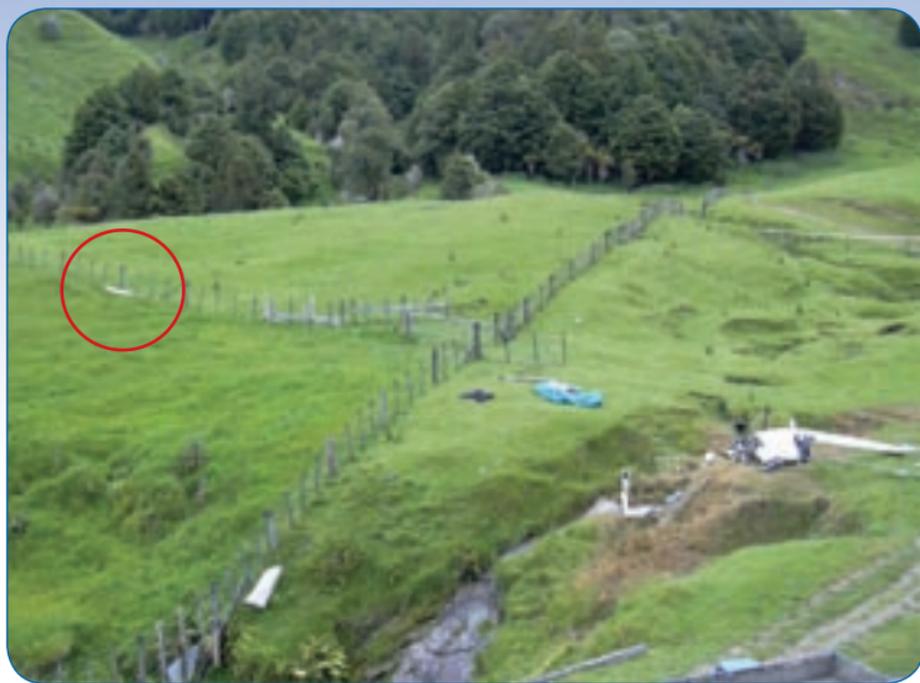
The recent and well publicised event, whereby a main rotor blade failed at the root on a Robinson R22 Beta II when the helicopter was only just airborne, is the first reported failure of this type in New Zealand. There have, however, been several instances of failures overseas. These failures are still subject to current investigations by Robinson, the FAA, and in the New Zealand case, CAA of New Zealand.

*Circle shows the location of the blade after the accident.*

In December 2004, Robinson issued a Mandatory Service Bulletin (SB94) requiring staged removal of the A016-2 blades. These blades are to be replaced with the “new” A016-4 blade. The Dash 4 blade has design changes in the grip, but Robinson’s stated major change was the stainless steel blade skin with improved resistance to corrosion and the increase of calendar finite life from 10 to 12 years. CAA New Zealand recommends that you follow this Service Bulletin; it is possible that an Airworthiness Directive will be issued.

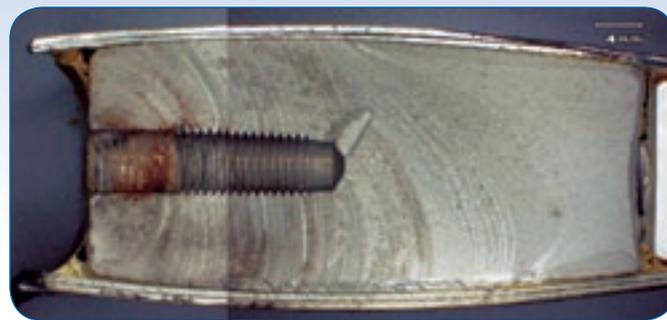
Fracture surface of an R22 blade root, showing fatigue cracking in the root fitting. Note: Growth of fatigue is obscured by external skin and doubler.

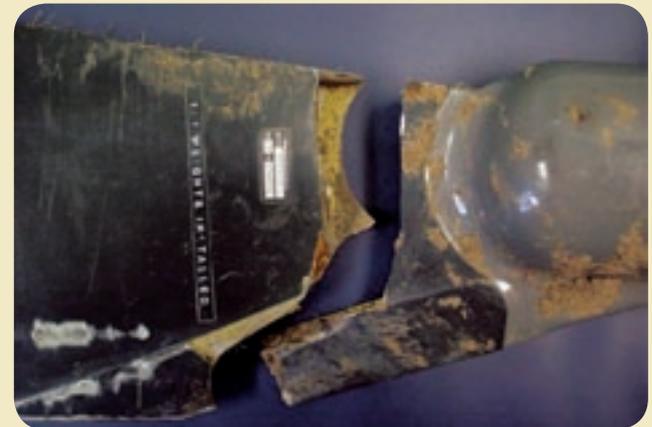
View of fractured blade root.
