# Airworthiness Directive Schedule

### Hawker Beechcraft 33, 35 and 36 Series (Bonanza and Debonair)

26 April 2018

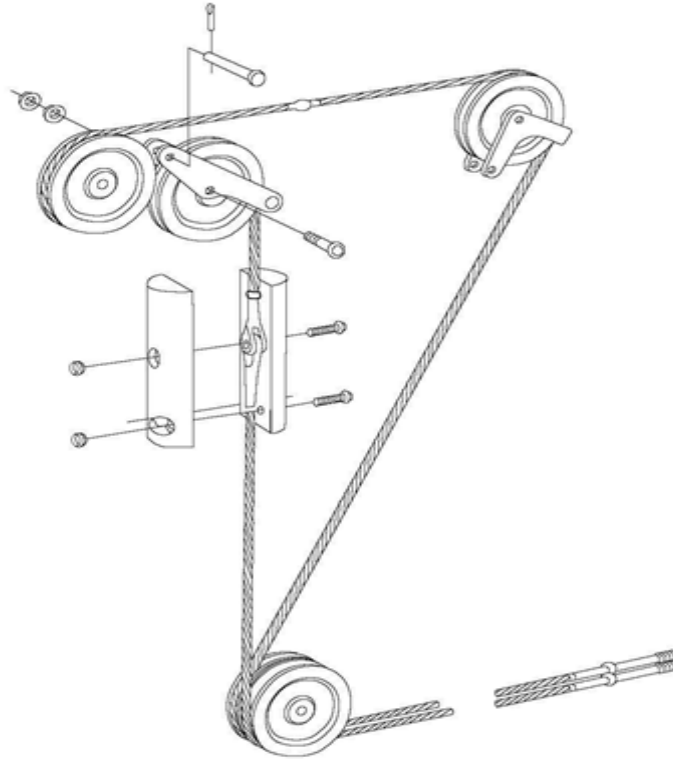
Figure 1 - Forward Elevator Control Cable - Adapted from the Beechcraft IPC.

**Note 1:** No further AD action required for those aircraft already in compliance with DCA/B35/32A. This AD revised to clarify the applicability and revise the requirement. Figure 1 introduced to provide additional information to determine AD applicability. The repetitive inspections and the requirement to replace forward elevator control cable assemblies which have been in service for more than 15 years has been removed from this AD with the publication of manufacturer Instructions for Continuing Airworthiness (ICA).

**Requirement:** To prevent loss of elevator control which could result in loss of aircraft control, accomplish the following:

1. Replace the forward elevator cable assembly, or  
Inspect the forward elevator control cable assembly for wear, broken wires and corrosion. If any defects are found, replace the forward elevator control cable assembly before further flight.
2. Cable assemblies or parts removed from service per the requirements of this AD may not be installed on any aircraft.
