# Airworthiness Directive Schedule

### Hawker Beechcraft 58 and 95 Series (Baron)

29 August 2013

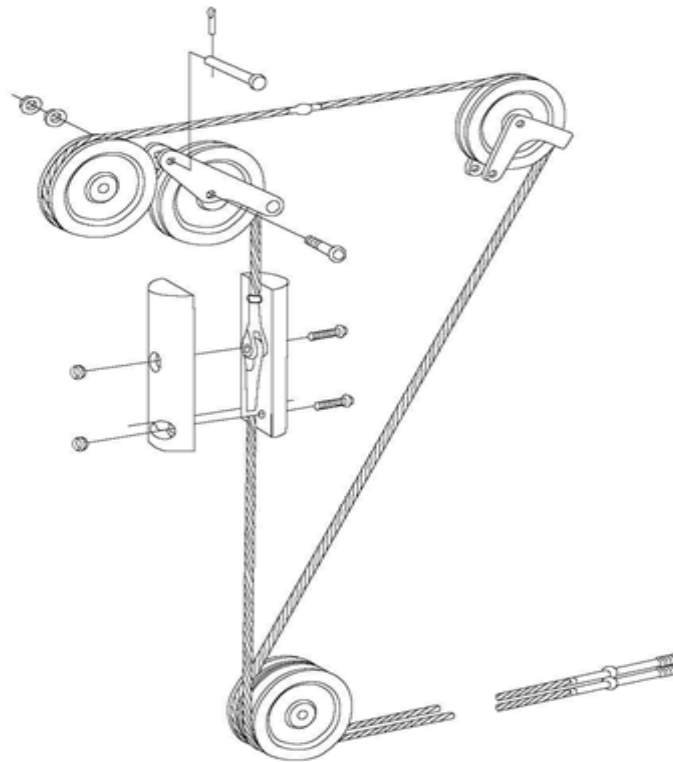
Figure 1 - Forward Elevator Control Cable - Adapted from the Beechcraft IPC.

Inspect the forward elevator control cable assembly for wear, broken wires and corrosion. If any defects are found, replace the forward elevator control cable assembly before further flight.

1. Replace the forward elevator cable assembly, or
