Airworthiness Directive Schedule

Aeroplanes

Cessna 210 Series

25 August 2016

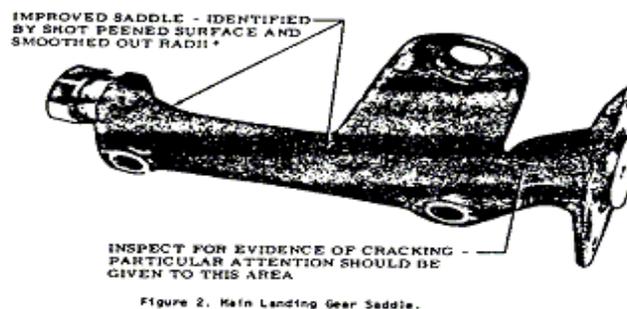
Inspect P/N 1241423-1 and 1241423-2 main landing gear saddles for cracks using dye penetrant method in accordance with either procedure 1 or 2 as specified in note 4 and 5 of this AD. Pay particular attention to the critical areas shown in Figure 2 of this AD.

If any cracks are found, replace saddles before further flight.
