Airworthiness Directive Schedule

Aeroplanes

De Havilland DH82 Series (Tiger Moth)

26 April 2018

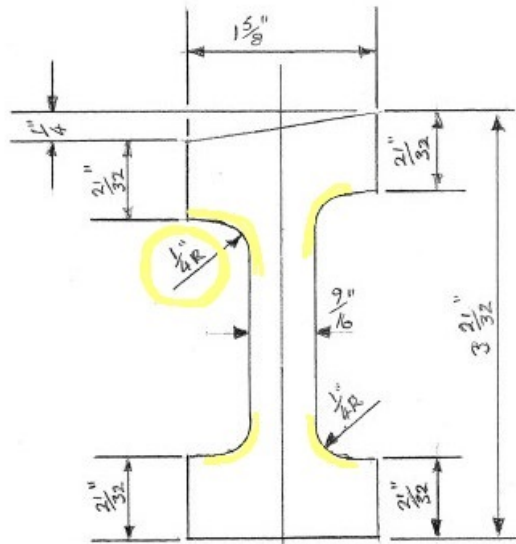
Figure 2 – Croydon Spar Profile:

If the wing spar section properties (minimum spar web radius and dimensions) are found not less than that shown in Figure 2, (i.e. the inside radii of the spar cut-outs

are found not less than 0.25 inches as shown in Figure 2), then no further action is required, and the previous flight limitations can be removed.

If the wing spar section properties (minimum spar web radius and dimensions) are found less than that shown in Figure 2, (i.e. the inside radii of the spar cut-outs are found less than 0.25 inches as shown in Figure 2), then remove the affected spar from service, and replace with a serviceable part, before further flight.

Report any machined spars with section properties less than that shown in Fig.2 to the CAA by completing a CA005 Defect Report form. Please provide the spar part and serial numbers, and a copy of the release documentation. The form can be obtained from CA005@caa.govt.nz. The completed form can be emailed to the CAA at http://www.caa.govt.nz/Forms/CA005D_Form.pdf
