# Airworthiness Directive Schedule

### Piper PA-32 Series (Cherokee 6, Saratoga, Lance and Seaplane)

27 July 2017

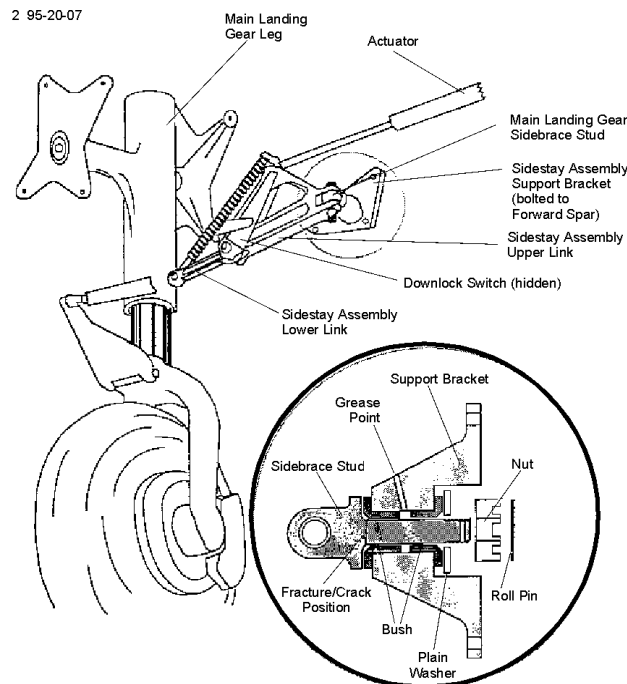
**Figure 1**

**Requirement:** To prevent main landing gear (MLG) collapse due to possible main gear sidebrace stud cracks which if not detected and corrected could result in loss of aircraft control during landing, accomplish the following:

Remove both the left and right main gear sidebrace studs from the aircraft per the instructions in the landing gear section of the aircraft MM. Inspect both the main gear sidebrace stud for cracks using Type I (fluorescent) liquid penetrant or magnetic particle inspection methods. Figure 1 of this AD depicts the area where the sidebrace stud is to be inspected.

**Note:** This figure is provided to depict the area of the sidebrace stud to be inspected. This is not intended to represent the configuration of all models affected.

For any main gear sidebrace stud not found cracked, before to further flight reinstall the stud per the instructions in the Landing Gear section of the applicable MM, and reinspect and replace (as necessary) per this AD.

For any main gear sidebrace stud found cracked, before to further flight replace the cracked stud with a serviceable part per the instructions in the Landing Gear section of the applicable MM and accomplish one of the following, as applicable:

- Reinspect and replace (as necessary) per the repetitive requirements in this AD, or
- For affected PA32R-300 aircraft the 9/16 inch main gear sidebrace studs (P/N 95299-00, 95299-02 or 67543 as applicable) are no longer manufactured: Install a new main gear sidebrace stud bracket assembly P/N 95643-06, 95643-07, 95643-08 or 95643-09 as applicable. No repetitive inspections will be required by this AD for when this bracket assembly is installed on both the LH and RH sides, or

- Ream the existing two-piece bushings P/N 67026-6 to an inside diameter of .624 inch to .625 inch, chamfer the head side of the bushing to accommodate the radius in the shank of the main gear sidebrace stud and install the 5/8 inch stud P/N 78717-02. No repetitive inspections will be required by this AD when this action is accomplished on both the LH and RH bracket assemblies. If the bushings cannot be reamed while installed in the bracket (i.e., the bushings are loose), then install a main gear sidebrace bracket assembly P/N 95643-06, 95643-07, 95643-08 or 95643-09, as applicable.
