# Airworthiness Directive Schedule

## Aeroplanes

### Piper PA-32 Series (Cherokee 6, Saratoga, Lance and Seaplane)

27 July 2017

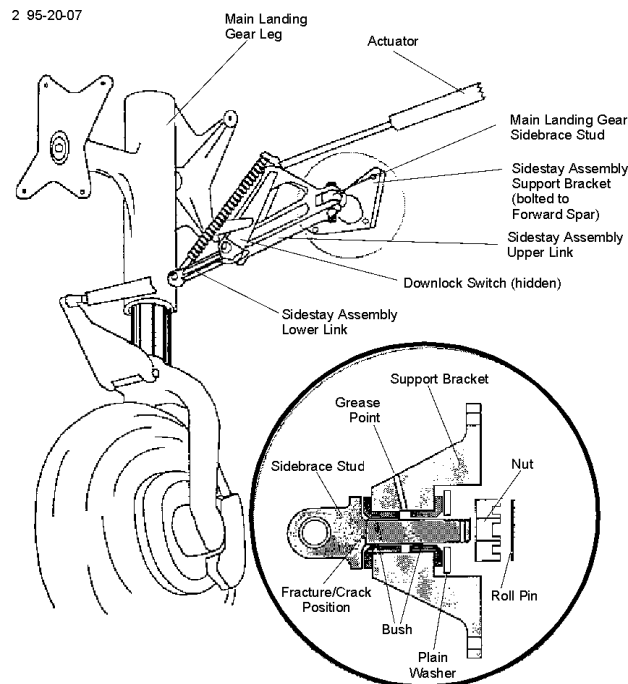
**Figure 1**

**Requirement:** To prevent main landing gear (MLG) collapse due to possible main gear sidebrace stud cracks which if not detected and corrected could result in loss of aircraft control during landing, accomplish the following:

Remove both the left and right main gear sidebrace studs from the aircraft per the instructions in the landing gear section of the aircraft MM. Inspect both the main gear sidebrace stud for cracks using Type I (fluorescent) liquid penetrant or magnetic particle inspection methods. Figure 1 of this AD depicts the area where the sidebrace stud is to be inspected.

**Note:** This figure is provided to depict the area of the sidebrace stud to be inspected. This is not intended to represent the configuration of all models affected.

For any main gear sidebrace stud not found cracked, before to further flight reinstall the stud per the instructions in the Landing Gear section of the applicable MM, and reinspect and replace (as necessary) per this AD.

For any main gear sidebrace stud found cracked, before to further flight replace the cracked stud with a serviceable part per the instructions in the Landing Gear section of the applicable MM and accomplish one of the following, as applicable:

- Reinspect and replace (as necessary) per the repetitive requirements in this AD, or
- For affected PA32R-300 aircraft the 9/16 inch main gear sidebrace studs (P/N 95299-00, 95299-02 or 67543 as applicable) are no longer manufactured: Install a new main gear sidebrace stud bracket assembly P/N 95643-06, 95643-07, 95643-08 or 95643-09 as applicable. No repetitive inspections will be required by this AD for when this bracket assembly is installed on both the LH and RH sides, or

- Ream the existing two-piece bushings P/N 67026-6 to an inside diameter of .624 inch to .625 inch, chamfer the head side of the bushing to accommodate the radius in the shank of the main gear sidebrace stud and install the 5/8 inch stud P/N 78717-02. No repetitive inspections will be required by this AD when this action is accomplished on both the LH and RH bracket assemblies. If the bushings cannot be reamed while installed in the bracket (i.e., the bushings are loose), then install a main gear sidebrace bracket assembly P/N 95643-06, 95643-07, 95643-08 or 95643-09, as applicable.
