Airworthiness Directive Schedule

Aeroplanes

Piper PA-34 Series (Seneca I, II, III, IV and V)

28 February 2013

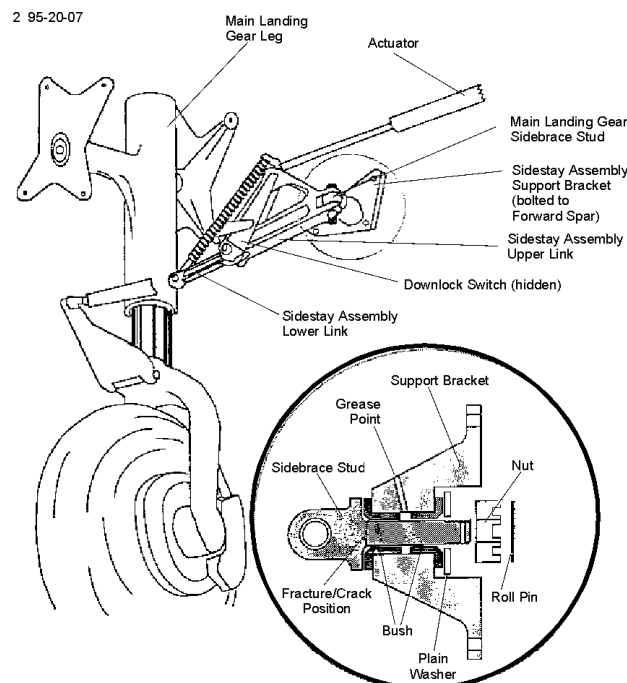
Requirement: To prevent main landing gear (MLG) collapse due to possible main gear sidebrace stud cracks which if not detected and corrected could result in loss of aircraft control during landing, accomplish the following:

Remove both the left and right main gear sidebrace studs from the aircraft per the instructions in the landing gear section of the aircraft MM. Inspect both the main gear sidebrace stud for cracks using Type I (fluorescent) liquid penetrant or magnetic particle inspection methods. Figure 1 of this AD depicts the area where the sidebrace stud is to be inspected.

Note: This figure is provided to depict the area of the sidebrace stud to be inspected. This is not intended to represent the configuration of all models affected.

For any main gear sidebrace stud not found cracked, before to further flight reinstall the stud per the instructions in the Landing Gear section of the applicable MM, and reinspect and replace (as necessary) per this AD.

For any main gear sidebrace stud found cracked, before to further flight replace the cracked stud with a serviceable part per the instructions in the Landing Gear section of the applicable MM and accomplish one of the following, as applicable:

- Reinspect and replace (as necessary) per the repetitive requirements in this AD, or
- For affected PA34-200 and PA34-200T aircraft the 9/16 inch main gear sidebrace studs (P/N 95299-00, 95299-02 or 67543 as applicable) are no longer manufactured: Install a new main gear sidebrace stud bracket assembly P/N 95643-06, 95643-07, 95643-08 or 95643-09 as applicable. No repetitive inspections will be required by this AD for when this bracket assembly is installed on both the LH and RH sides, or

- Ream the existing two-piece bushings P/N 67026-6 to an inside diameter of .624 inch to .625 inch, chamfer the head side of the bushing to accommodate the radius in the shank of the main gear sidebrace stud and install the 5/8 inch stud P/N 78717-02. No repetitive inspections will be required by this AD when this action is accomplished on both the LH and RH bracket assemblies. If the bushings cannot be reamed while installed in the bracket (i.e., the bushings are loose), then install a main gear sidebrace bracket assembly P/N 95643-06, 95643-07, 95643-08 or 95643-09, as applicable.

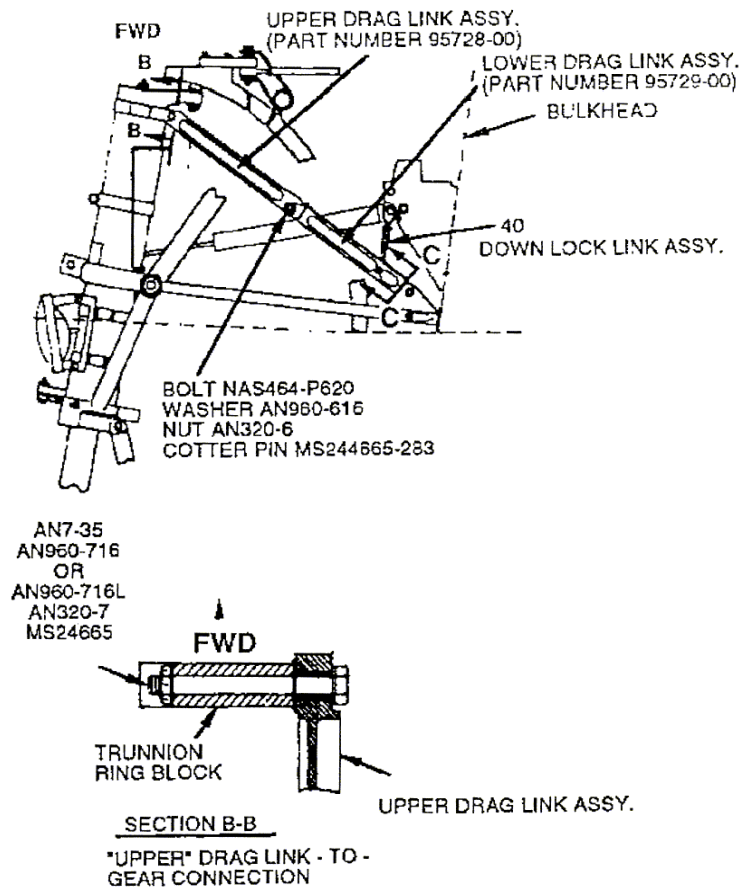
- Applicability:** Model PA-34-200, PA-34-200T and PA-34-220T aircraft, all S/N.
- Note 1:** This AD supersedes AD DCA/PA34/24 and introduces new NLG inspection and rigging procedures. Accomplish the requirements in this AD per Piper SB No. 1123B because to SB No. 1123A is no longer active.
- Requirement:** To prevent prevent failure of components of the NLG which could result in the NLG collapsing, accomplish the following:
1. Replace the bolt and stack up that connects the upper drag link to the nose gear trunnion with new Piper parts (or approved equivalent parts) per the figure in this AD:
Piper bolt P/N 400 274 (AN7-35).
Piper washer P/N 407 591 (AN960-716L), as applicable.
Piper washer P/N 407 568 (AN960-716).
Piper nut P/N 404 396 (AN320-7).
Piper cotter pin P/N 424 085.

If any defects are found accomplish all the required corrective actions in table 1 of SB No. 1123B before further flight.
