AIRCRAFT ACCIDENT REPORT
OCCURRENCE NUMBER 12/1417
ZENAIR ZODIAC 601UL
ZK-JFN
LOSS OF CONTROL DURING FORCED LANDING
SOUTH HEAD,
HELENSVILLE
1 APRIL 2012

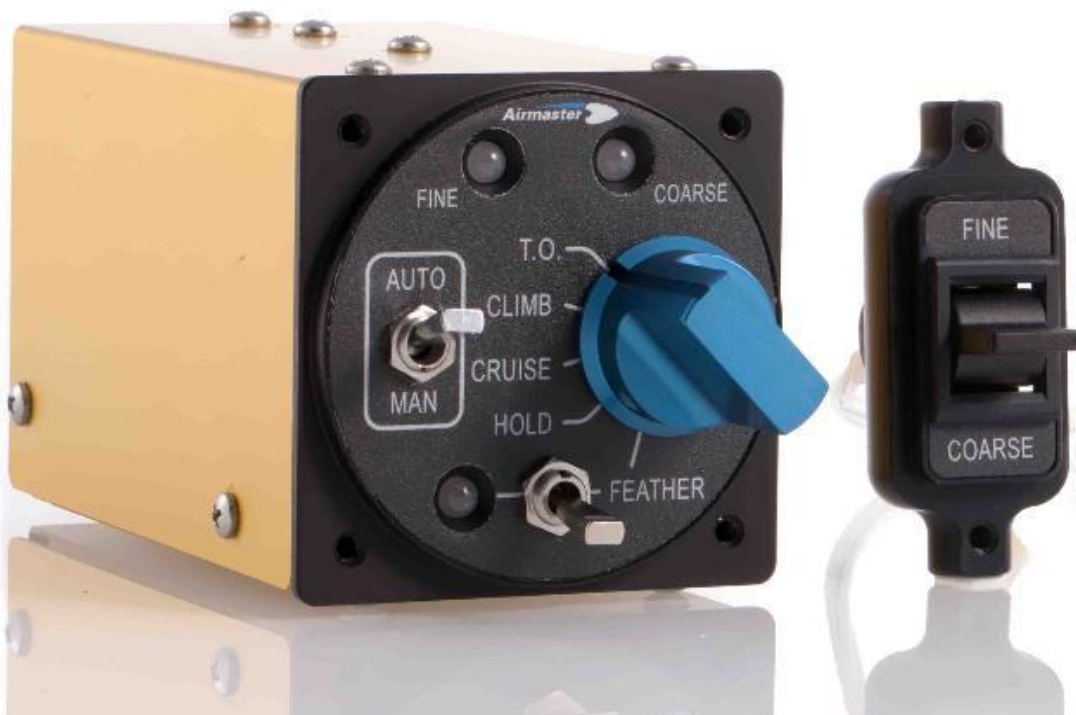
Figure 1. Airmaster AC200 Propeller Controller

- 1.6.3 The propeller controller incorporated normal automatic control and manual over-ride (refer to figure 1). When the 'auto/manual' switch was in the 'auto' position the desired governing speed of the propeller was selected using a rotary selector switch on the controller. The rotary selector switch had positions marked 'T.O., Climb, Cruise, Hold, and Feather'. When the 'auto/manual' toggle switch was in the 'manual' position the rotary selector switch had no functionality, and the pitch of the propeller was selected directly using a separate manual control switch mounted on the instrument panel near to the controller. The toggle switch moved the propeller pitch toward fine or coarse. Three tri colour LED indicator lights reflected the current status of the propeller and control system.

- 1.18.2 The pilot mentioned that the gauge marked 'manifold pressure' had indicated zero for the duration of the flight, which the pilot thought was normal. The pilot thought that another gauge marked 'boost' was an indication of engine power. There was some confusion regarding the purpose of the gauges. It was determined the pilot did not know how to operate the propeller controller correctly, using the automatic rotary selector to attempt to control the propeller speed while the controller was selected to 'manual' over-ride. The group thought that the manifold air pressure gauge reading zero reflected that the propeller had remained in 'fine' pitch for the duration of the flight, resulting in the excessive fuel usage. The friends believed that the pilot appeared to have learned how to correctly operate the propeller controller prior and read the engine instruments prior to the take-off, on the accident flight.

- 2.5 It is evident that the pilot had exhibited inadequate knowledge of the propeller control system and engine indications, and appears to have demonstrated poor handling of the aircraft at times during the flight, causing concern to other pilots. This was probably an indication that the pilot may not have been competent with the operation and handling of his aircraft at the time of the accident. The apparent lack of competency may explain the pilot's difficulty in conducting a successful forced landing.
