CAA Safety Investigation Report

Loss of control in flight

RANS S6-ES Coyote II ZK-TJE

CAA Final Report 17/1635

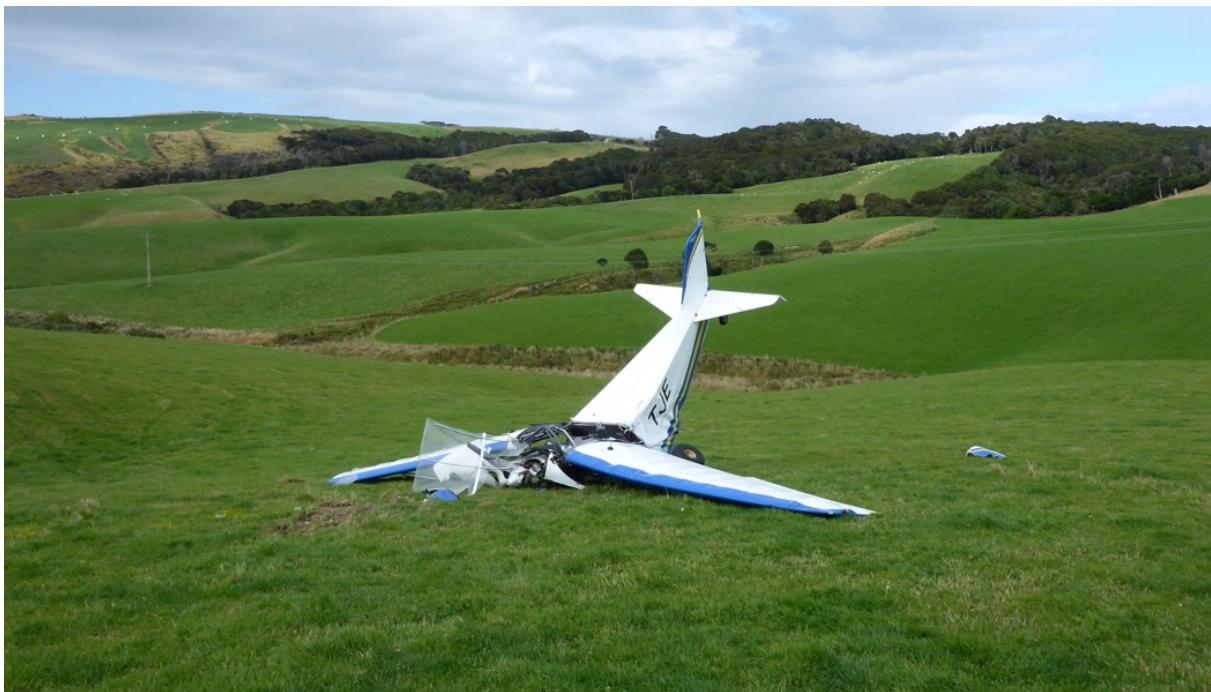
Figure 2: The accident site (Source: CAA field investigation)

Wreckage signatures indicate the aircraft struck the ground on an easterly heading, in a nose-down attitude of approximately 40°. After striking the ground the aircraft rotated to the right, coming to rest approximately five metres from the point of impact on an approximately northwesterly heading. The aircraft was contained within an approximate 15 metre radius of the impact point, with the exception of some lightweight debris (see Figure 2).

The wreckage signatures found are consistent with the aircraft pitching nose down at the stall, with some evidence the aircraft was beginning to enter a spin.

Pre-impact control integrity was established as far as possible. No pre-existing defects were identified during the safety investigation that may have affected normal flight.

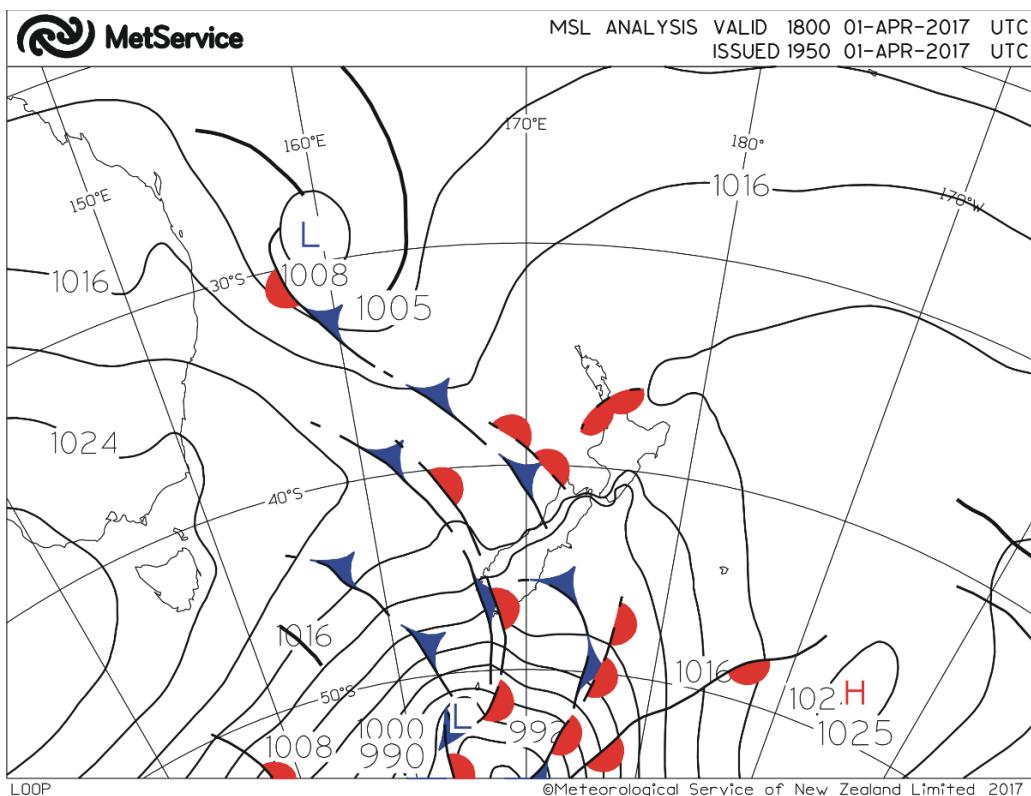
Figure 3: The mean sea level analysis valid around the time of the accident (Source: MetService)

The aviation weather forecast available before the pilot departed his airstrip indicated that a frontal system, with increasing wind and turbulence, was expected to pass through the area during the morning (See Figure 3).

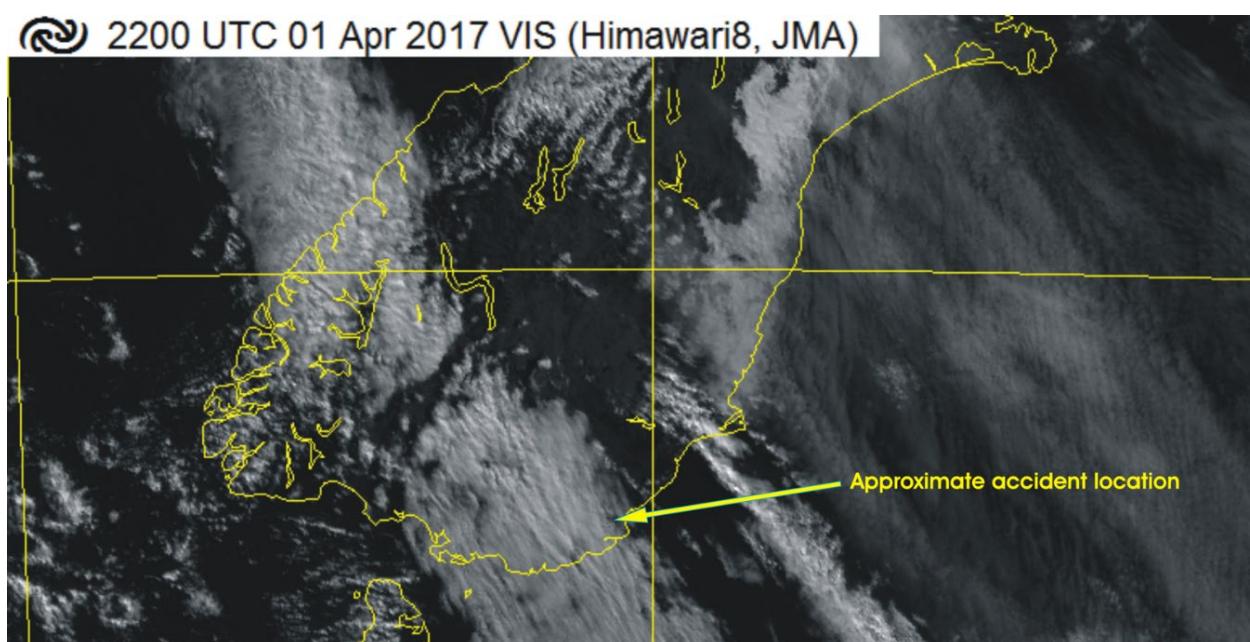
Figure 4: Satellite imagery at the time of the accident (Source: MetService)

Satellite imagery and wind recordings from the MetService Nugget Point weather station, situated approximately six nautical miles south-east of the accident site, confirm the presence of the weather front in the immediate vicinity at the time of the accident (see Figure 4). A MetService specialist who analysed the data from the Nugget Point weather station stated that: "Nugget Point is quite close to the incident location, so I would expect these changes [in wind velocity] to have been experienced there, too" (see Figure 5).

The combination of weather data and witness statements indicates that at the time of the accident there was significant wind and turbulence, with wind shear⁸ likely at low level. Wind shear is known to increase the risk of a departure from controlled flight.

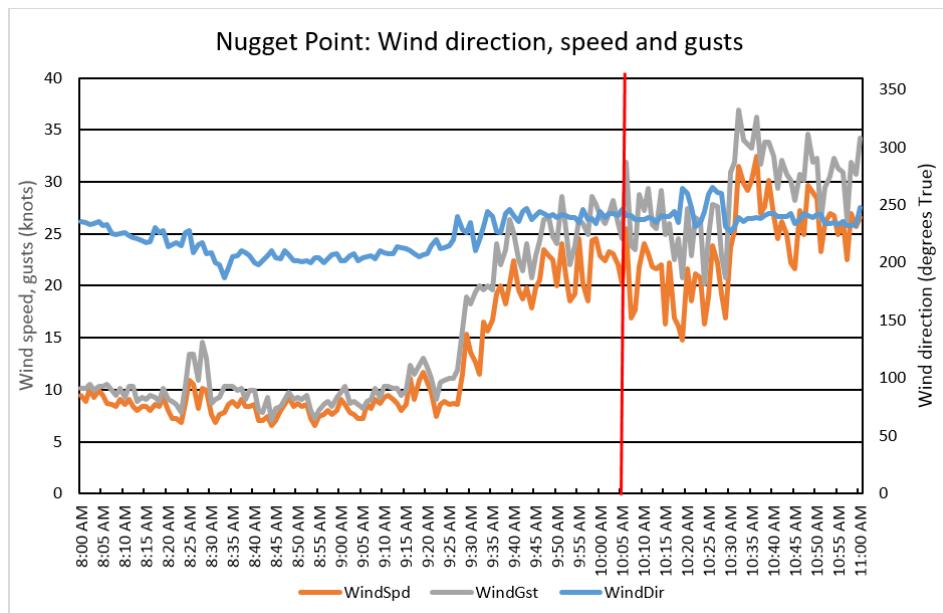
Figure 5: Recorded wind at Nugget Point with time of accident highlighted (Source: MetService)

- 1000-1010 Wind speed at Nugget Point MetService weather station averaging 20 knots, minimum lull 17 knots, maximum gust 32 knots
