July / August 2003

# VECTOR

## **Pitot-Static Systems**

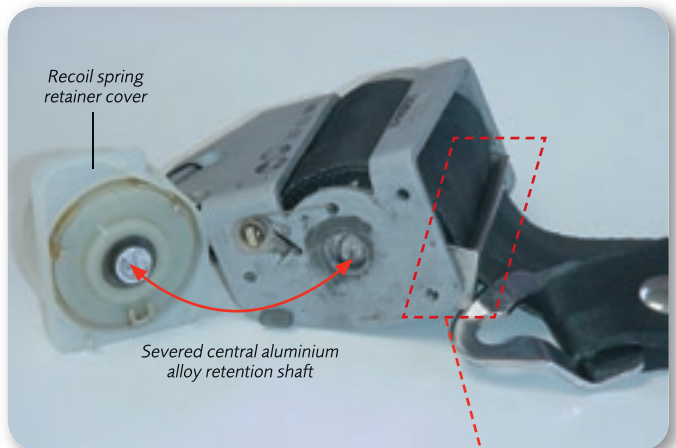
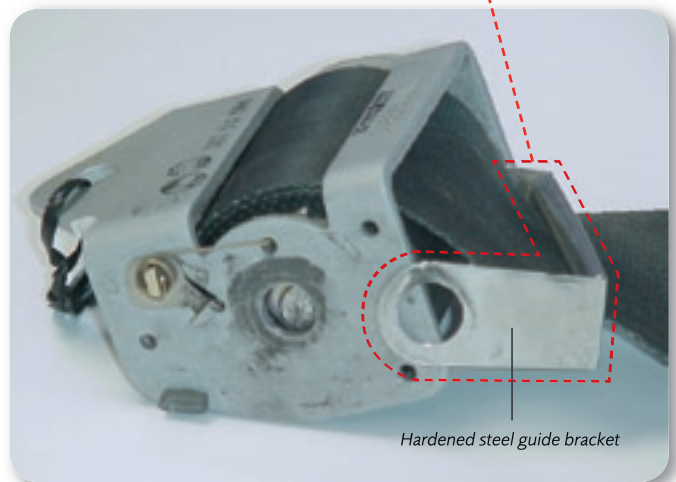
## Pacific Scientific Inertia Reel

The recent failure of a seat belt inertia reel mechanism fitted to a Piper Arrow has highlighted an underlying design fault in some models of inertia reel that are commonly used in New Zealand aircraft.

The problem is being caused by the hardened steel seat belt guide bracket wearing through the central aluminium alloy retention shaft (see photographs for details). In some cases the retention shaft has been completely severed, which normally causes the reel to jam, but could result in it pulling loose from its mounting. Reels manufactured after June 1992 contain a stainless steel retention shaft, which corrected the problem.

We urge you to take the time to ascertain whether or not your aircraft falls into this category, and to take corrective follow-up action if it does. The alternative is perhaps having a faulty restraint system that fails when it is most needed, something that does not bear thinking about. ■

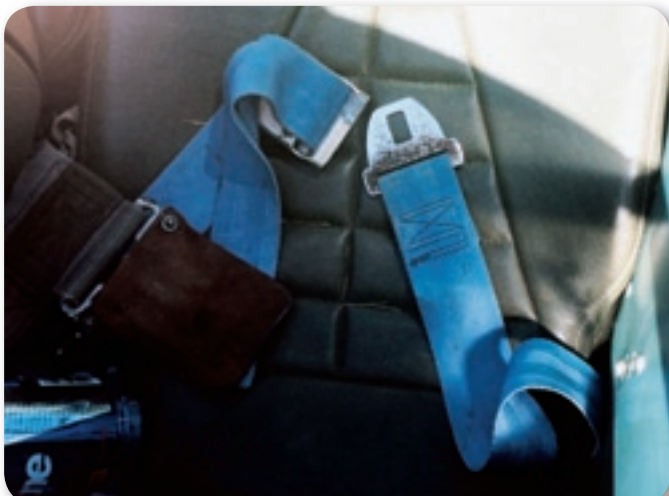
“As you can see, the alloy buckle has a huge scab of corrosion and the steel tongue is badly rusted [see accompanying photograph]. If this was in a car, it would not get a warrant of fitness, so what’s it doing in an aircraft?

The poor condition of this seat belt is certainly cause for concern.

- Examining each strap for wear, damage, broken stitches, discolouration and deterioration.
- Examining attachments and fittings for security, wear and elongation of attachment holes.
- Checking the release mechanism and means of adjustment for freedom from slip.
- Checking the action of the release mechanism.
- Checking each inertia reel for correct function and freedom of operation.
