May / June 2002

# VECTOR

# That Sinking Feeling

# Timely Reporting

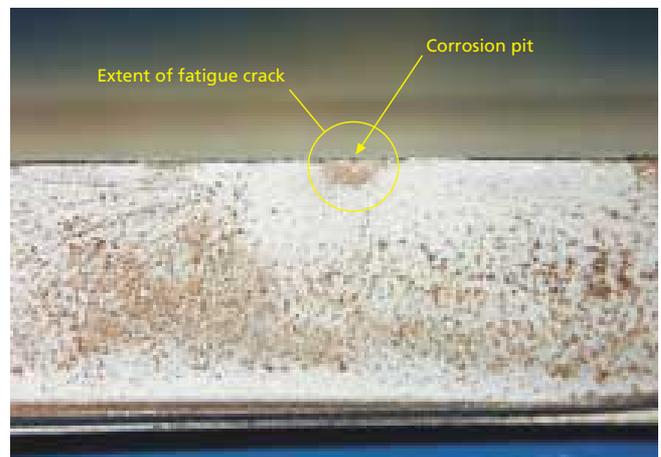
The Cessna TU206A was taxiing clear of the grass vector when its lefthand main landing gear (MLG) leg fractured and separated from the fuselage. Fortunately the damage was limited, as the failure occurred at low speed. Investigation revealed the leg had suffered a fatigue failure resulting from a crack initiated by a very small corrosion pit (see accompanying photograph).

Cessna spring legs are made of a particularly hard steel, SAE 6150. The spring tempering process leaves the steel very sensitive to fatigue crack initiation. To overcome this 'notch sensitivity', the undersides of the legs (loaded in tension) are shot-peened at manufacture to produce a thin layer of steel in compression. The compressive stress in this surface layer increases fatigue resistance. In the case of the Cessna TU206A leg failure, the corrosion had in fact penetrated the shot-peened layer (0.006 inches or 0.15 mm). Without the benefit of the compressive stress, a crack soon initiated from the corrosion pit. The crack spread with each landing gear cycle until the remaining material failed. The small size of the fatigue crack relative to the failed leg cross-section showed that the Cessna spring legs are highly stressed, with very little damage tolerance.

*The small semicircular fatigue crack that led to the leg failure is highlighted above. The corrosion pit that initiated the crack is the barely-visible black dot indicated by the arrow.*

All of the failures to date have initiated from corrosion, which has resulted after a breakdown in the paint finish. To ensure the structural integrity of spring legs, it is clear that a high-quality paint finish must be maintained. The accompanying photograph of the TU206A accident leg shows that, in this particular case, it had suffered a moderate amount of wear and tear, but probably not enough to attract a LAME's attention.

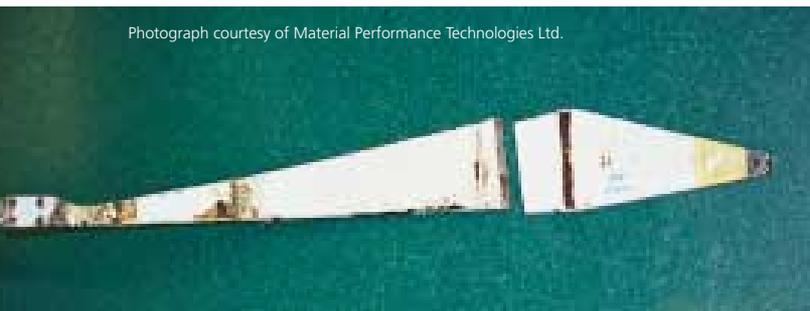
*The failed TU206A undercarriage leg. Note the poor condition of the paint that allowed corrosion to develop.*

Like propeller blades, undercarriage spring legs need to be protected from corrosion and foreign object damage. The best way to do this is to ensure that they are finished with a high-quality paint job. The emphasis **must** then be on protecting the paint, as once corrosion attacks the metal beneath, that sinking feeling could be only a few landings away. ■

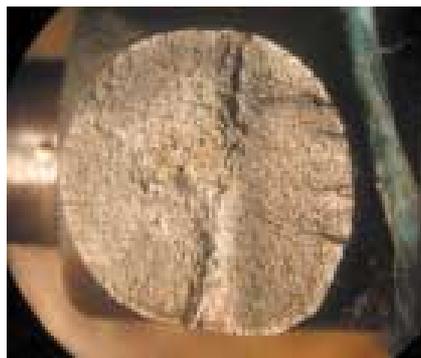
This time the incident became an accident and was reported to the Civil Aviation Authority. The tailwheel was subjected to detailed analysis by CAA investigators. The casting is a strange piece of metal – under the microscope it looks almost like hokey-pokey toffee with bubbles and vacuoles and comparatively large cavities (see the accompanying photograph). In short, it is not a piece of casting you'd expect to have take the repeated pounding of landing, or the centrifugal stresses associated with snap manoeuvres. A video of a Pitts landing showed the tailwheel oscillating very rapidly at the start of the landing roll. The analysis showed that cracking from multiple propagation sources had begun on the side closest to the wheel, which is the worst possible spot to inspect. The nature of the metal meant the cracks had little resistance to their propagation. When the cracking reached a large cavity at mid-point through the diameter of the casting, the rest of the metal failed in overload. Whoever flew this aircraft was in for a shock at some stage.

*A cross-section of the failed Pitts tailwheel fork.*

The CAA issued an Airworthiness Directive (DCA/Brakes/5 “Tailwheel Fork – Inspection”, effective 28 February 2002), on this make of Maule tailwheel, requiring inspection of the casting by dye-penetrant within a month, with repeated inspections every 100 hours or annually. The intention is to
