Missing Aircraft Detection & Location

Technology & System Status Review 2010

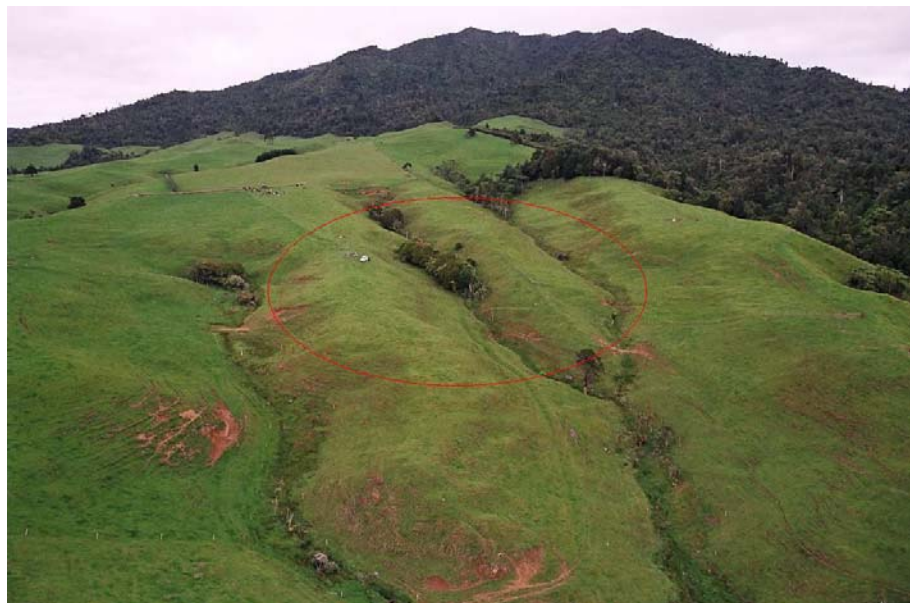
Figure 1: ZK-HTF Crash Site.

The photograph in Figure 1 shows the crash site of ZK-HTF; the actual crash site is in the patch of bush in the narrow valley surrounded by grassland in the centre of the picture. This patch of bush is 13 metres wide; three metres greater than the diameter of the EC120B rotor. The helicopter wreckage was not visible from the air or the ground immediately adjacent to the valley. Air traffic services radar data from the helicopter ceased when it was in the vicinity of Mt Karioi. The area was covered early in the search programme.

In the crash, the ELT antenna was broken off by a tree branch. The TSO C126 406 MHz ELT activated and transmitted the required signals; this was verified by accessing the ELT memory. Because of the broken antenna neither the 406 MHz nor the 121.5 MHz signals were radiated from the crashed aircraft.

The lack of a crash tolerant antenna on the helicopter meant that the initial search was later in commencing and then ineffective. Had the ELT system functioned correctly, the search would have been completed very quickly and at a fraction of the sum that was the final cost of the public and private searches. This type of hidden accident site will always be a challenge but this case shows that a functioning ELT still provides the best opportunity for early detection and location of missing aircraft. It also shows that a FTD can be an excellent complement to the ELT in that it can provide confirming information for the general location of a crash.

The well publicised crash of Eurocopter EC120 ZK-HTF near Raglan that killed Michael Erceg and a passenger is another case where the antenna failed. The ELT itself was found to have functioned correctly but a tree branch broke the non-crash tolerant ELT antenna during the crash sequence and so prevented the transmission of the distress signal.
