Aircraft Effluent Claims

History

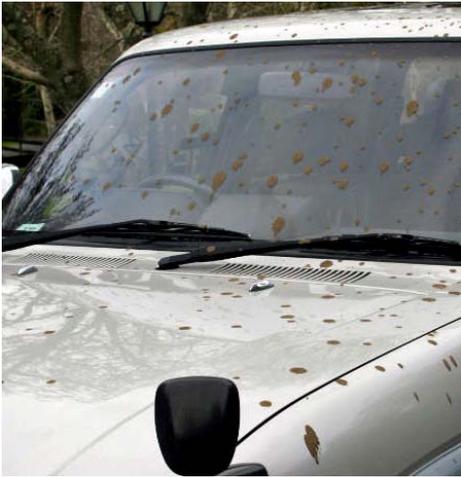
The dry sample was viewed under a 3D dissecting microscope, and he found that it was typical of what he would expect dried out waterfowl excrement to look like. It was predominantly fibrous in content and appearance. Some plant remains were clearly undigested and still green in colour and the cell contents were fully intact.

The sample was then hydrated and a small portion viewed with a powerful microscope at 25x and 40x magnification. Dr Williams noted several individual strands of the substance and he was able to determine, in his opinion, that their microscopic structure was typical of digested plant material.
