VECTOR

In-Flight Fin Failure

November / December 2002

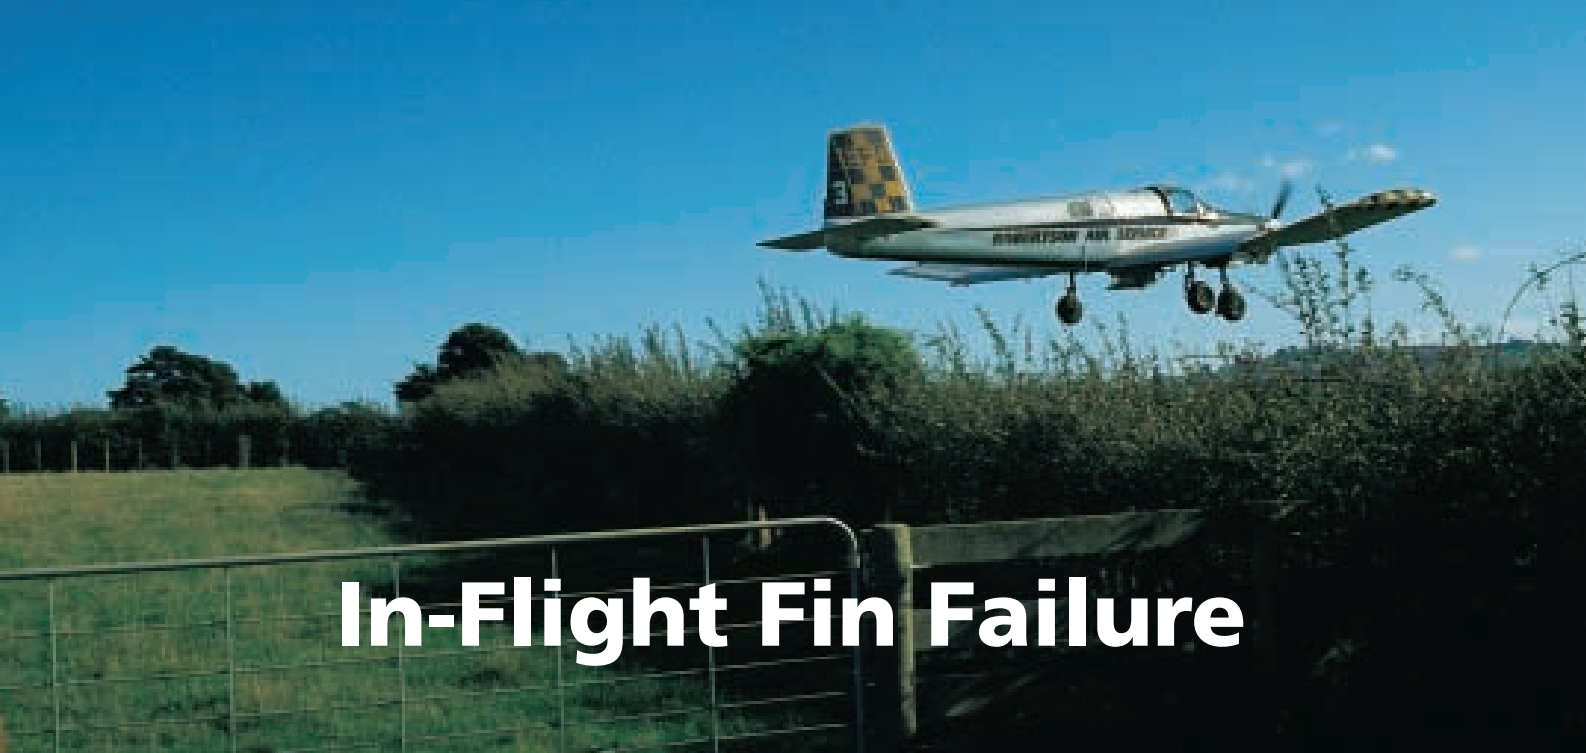
Tail Fin Failure

Investigation revealed that the fin failed due to a fatigue crack in the skin near the base of the leading edge. The crack progressed until the skin failed suddenly, immediately aft of the forward attachment fitting. Without the support of the forward fitting, the rear-mounted spar was unable to resist the aerodynamic loads and the fin departed over the left side of the aircraft.

Examination of the fracture surfaces revealed the fatigue crack had initiated from a score mark in the 0.020-inch skin of the leading edge. The score mark appears to have been caused by the knife used to trim the anti-abrasion rubber strip that had been applied to the leading edge of the vertical fin (refer to the accompanying photographs).

When the cause of the accident became apparent, an emergency AD was issued. Subsequent to this, two more aircraft were found to have sustained skin damage during the application of the rubber

leading-edge abrasion strips. As the skin on the vertical fin's leading edge is only 0.020 inches (0.51 mm) thick, repair was not possible, and in both of these instances the damaged skin was replaced.
