# Ag Work

## A Recent Accident

# and the R22

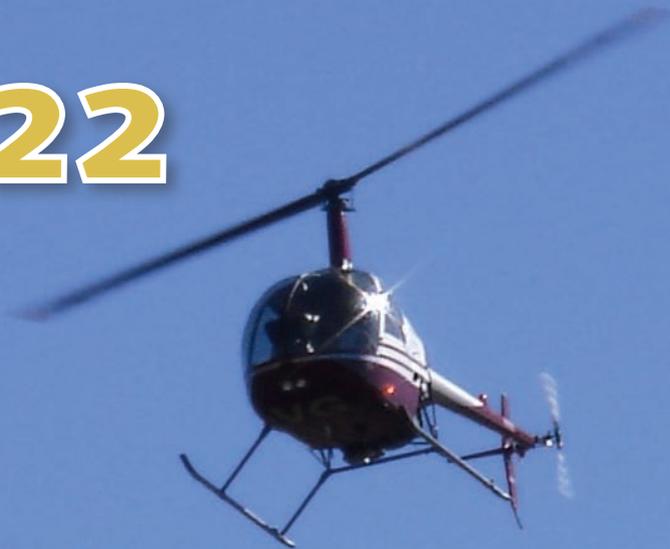
The R22 teetering hub, coupled with individual blade coning hinges and its relatively low inertia disc, means that the cyclic is very light and responsive. During rapid and large cyclic inputs, an upward moving blade will have the tendency to be trying to lead, while the opposite down-going blade will be trying to lag. The problem is, that the rotor head, in common with all two-blade rotor heads, does not allow for blades to lead and lag, so excessive cyclic inputs will result in the blade grip area taking excessive bending loads as well as the centrifugal loads. At 530 rotor rpm, for example, these Coriolis loads are occurring around nine times per second, and practices such as using excessive manifold pressure, or exceeding rotor rpm limits by overriding the governor with the "big twist and heave" will have the effect of seriously eating into the certificated safety margin. **And it could well precipitate the onset of fatigue cracking in regions not as yet able to be readily inspected.**

Even at the correct rpm, the use of full throttle at sea level would involve the drive train and rotor system in an excess of 22% above the manufacturer's published limits on a R22 Beta, and 37% on a R22 Beta II. There is **no** agricultural overload allowable for helicopters. The main reason for change of powerplant to the Lycoming 0-360-J2A in the Beta II was **not** to give the helicopter any **additional** sea level performance. It was to provide the rated 131 hp limitation to a greater altitude than that of the R22 Beta with the smaller Lycoming 0-320-B2C.
