May / June 2002

# VECTOR

# That Sinking Feeling

# Timely Reporting

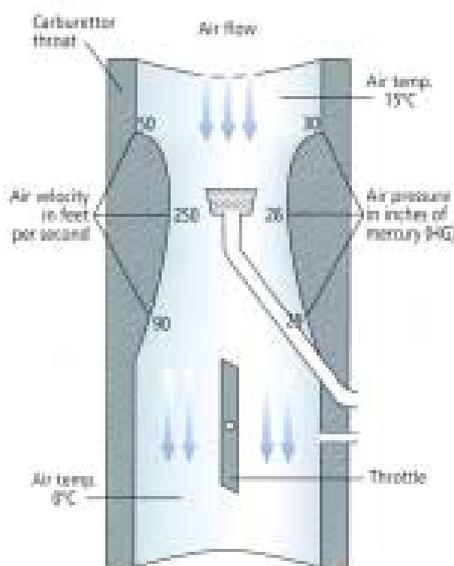
Figure 1 shows the change in air temperature through the venturi. Air temperature at entry is 15°C, but after passing through the venturi it falls to approximately 0°C – a net drop of 15°C.

**Figure 1.** Simplified views of a venturi showing changes in air velocity and temperature. These vary in relation to changes in throttle opening and engine rpm.

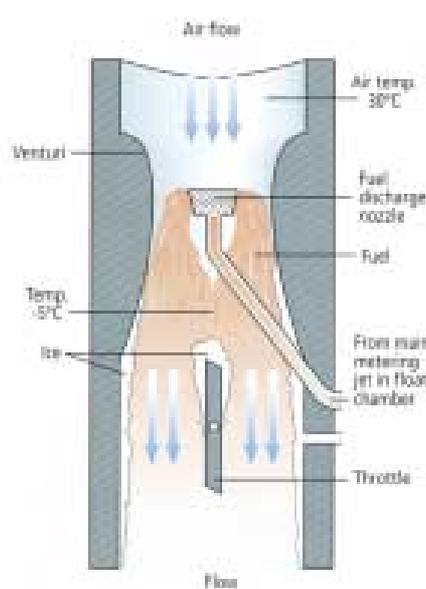
Figure 2 shows a venturi and throttle valve as in Figure 1, except that a fuel discharge nozzle is present in the venturi bore. This is typical of float-type carburettor design. Location of the fuel discharge nozzle in the low-pressure area of the venturi causes fuel to flow from the float chamber to the discharge nozzle. The rate of flow varies according to the airflow through the venturi.

Note in *Figure 2* how ice is forming on the throttle and throat below the venturi. If the situation were allowed to continue power loss must ultimately occur. Ice is not depicted on the discharge nozzle or the upper area of the venturi since it is intended to show only the effects of refrigeration icing from fuel vaporisation. However, it is possible to accumulate ice on the nozzle and upper venturi areas because they are also chilled by the venturi and vaporisation actions.

**Figure 2.** Float-type carburetors have a fuel discharge nozzle located in the venturi. Venturi action plus cooling effect of fuel vaporisation can reduce mixture temperatures markedly.

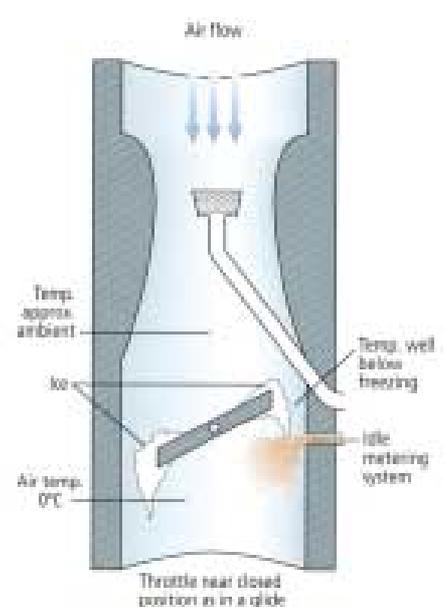
When sufficient moisture is present, ice will form on the cold throttle plate. This can be quite hazardous, as only a small amount of ice is required to quickly bridge the gap between the throttle and the throat wall (*Figure 3*). This condition can freeze the throttle valve to the walls of the carburettor throat, and when the unsuspecting pilot attempts to apply power she or he may

**Figure 3.** The risk of serious carburettor icing is greatest at low or idle power settings. When carrying out prolonged glides, the engine must be warmed regularly to provide sufficient exhaust heat to the hot-air heat exchanger.

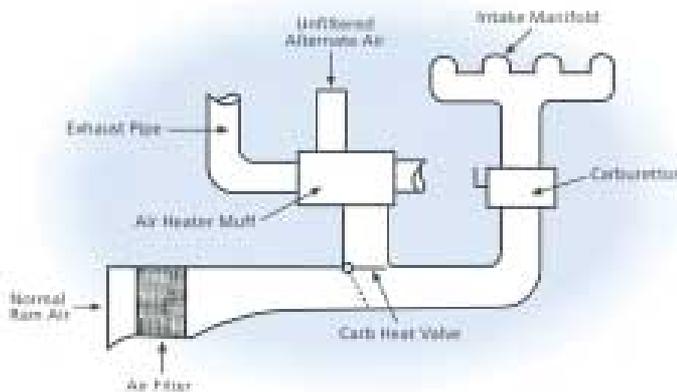
**Figure 4.** Simplified induction system showing the carburettor hot-air heat exchanger and valve. For carburettor heat to be fully effective, exhaust system temperatures must be maintained at a reasonable level.
