# INTELLIGENCE & SAFETY ANALYSIS

# 2019 GA SAFETY PERFORMANCE UPDATE

Prepared by JOE DEWAR  
CIVIL AVIATION AUTHORITY

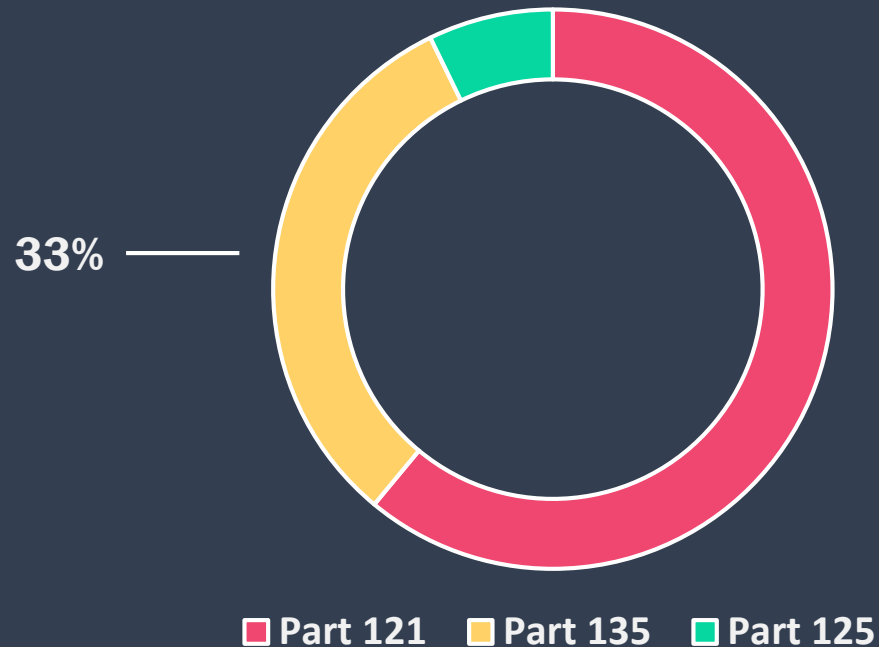
NZ Domestic Air Transport Hours 2018-2019

**498 HELICOPTERS**

**200 SMALL AEROPLANES**

**TOTAL PAX SEAT CAPACITY – 3,980**

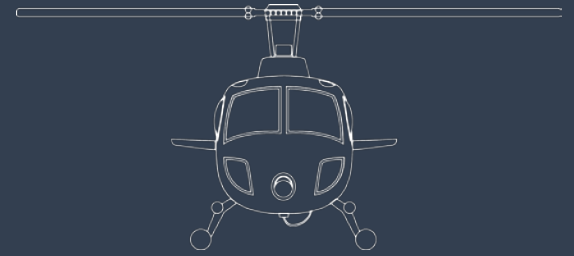
Cargo hook universal joint failed during agricultural fertiliser operation.

During scheduled maintenance, while complying with Airworthiness Directive DCA/AS350/129A on the cargo swing gimbal/universal joint assembly, P/N OAL 114-10504, a crack indication was identified. The part was removed and the 146 Design Organisation was notified of the defect.
