VECTOR

Pointing to Safer Aviation

Agricultural Airstrip Standards

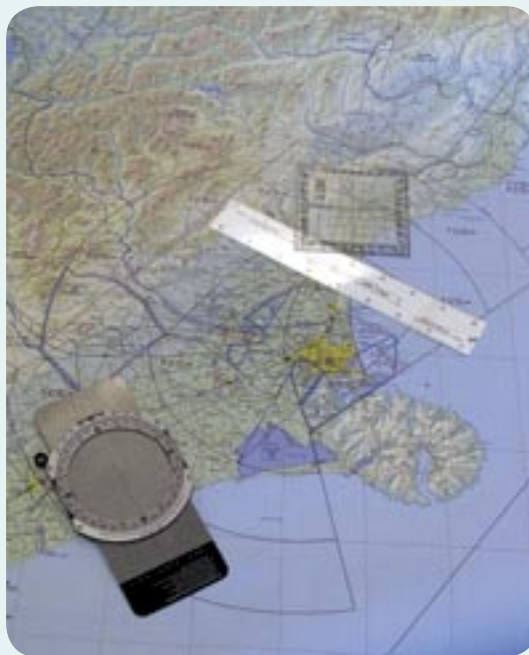
An example of the new Visual Navigation Charts.

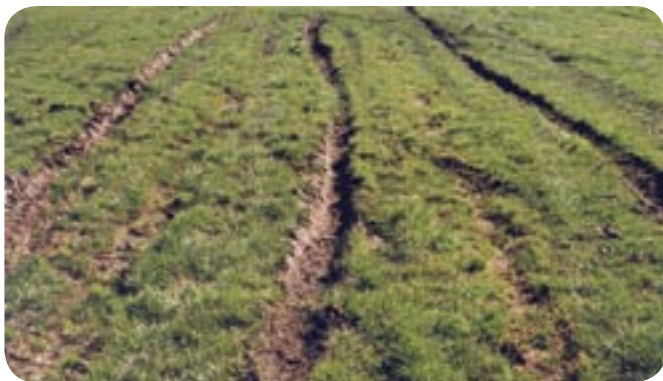
The airstrip used by the accident aircraft.

The aircraft was flown to a farm airstrip, then loaded with a small amount of agricultural product. An extremely soft airstrip surface condition, combined with a quartering tailwind, degraded the aircraft's performance to the extent that it was unable to become airborne within the available takeoff distance. The load was jettisoned, but the aircraft struck a fence and scraped the ground with its left wingtip and aileron. The aircraft did become airborne, but was unable to be effectively controlled and turned back into a lefthand orbit towards rising terrain, subsequently striking the ground. The pilot received serious injuries.

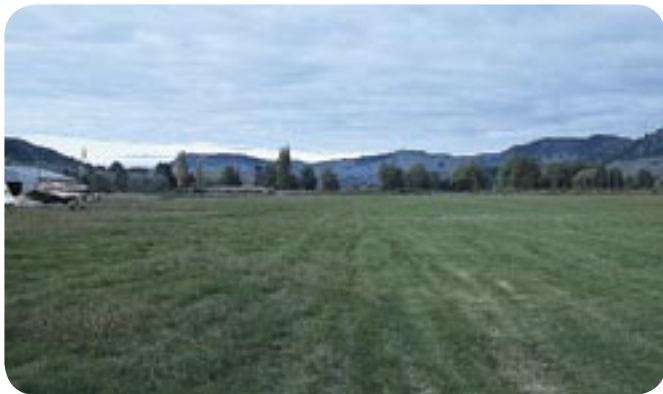
The airstrip dimensions are particularly important because they act as a safety buffer should the aircraft depart the runway unexpectedly.

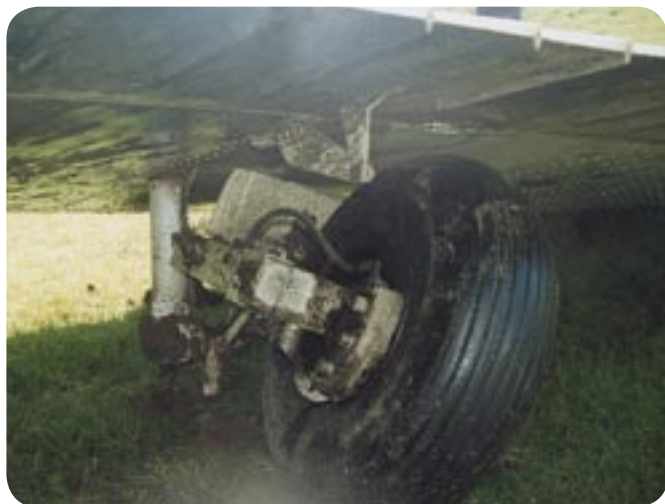
It is important to ensure the surface condition of the airstrip is suitable to minimise undercarriage stress.

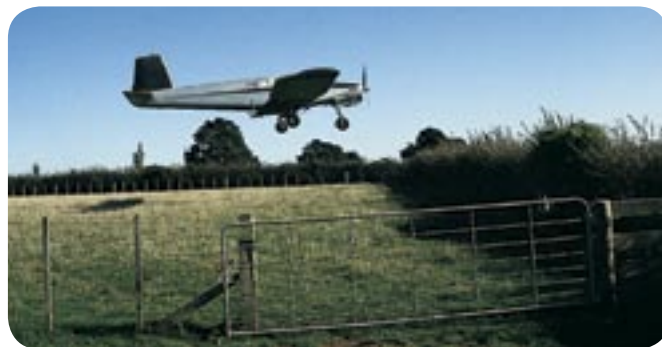
If possible remove the fence at either end of the strip or adjust the threshold accordingly.

A significant number of agricultural aircraft incidents/accidents are caused by fence strikes. The risk of this happening can be **greatly** reduced by removing **all** fencing (including temporary electric fencing) within 200 metres of each end of the runway, or from the landing threshold in the case of a one-way airstrip. This should be done for the duration of the topdressing. The landowner needs to be advised of this well in advance. If this is not possible, the threshold will have to be inset accordingly and a reduced payload may have to be carried.

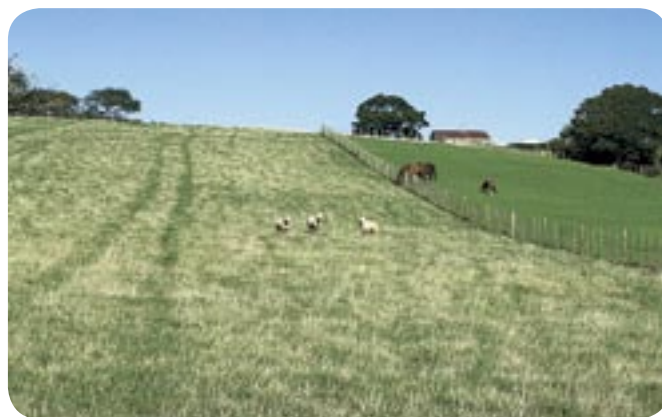
Ideally the entire airstrip should be well fenced to keep stock out prior to, and during, top dressing operations.

There are many reports on record of damage to aircraft caused by collision with livestock. Each occurrence is an unwanted expense to the operator. It is vital that the entire airstrip (including the bulk bin and loading area) is well fenced to keep stock out prior to, and during, topdressing operations. Even so, an inspection of the airstrip for rogue stock should be completed before the first landing.

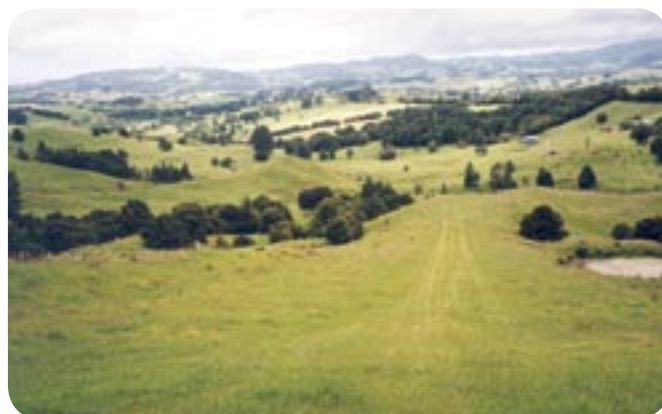
An obstruction within the takeoff path can be dangerous especially if the aircraft needs to maintain (or lose) height to accelerate to best angle of climb speed.

Every agricultural pilot knows just how critical the initial phase of flight can be after takeoff in a heavily laden aircraft. An obstruction within the takeoff path can be extremely hazardous, especially if the aircraft needs to maintain (or lose) height to accelerate to best angle of climb speed. The worst-case scenario must be allowed for as unexpected tailwinds or downdraughts may be encountered at the worst possible time and the angle of climb will be drastically reduced.

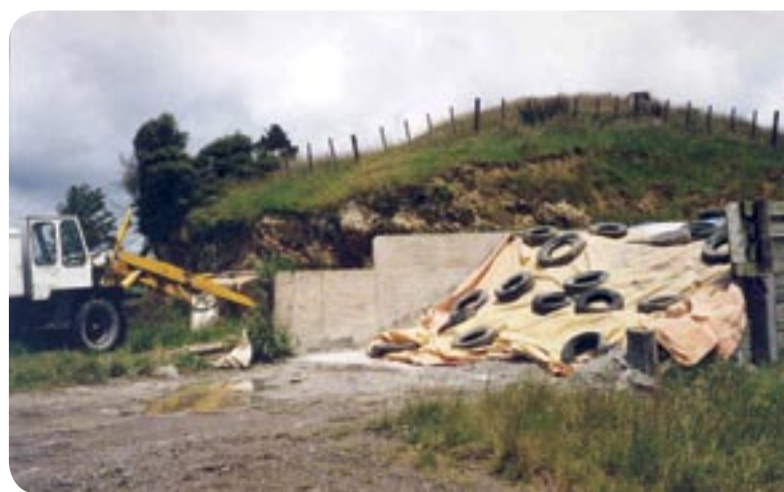
Ideally, the bulk bin should be fully enclosed to prevent the product from becoming damp. If the bin has been exposed to the weather, it is essential to reassess the suitability of the product.

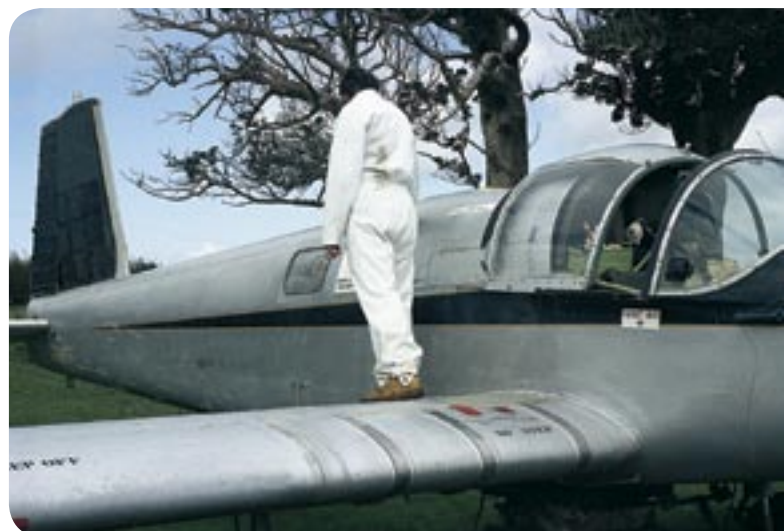
Constantly check the hopper for product bridging.

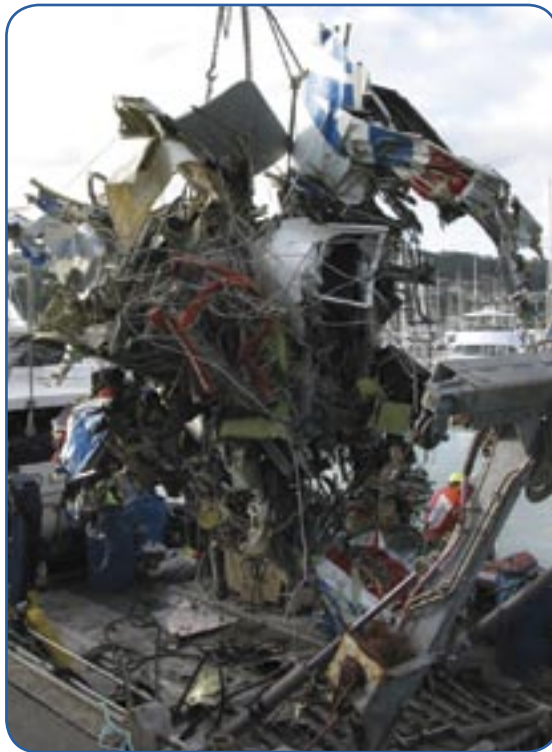
Forward section of the accident aircraft.

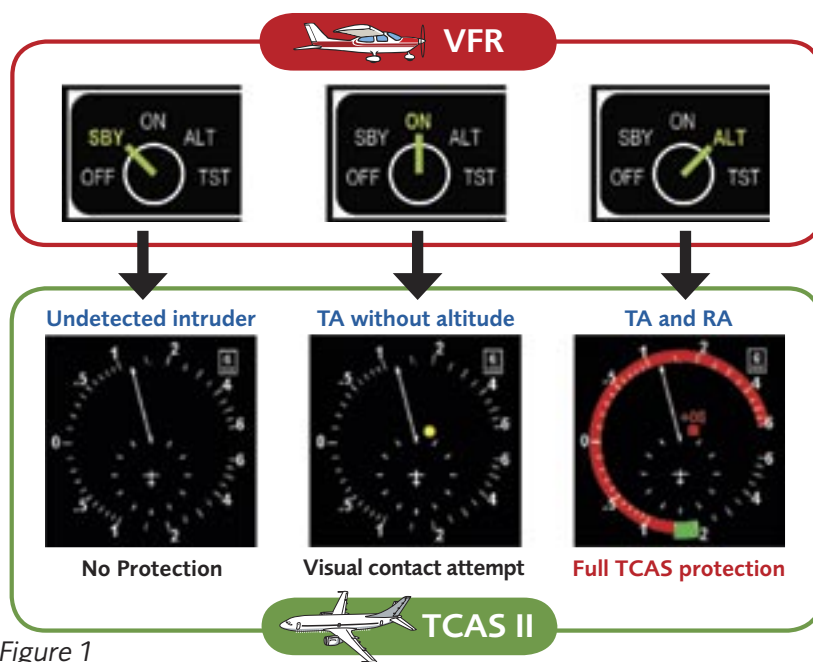
Figure 1

VFR Traffic Transponder Mode and TCAS II Alerts

- **“ALT”**: TCAS II can trigger TAs and Resolution Advisories (RAs). An RA, if followed, protects the VFR traffic, as well as the traffic equipped with TCAS II, from collision.

For maximum safety benefit from TCAS II, VFR aircraft must squawk ALT (Mode C).

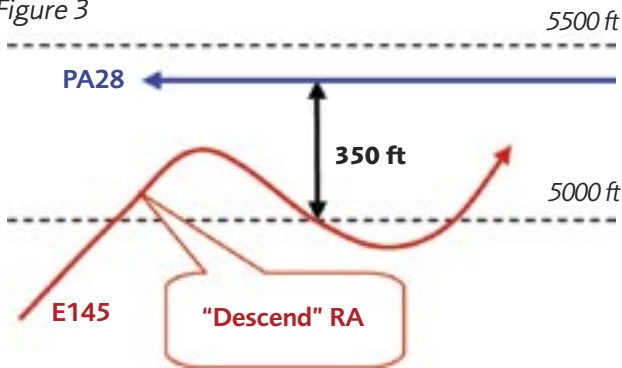
Figure 3

The controller also provides traffic information to the PA28 about the E145, “12 o’clock, opposite route, passing your altitude”. Then, he provides further traffic information to the E145 (traffic at 12 o’clock, 4 nm). About 15 seconds later, the E145 receives a “Descend” RA, when passing 5100 feet. The pilot follows the RA correctly and initiates a descent.

Four seconds before passing the E145, the PA28 pilot reports visual contact.

As a result of following the “Descend” RA, the E145 passed about 400 feet below the PA28. Simulations indicate that **without TCAS, the separation between the aircraft would have been only about 100 feet and 0.04 nm.**
