vector

THINGS THAT **JEOPARDISE YOUR LOOKOUT**

In this issue...

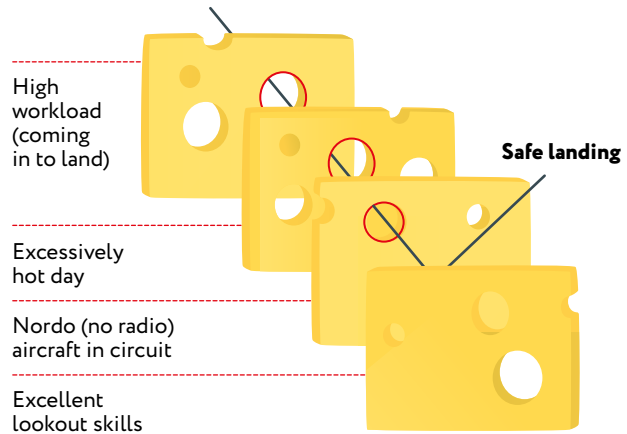
The ‘swiss cheese’ model of accident causation

Pilots’ lookout and situational awareness can be the last slice of cheese, where the holes *don’t* line up, preventing a catastrophe.

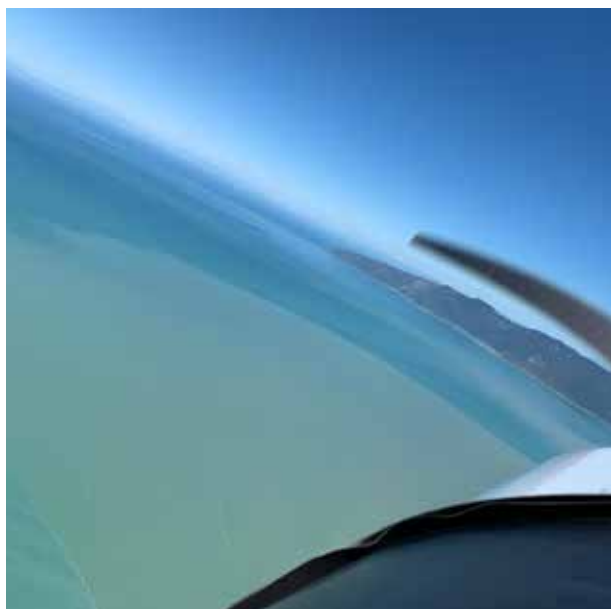
Photo: CAA/Marc Brogan

Let's refer to the image below, often used for perspective, and reference to the horizon, in medium and steep turn lessons.

The image depicts the left-hand turn with the pilot sitting upright in the aircraft – their horizon is angled.

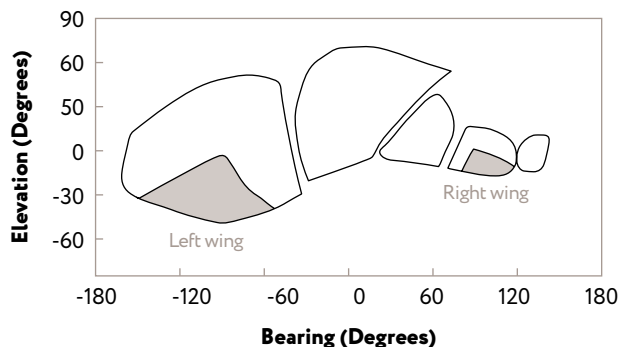
Limited cockpit visibility from a typical general aviation aircraft

Source: ATSB "Limitations of the see-and-avoid principle" 1991

As you can see, the actual usable FOV – when you allow for aircraft design and our human eyeballs – is extremely limited. If you were to overlay this on to a real-world image – diagrammatically presented below – the picture becomes obvious.

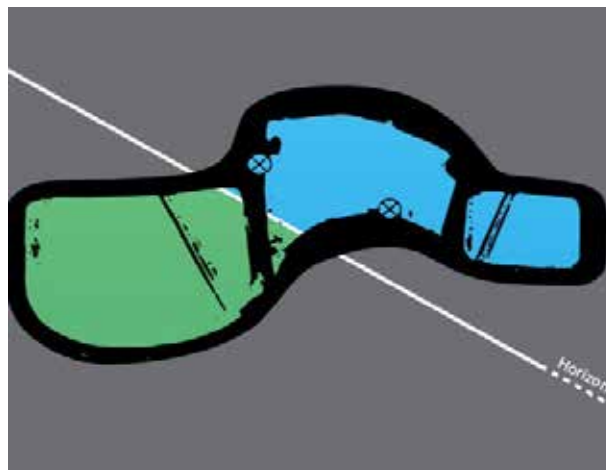
Pilot forward view, without tilting their head

Source: CAA

By leaning slightly *away from the turn*, your head can now be moved, with a greater reference to the actual horizon, past aircraft design features that may otherwise limit the view and your peripheral vision.

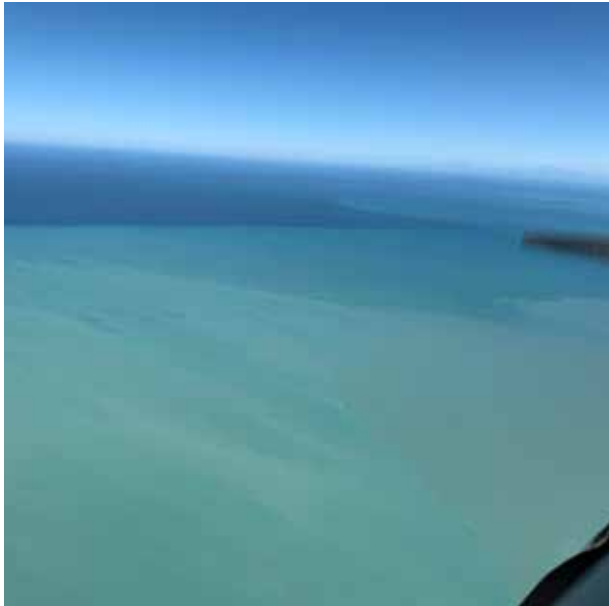
Photo: CAA/Marc Brogan

» The picture below simulates that change of view, as does the second diagram.
