VECTOR

Pointing to Safer Aviation

Over the Limit

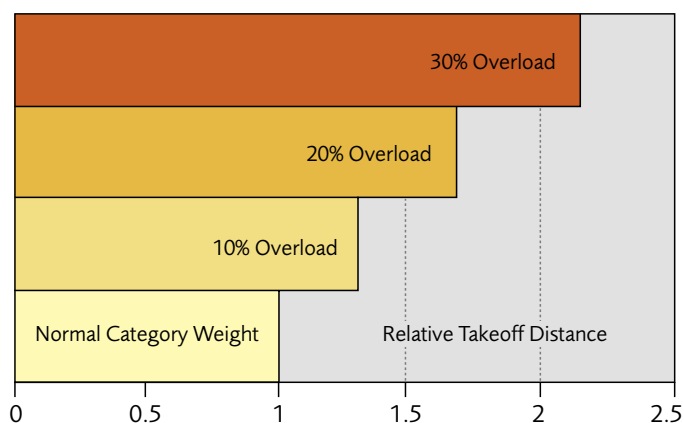
Increased Takeoff Distance – The distance required for ground roll to liftoff and accelerate to best climb speed increases dramatically with overloading, as the first bar chart shows.

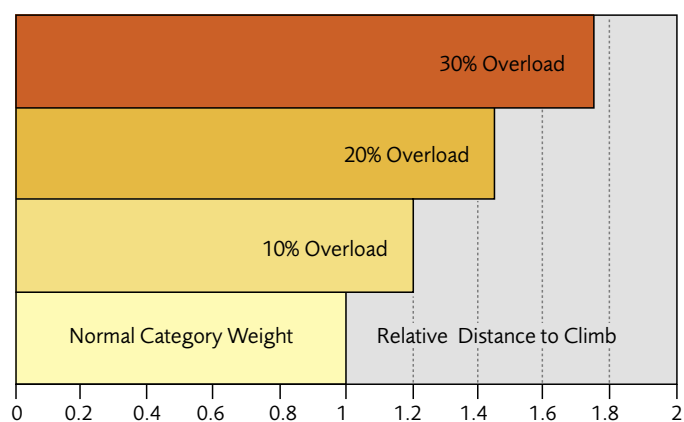
Reduced Angle/Rate of Climb – The angle and rate at which the aircraft is able to climb are significantly reduced at higher weights. This of course translates into a much greater distance to gain height.

Such large increases in climb distance can make obstacle avoidance in the takeoff flight path difficult, and they certainly limit options when manoeuvring in a confined space, such as a valley. Out-climbing the terrain at the higher weight just may not be an option unless the load is jettisoned.

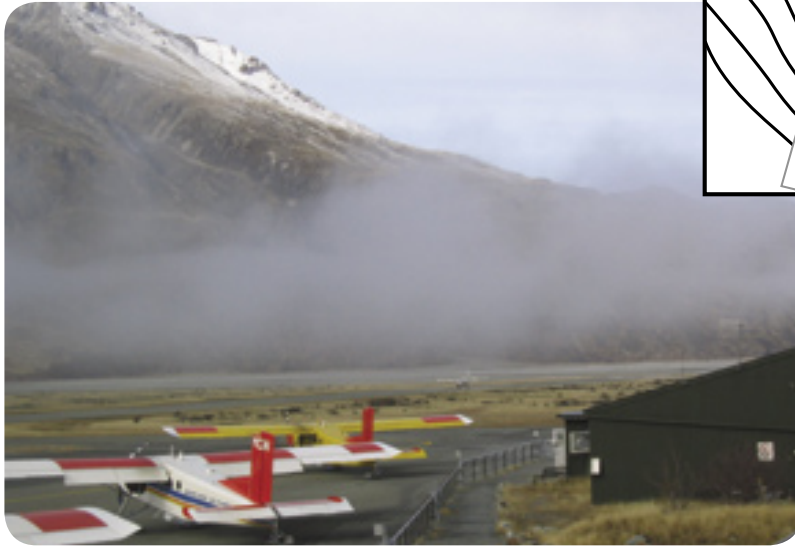
Radiation Fog clearing at Mount Cook aerodrome.

Radiation fog normally occurs during a clear night, or in the early morning after sunrise. The depth of the fog layer varies depending on the availability of moisture, but typically is around 100–200 feet. Radiation fog can thicken after sunrise.
