# VECTOR

*Pointing to Safer Aviation*

FIXED-WING ACCIDENTS  
AND INCIDENTS

HAND-SWING STARTING

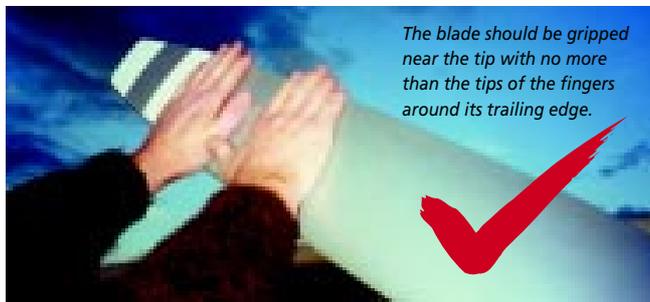
*The blade should be gripped near the tip with no more than the tips of the fingers around its trailing edge.*

The propeller blade should be gripped near the tip with no more than the tips of the fingers around its trailing edge. Ensure that you have removed any loose items of clothing such as neckties (can be tucked into shirt to secure), jackets, and baggy jerseys – getting any of these caught in a rotating propeller does not bear thinking about. Wrist-watches should not be worn (unless well protected under clothing), particularly those with metal wrist straps, as the catch could unfasten during the downward swing allowing the loose strap to become caught by the prop tip. Rings can be a danger also, as the propeller could kick back and catch the ring finger against the trailing edge, probably ripping off the whole finger.
