# **Fletcher FU24 Fin Engineering Review**

## **Summary Report – Final**

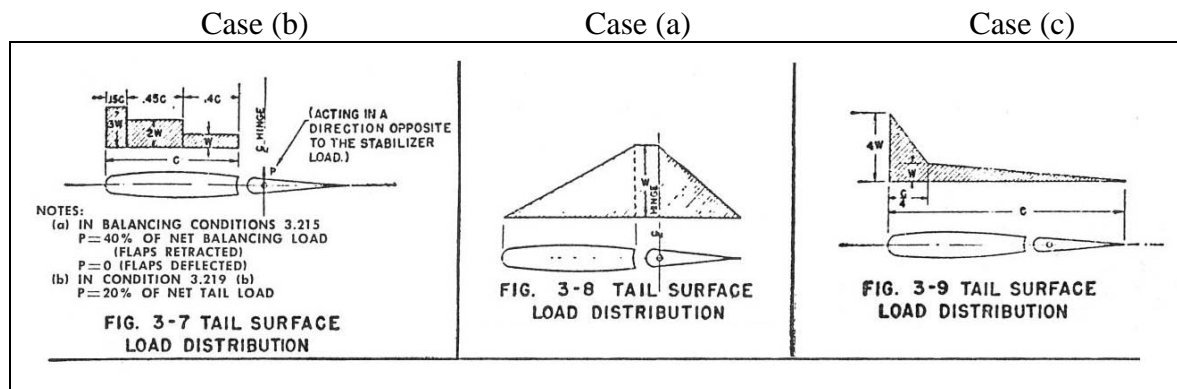
There are thus three design cases to consider, which can be summarised as Case (a) full rudder deflection at  $V_A$  (maximum manoeuvring speed), Case (b) full rudder deflection in a sideslip, and Case (c) neutral rudder in a sideslip. Case (a) assumes a middle load distribution in Figure 3-8 due to the high camber of the deflected surface, while the latter two cases (b and c) assume a forward-biased load distribution per Figures 3-7 and 3-9, as reproduced below. CAR 3 also provided for a simplified method of determination of the average loading (of the tail surfaces, including the vertical fin), using a table which was effectively proportional to the aircraft weight.

In practice, Case (b) is usually the same as or less than Case (c) so that only (a) and (c) need be considered. Case (a) is also usually numerically higher, but Case (c) more severe because of the forward loading. These requirements are virtually unchanged under the later FAR 23 design standard in paragraph §23.441, as used for the Cresco. (There are small changes in the wording.) However from Amendment 23-42 dated 2/4/91 the option to use the simplified average loading and load distributions are removed.

- (a) With the airplane in unaccelerated flight at zero yaw, a sudden displacement of the rudder control to the maximum deflection as limited by the control stops or pilot effort, whichever is critical, shall be assumed. Note: The average loading of Figure 3-3 and the distribution of Figure 3-8 may be used.

- (c) The airplane shall be assumed to be yawed to a sideslip angle of 15 degrees while the rudder control is maintained in the neutral position (except as limited by pilot effort). The assumed sideslip angles may be reduced if it is shown that the value chosen for a particular speed cannot be exceeded in the cases of steady slips, uncoordinated rolls from a steep bank, and sudden failure of the critical engine with delayed corrective action. Note: The average loading of Figure 3-3 and the distribution of Figure 3-9 may be used.
